The Archaeology of Furnace Falls:

A Mitigation Report on the Use of GIS, GPS & LIDAR
for the Definition & Documentation of Furnace Falls
Dam, Spillway, Weir & Channel

Stanhope/Netcong
Morris & Sussex Counties, New Jersey

Final Report to NJDEP - June, 2004

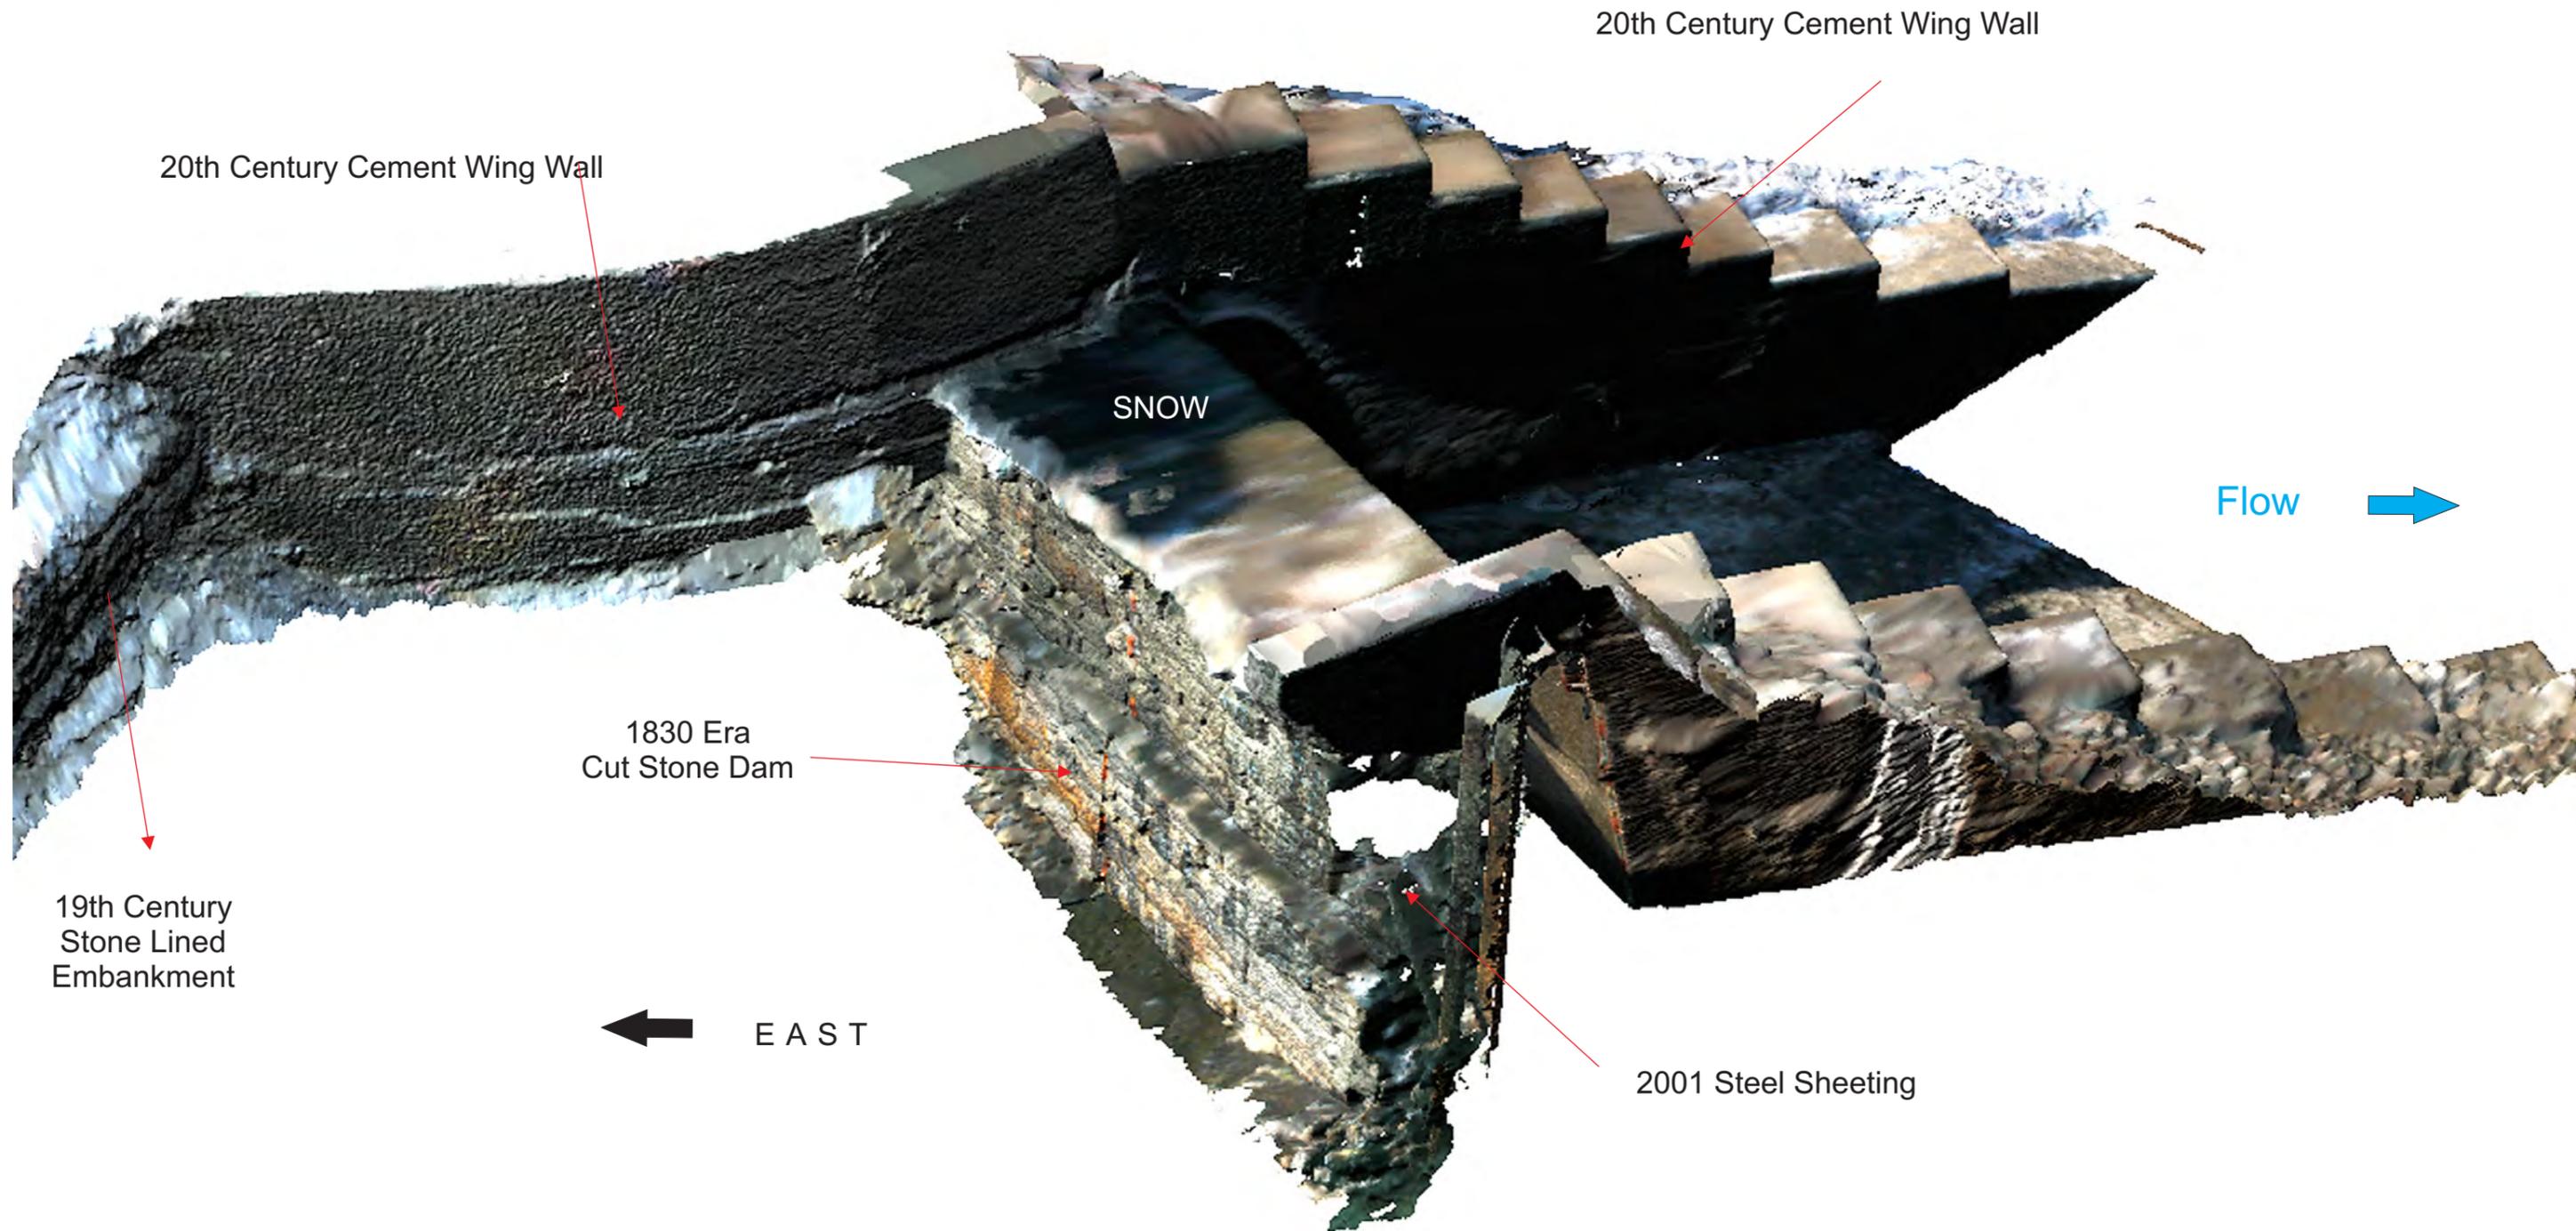
Figure 50: Virtual 3D Color LIDAR birds eye view of partially exposed historic Furnace Falls Dam, looking southwest and down from 50 ft., at its eastern cut stone face, later covered by 20th century cement cladding and cut into by cast cement wing walls.

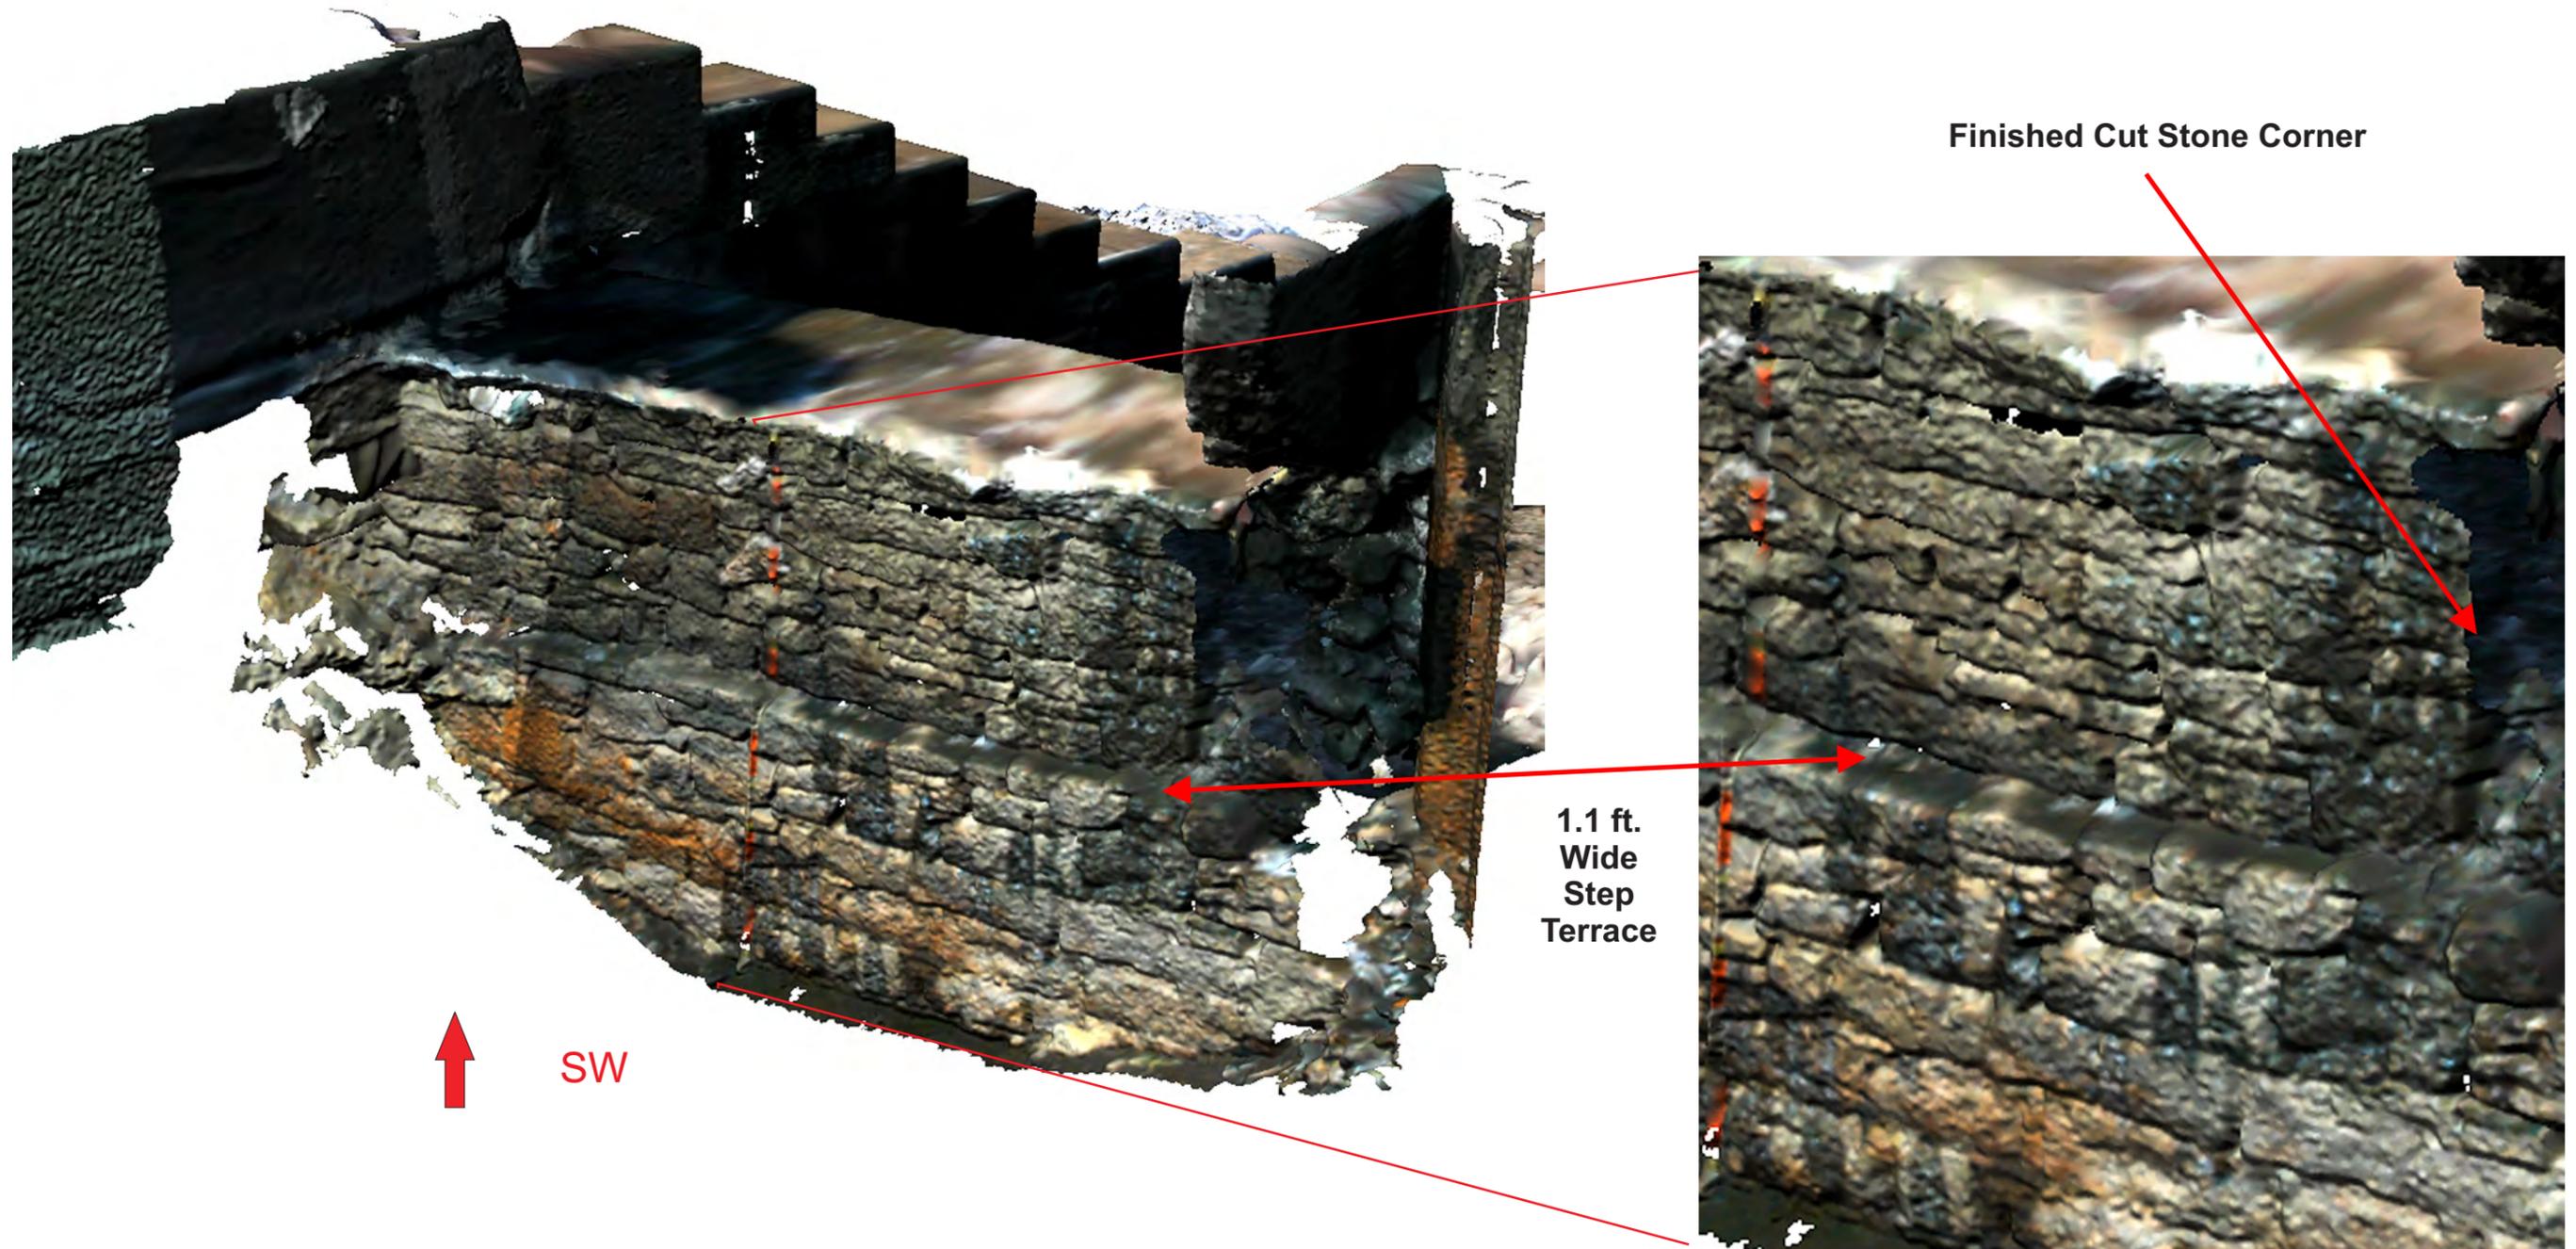
Figure 51: Virtual 3D color LIDAR perspective, looking south-west, highlighting finished northeast cut stone corner of historic Furnace Falls Dam. Although disturbed by the construction trenches and cement work of the later wing walls, the finished edge suggests a former, early 19th century, sluiceway to the north of the recently removed cement Spillway. The ability to “reinvestigate” the site in geo-referenced 3D color space provided otherwise unavailable access and proximity to areas of the dam too dangerous to approach during the excavation.

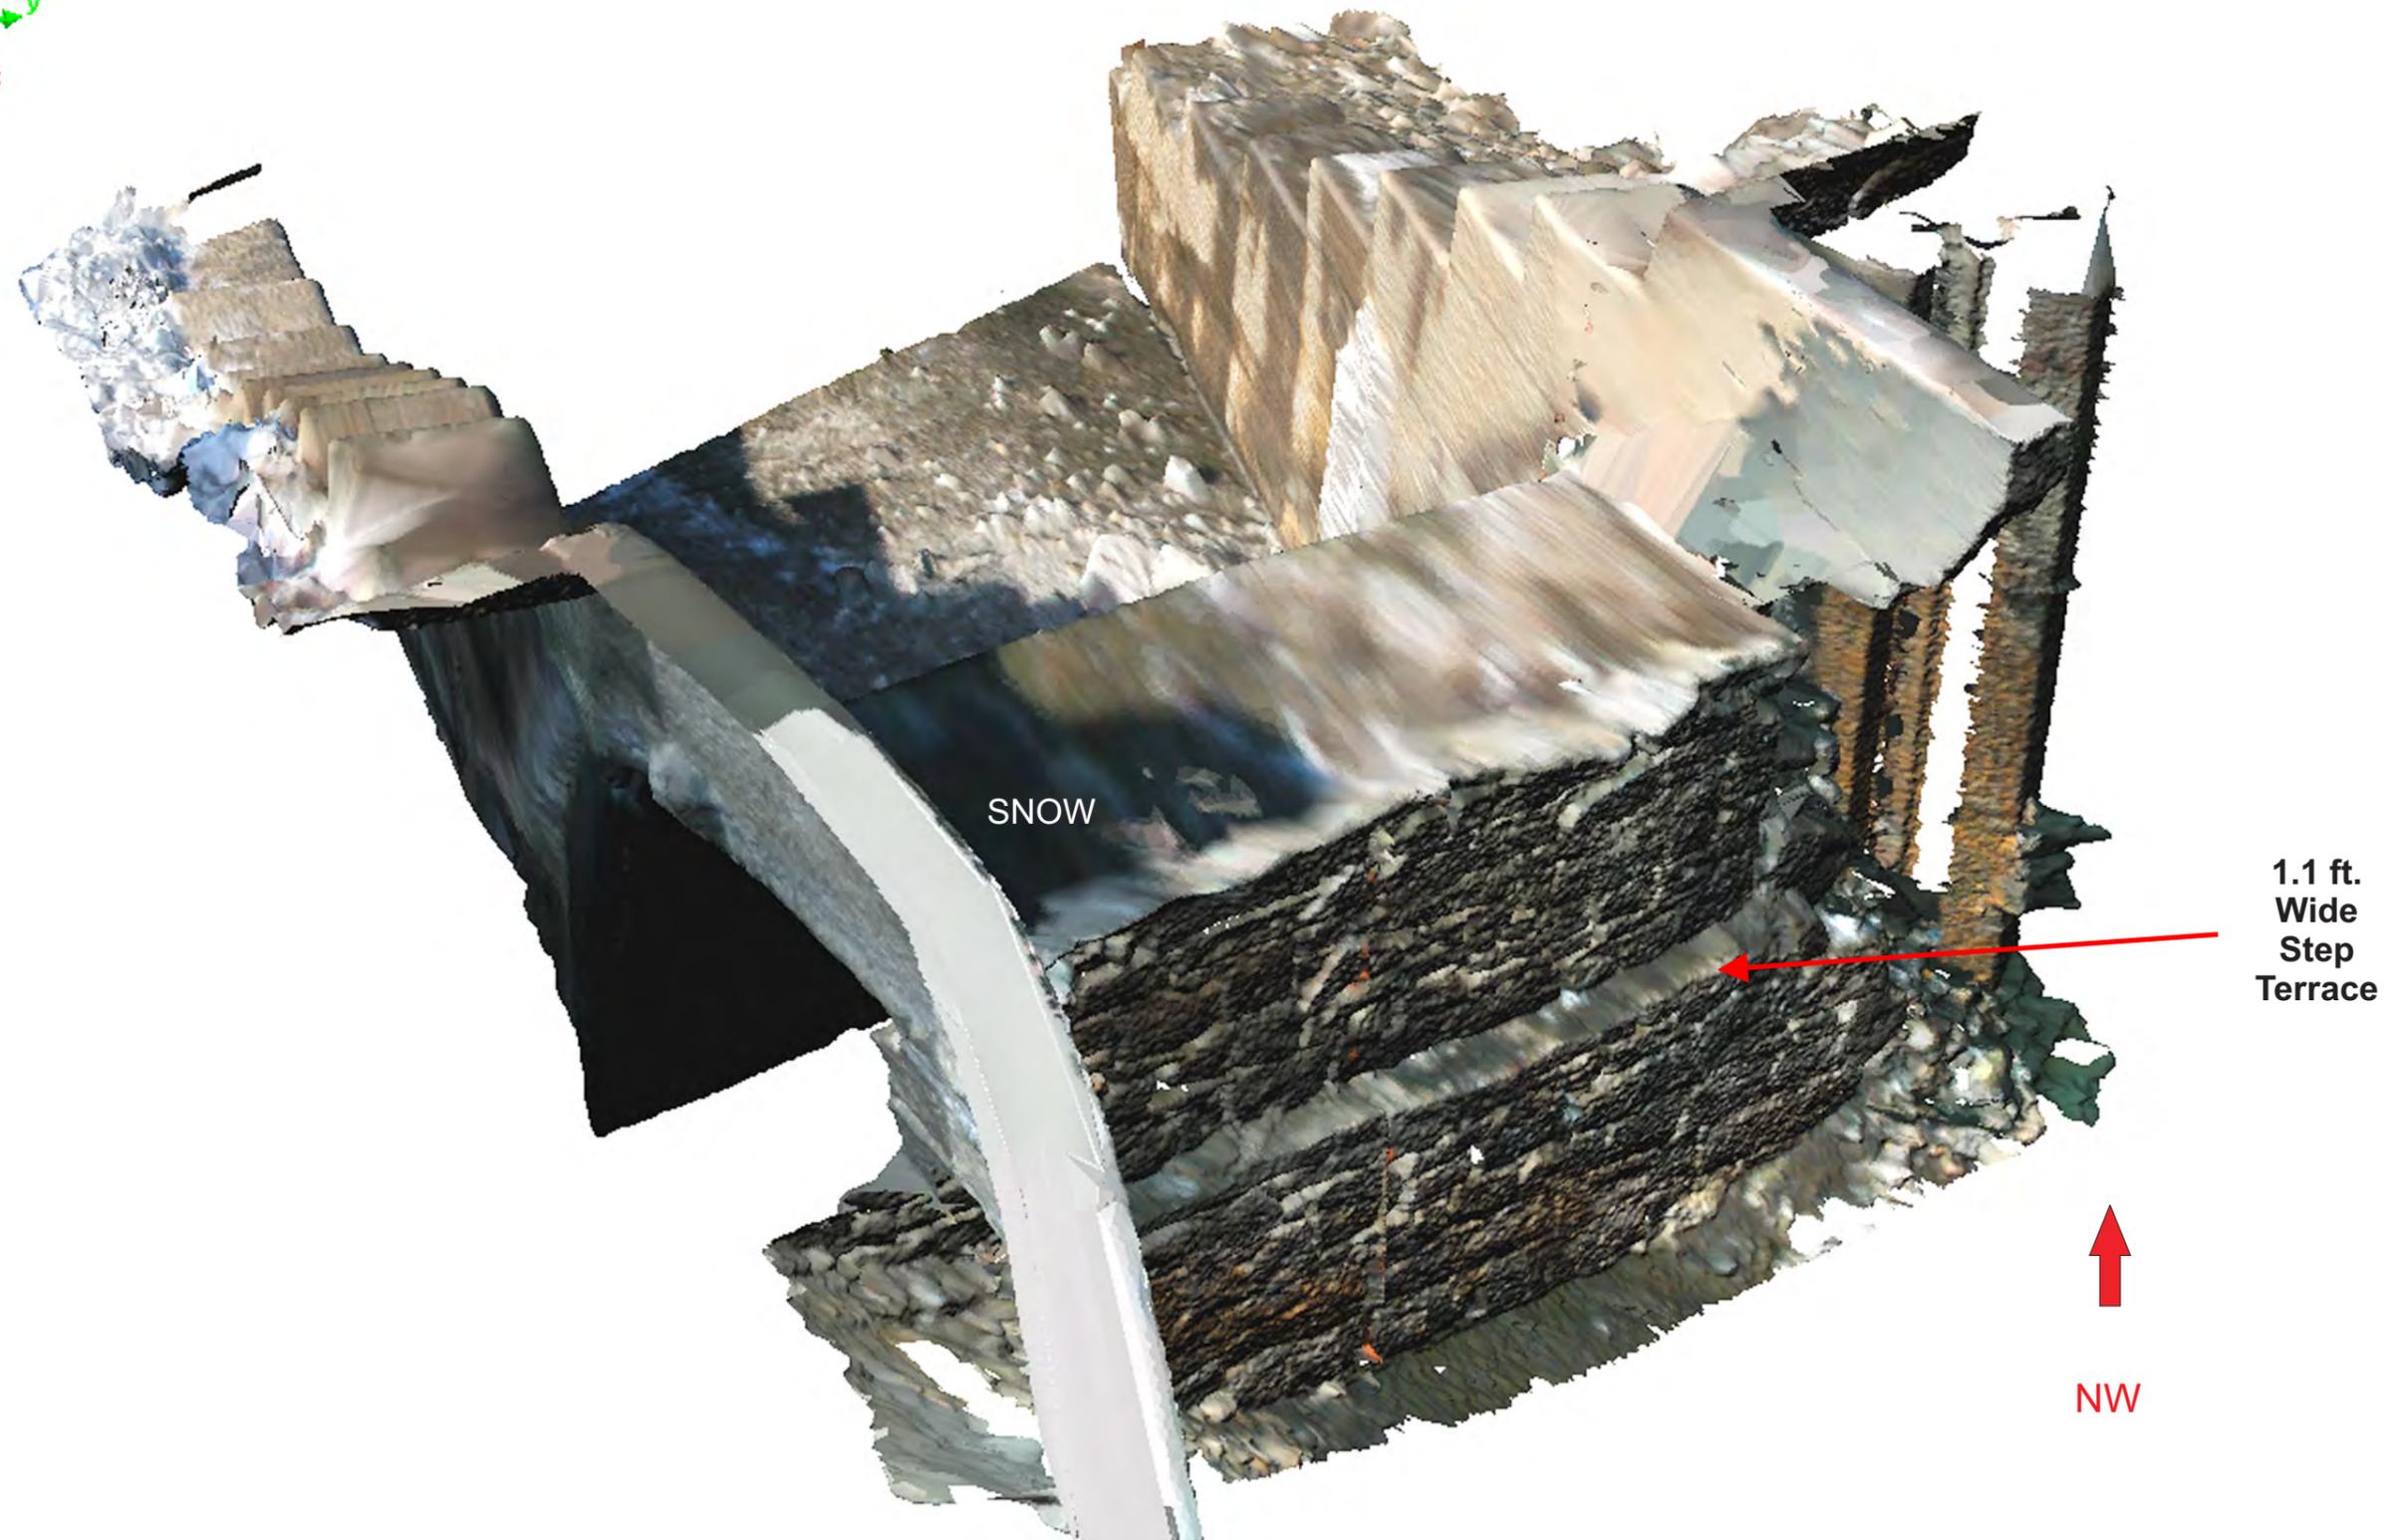
Figure 52: 3D color LIDAR view looking northwest at exposed eastern cut stone face of historic Furnace Falls Dam showing 1.1 ft wide step terrace 6 feet below the top of the spillway.

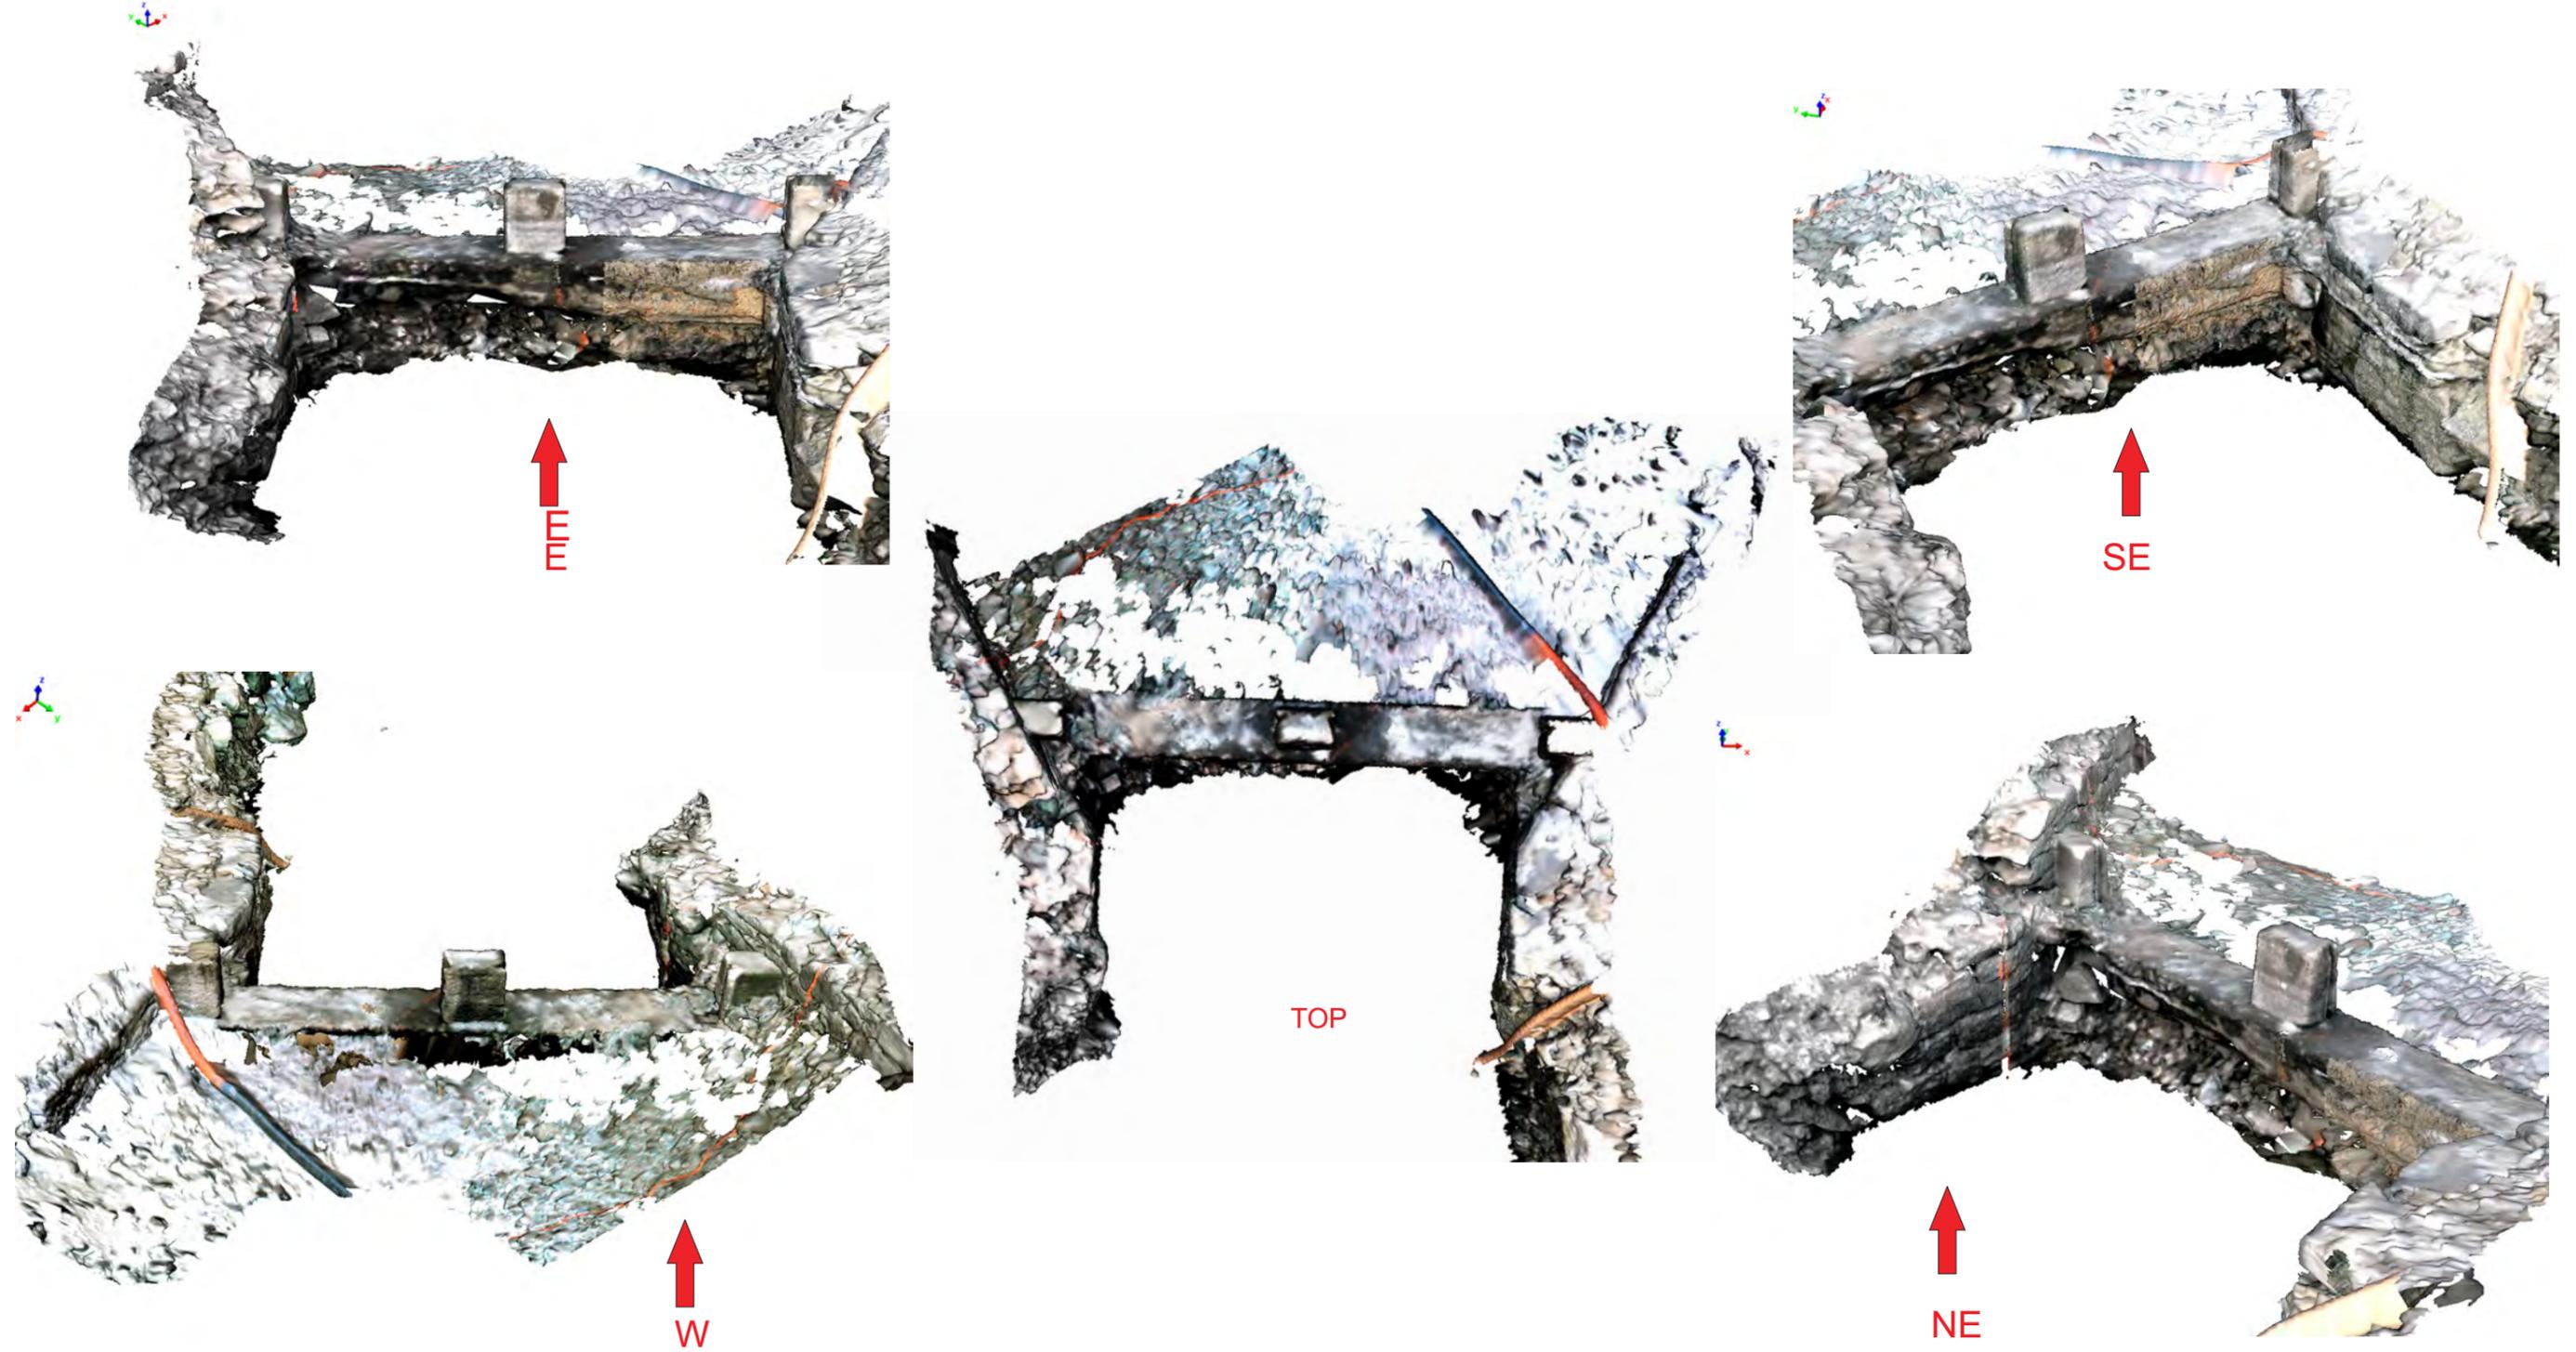
Figure 53: 3D color LIDAR scans of post-1927 cement Weir and earlier, 1874, cut stone wing walls of former arched bridge at Furnace Falls Pond.

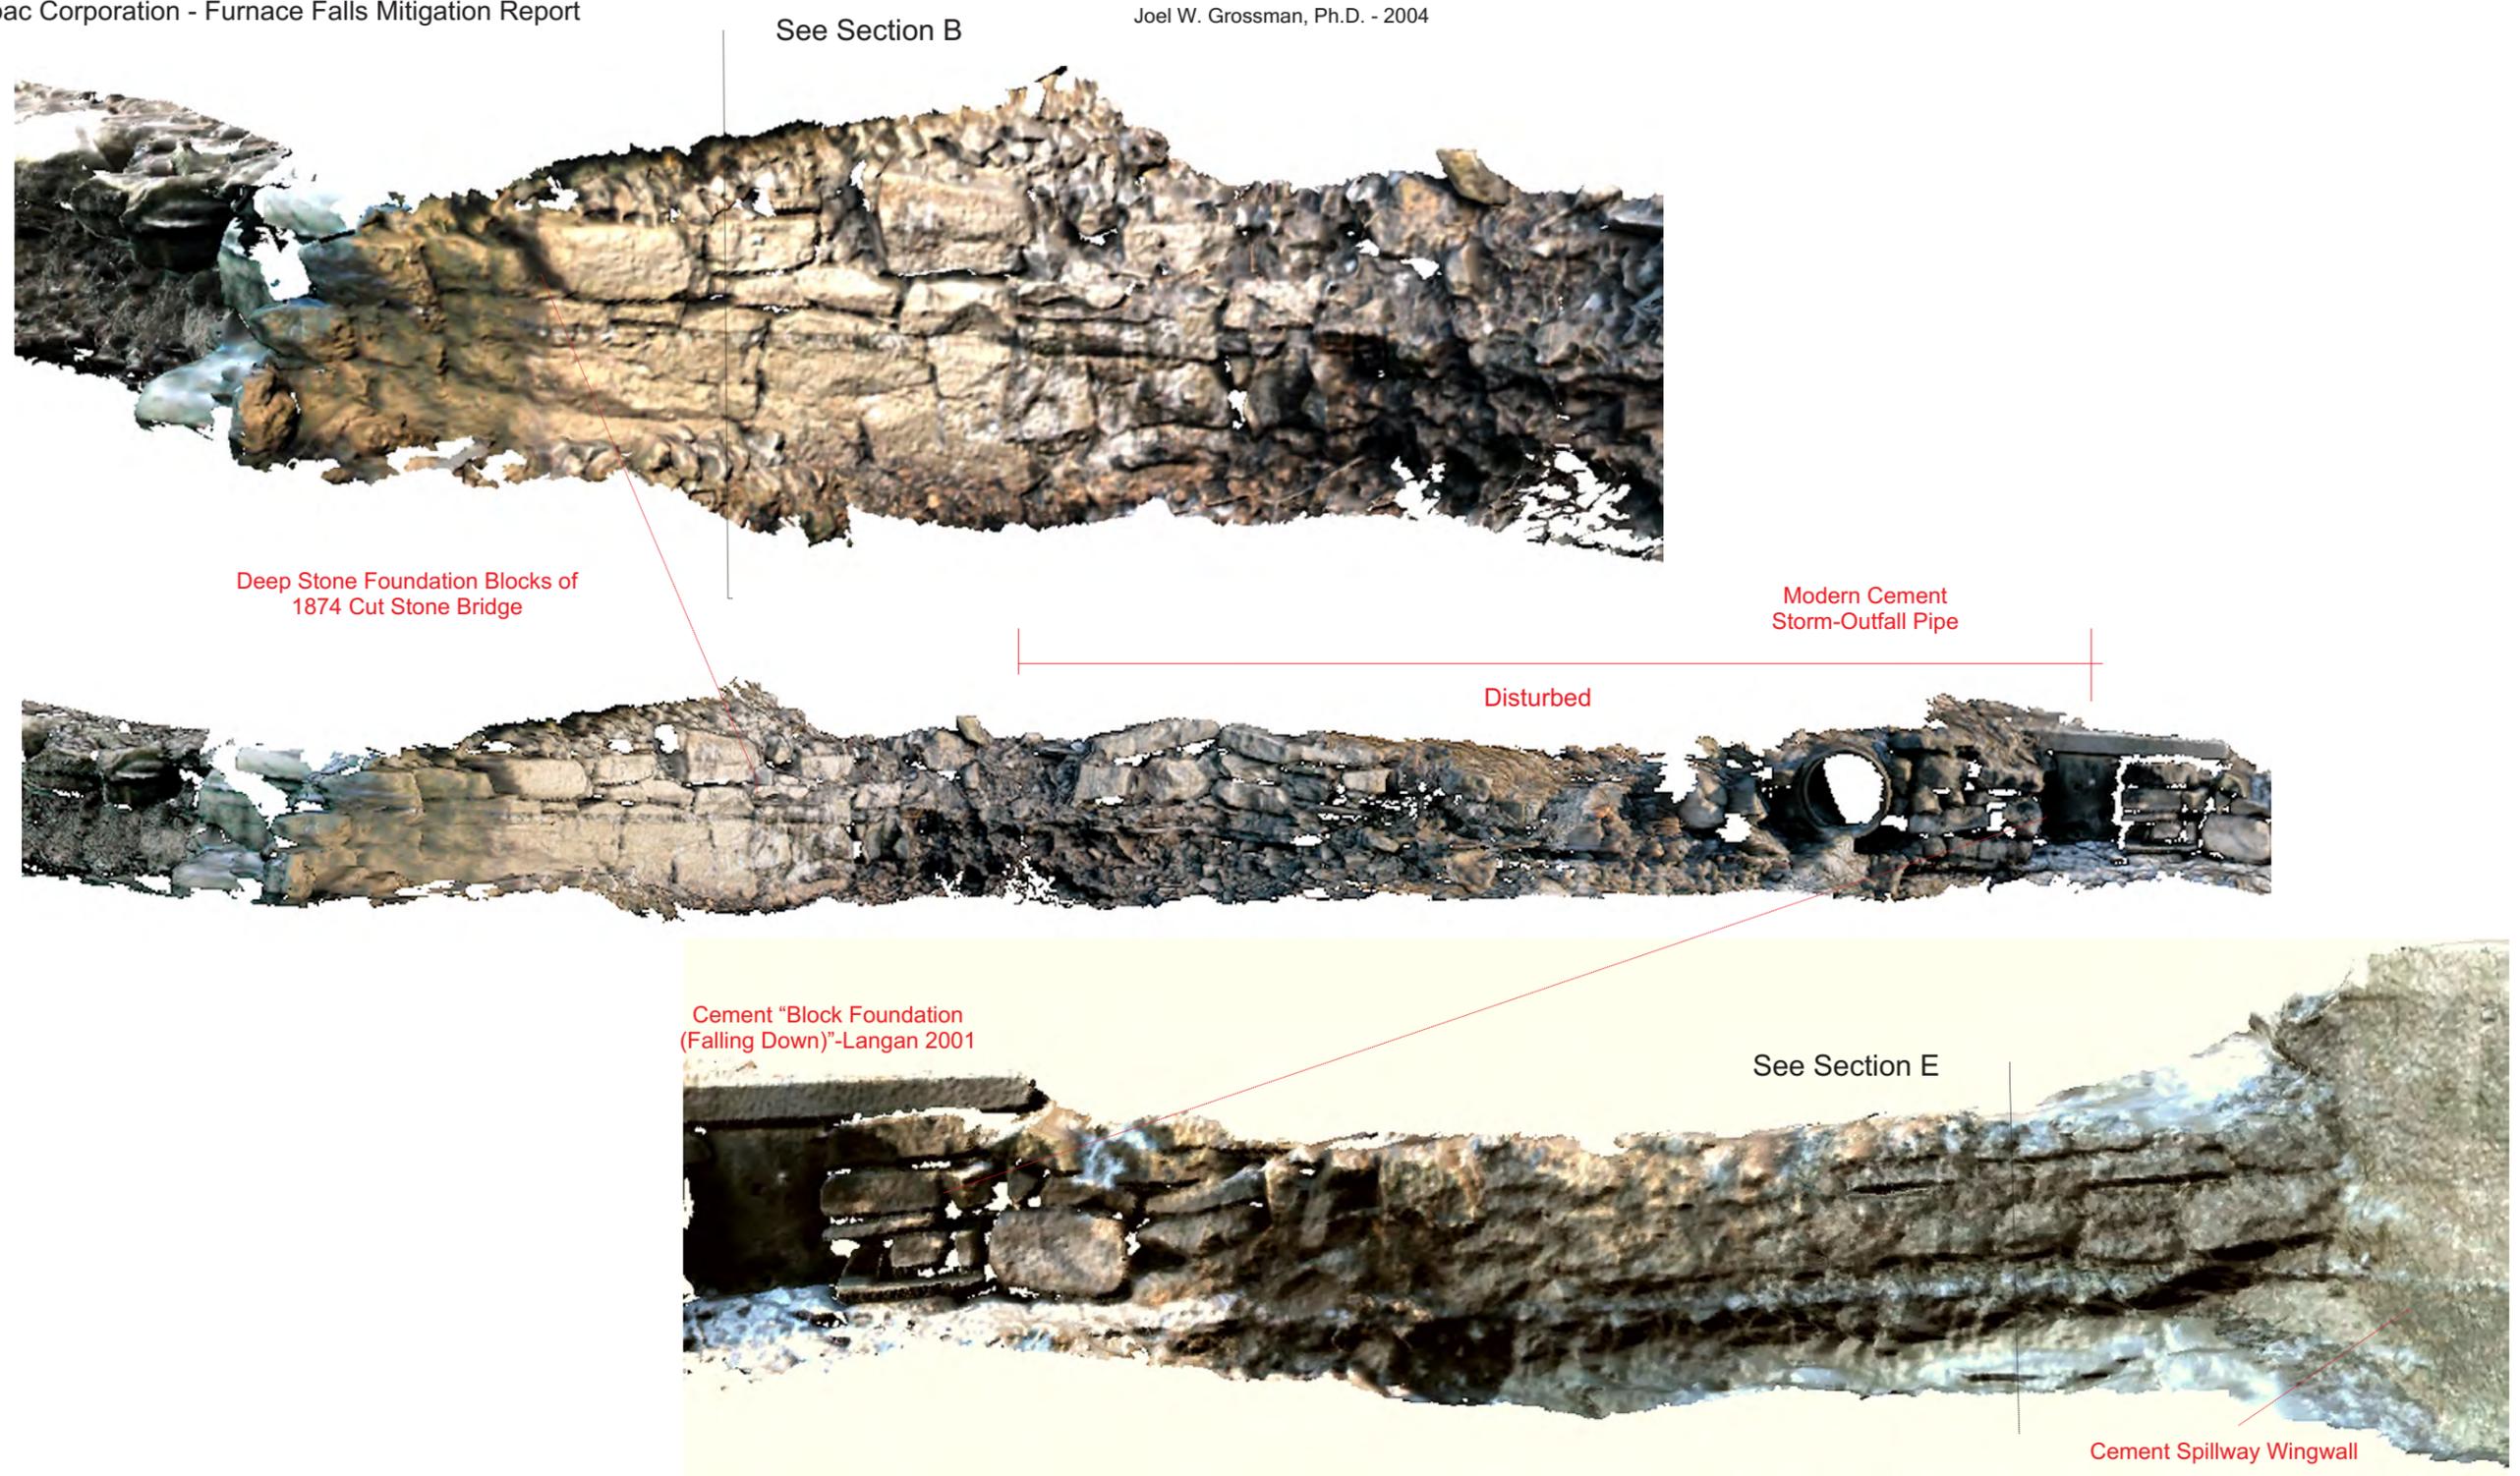
Figure 54: 3D color LIDAR scans of three sections of the south embankment of Furnace Falls channel: 1) The eastern end (top), near the former 1874 cut stone bridge, contained large, seven foot deep, stone blocks of the former bridge abutment between elevations 827 and 835+ feet. 2) The center section was disturbed by modern, ca. 1960, intrusions associated with the installation of a storm sewer outfall pipe and cast cement utility box. 3) The western 30 ft. section (right), adjacent to the cement Spillway wing wall, consisted of a three-course, five foot high, line of cut stone blocks between elevations 828 and 834 ft.

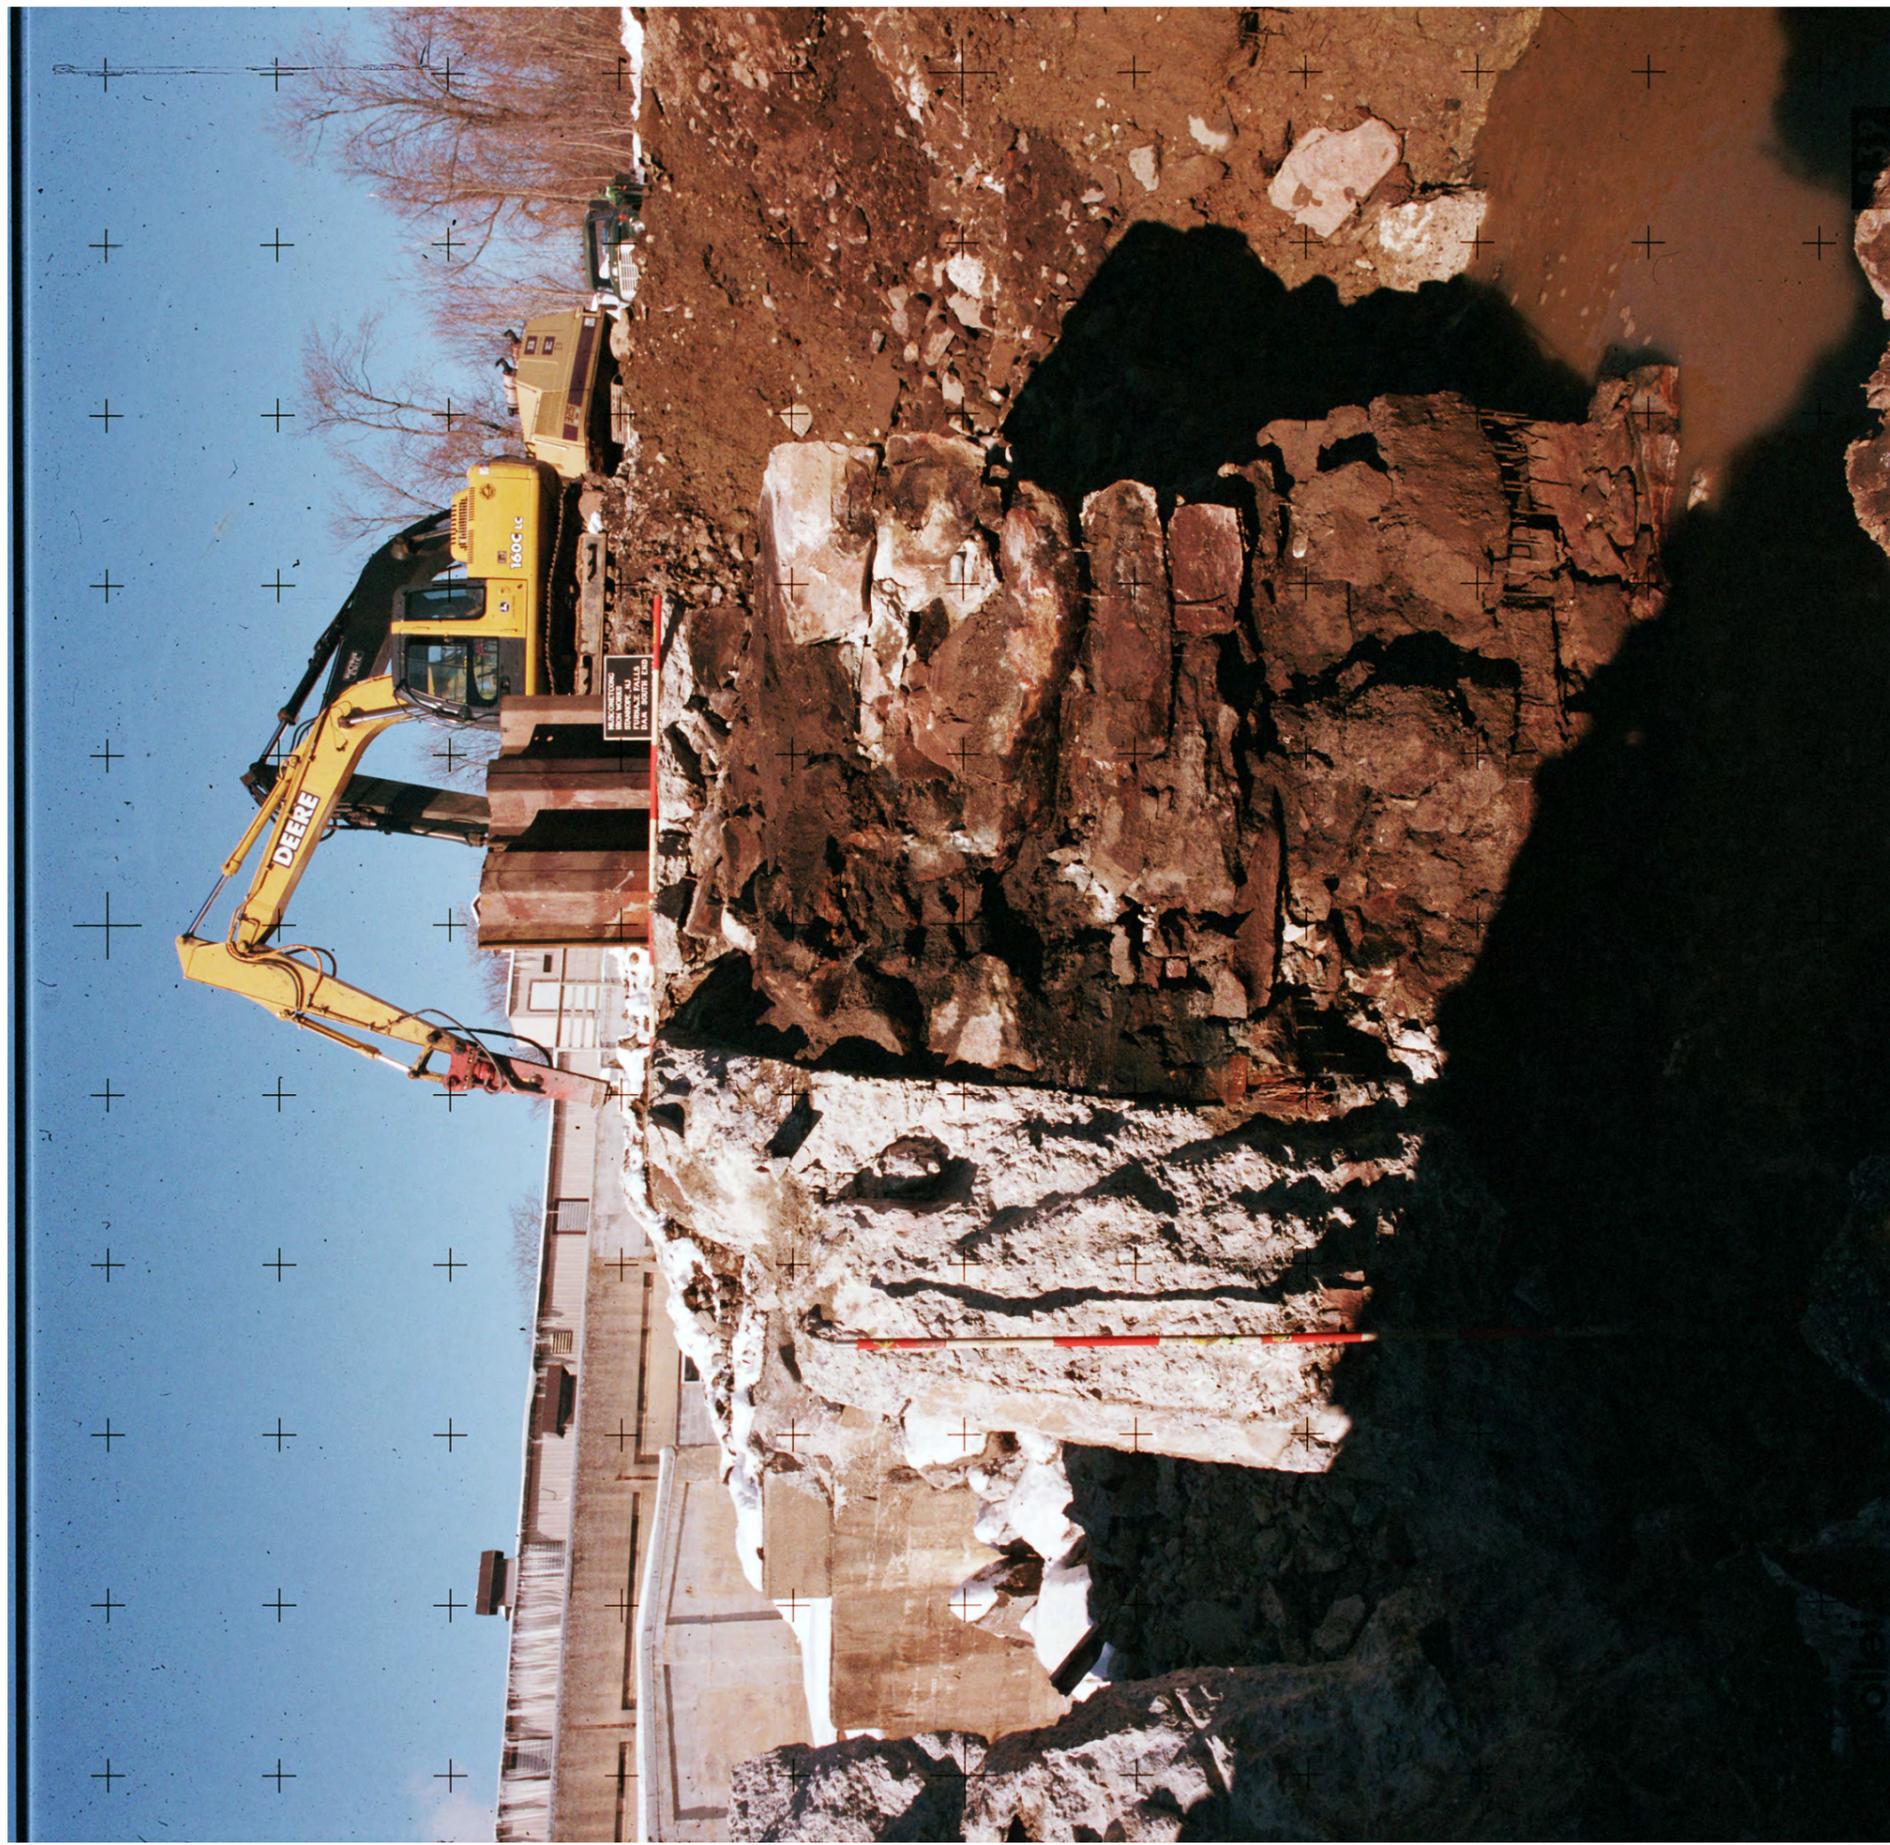
Figure 31: Rolleimetric film-based macro flat field photograph of southern profile of Furnace Falls Dam exposed to 11 feet (el: 819 ft.) below lip of spillway(@ 830 ft.). Note imbedded calibration marks for photogrammetric image rectification. Photo by Joel W. Grossman, Ph.D.
