The Archaeology of Furnace Falls:

A Mitigation Report on the Use of GIS, GPS & LIDAR
for the Definition & Documentation of Furnace Falls
Dam, Spillway, Weir & Channel

Stanhope/Netcong
Morris & Sussex Counties, New Jersey

Final Report to NJDEP - June, 2004

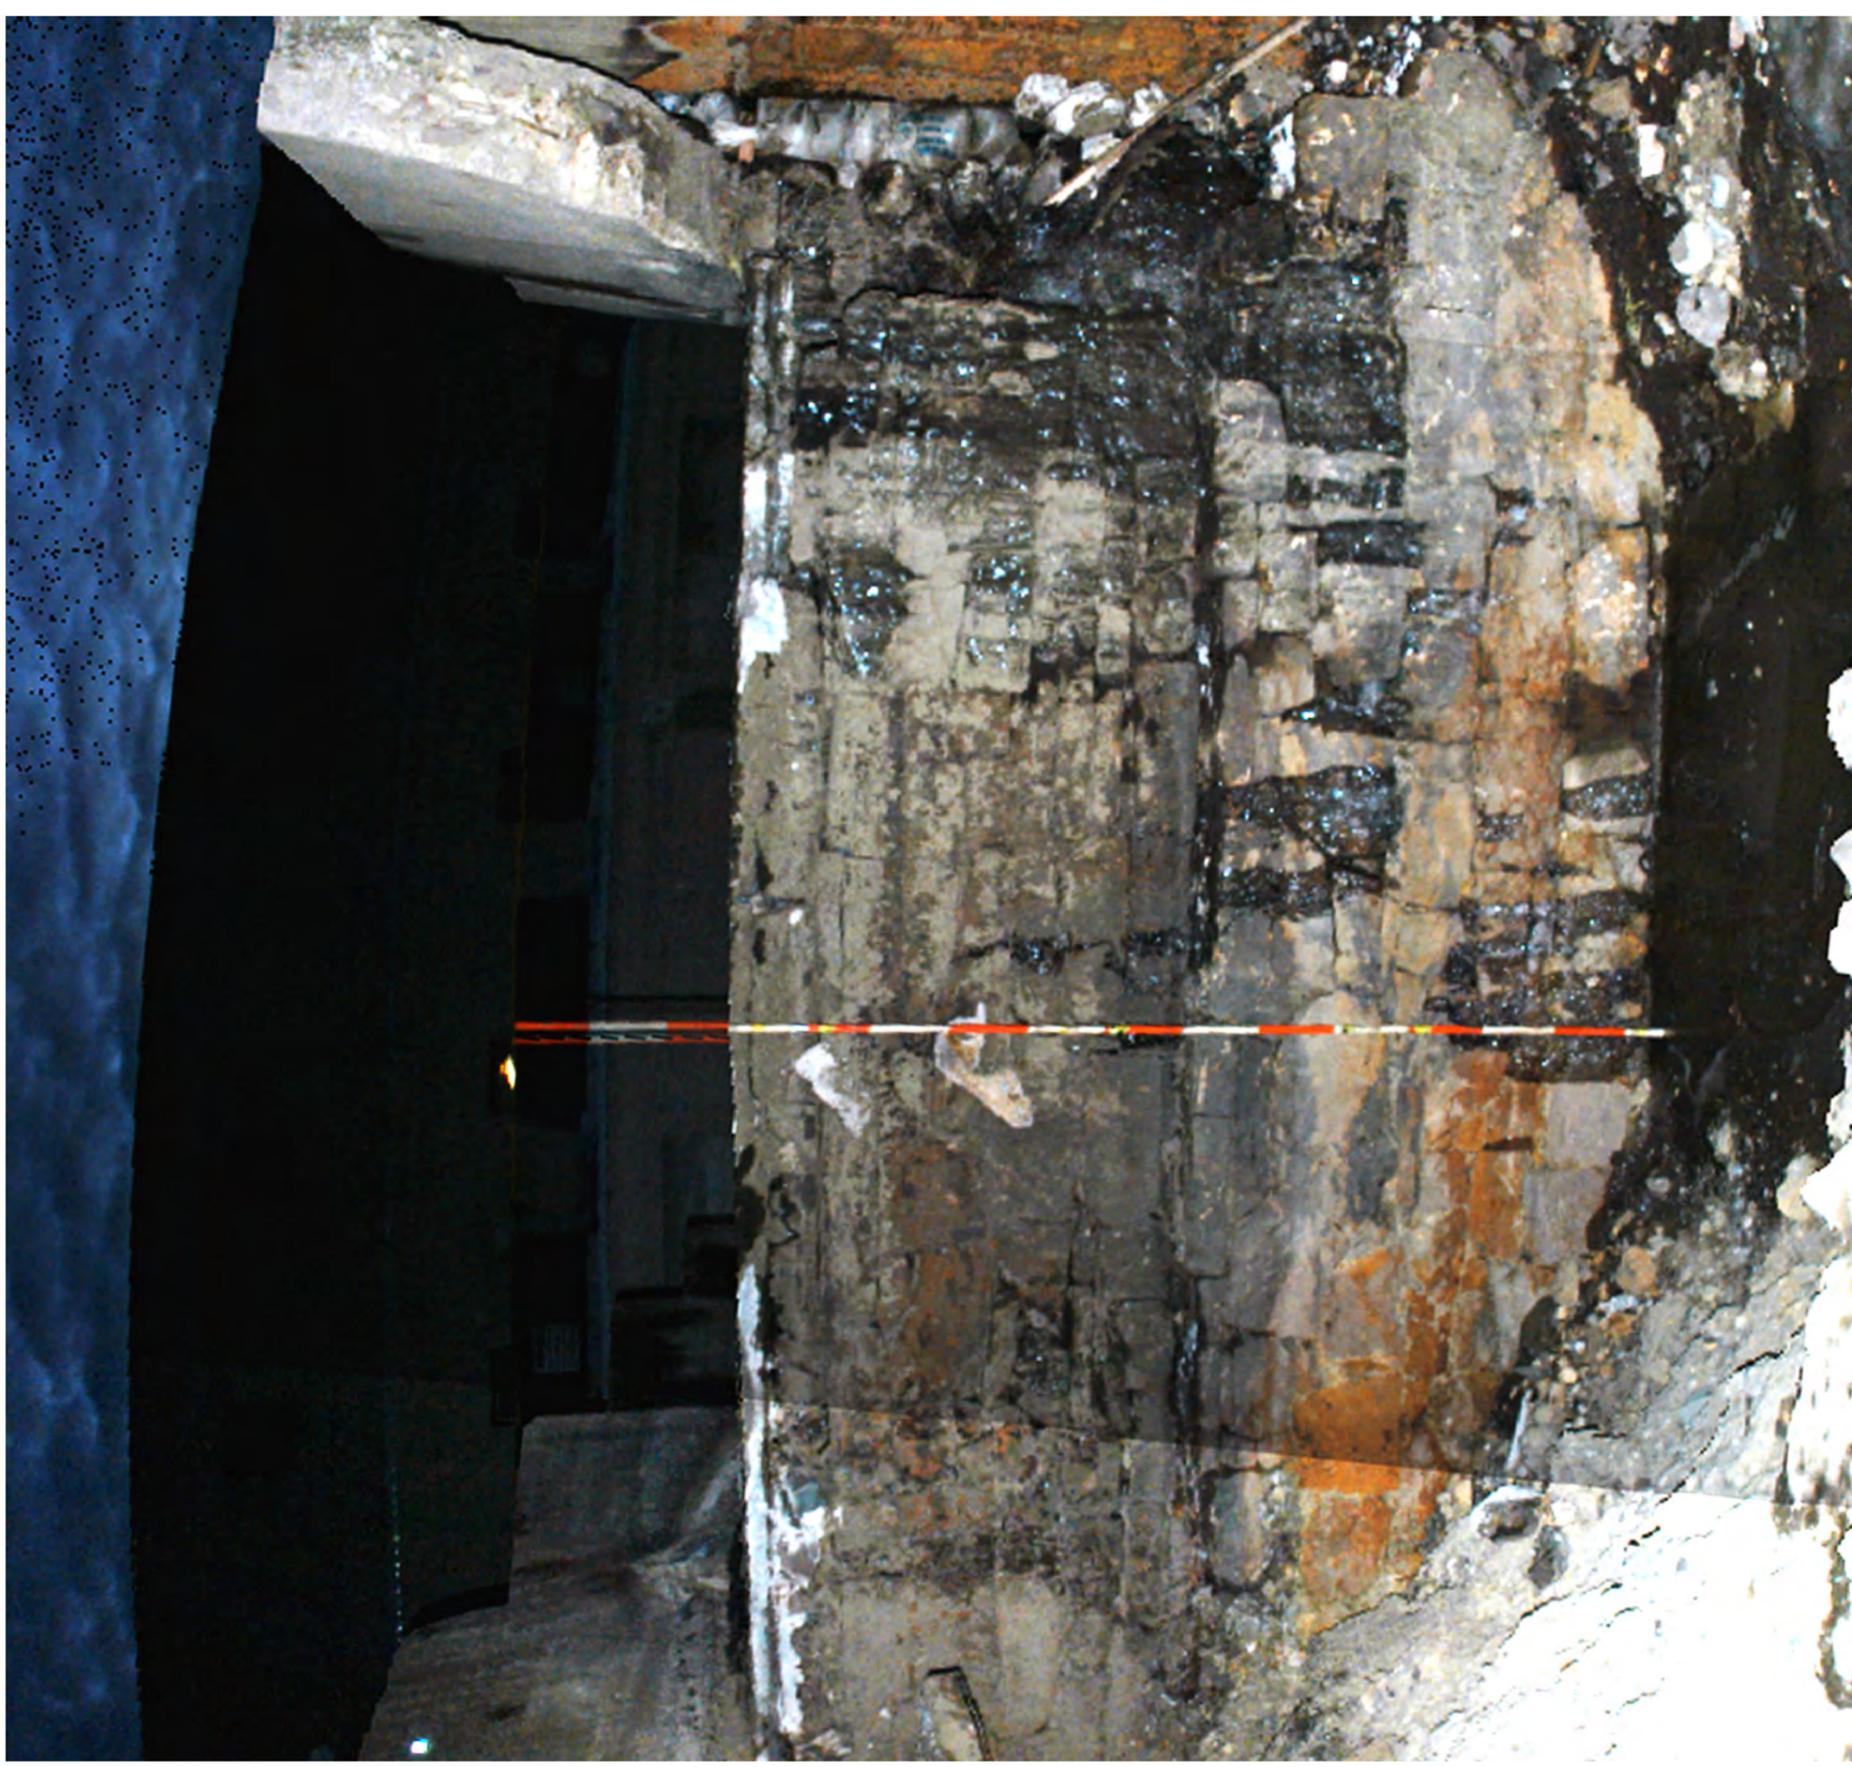
Figure 27: Panoramic composite, looking west at the exposed eastern face of the 1830 era Furnace Falls dam, taken by integrated, computer controlled, Nikon digital camera mounted on the Riegl LIDAR scanner. The "seamed" digital picture, which shows the scanner's field of view (what it "saw"), was matched, pixel by pixel, to the 6 mm. precise LIDAR scanner-derived coordinate points, to render the true color 3D data captures of the formerly submerged dam. Overlapping digital photo series were taken with flash after sunset during final LIDAR scan of dam on January 21, 2004. Temperature range: 10 - 14 degrees F.

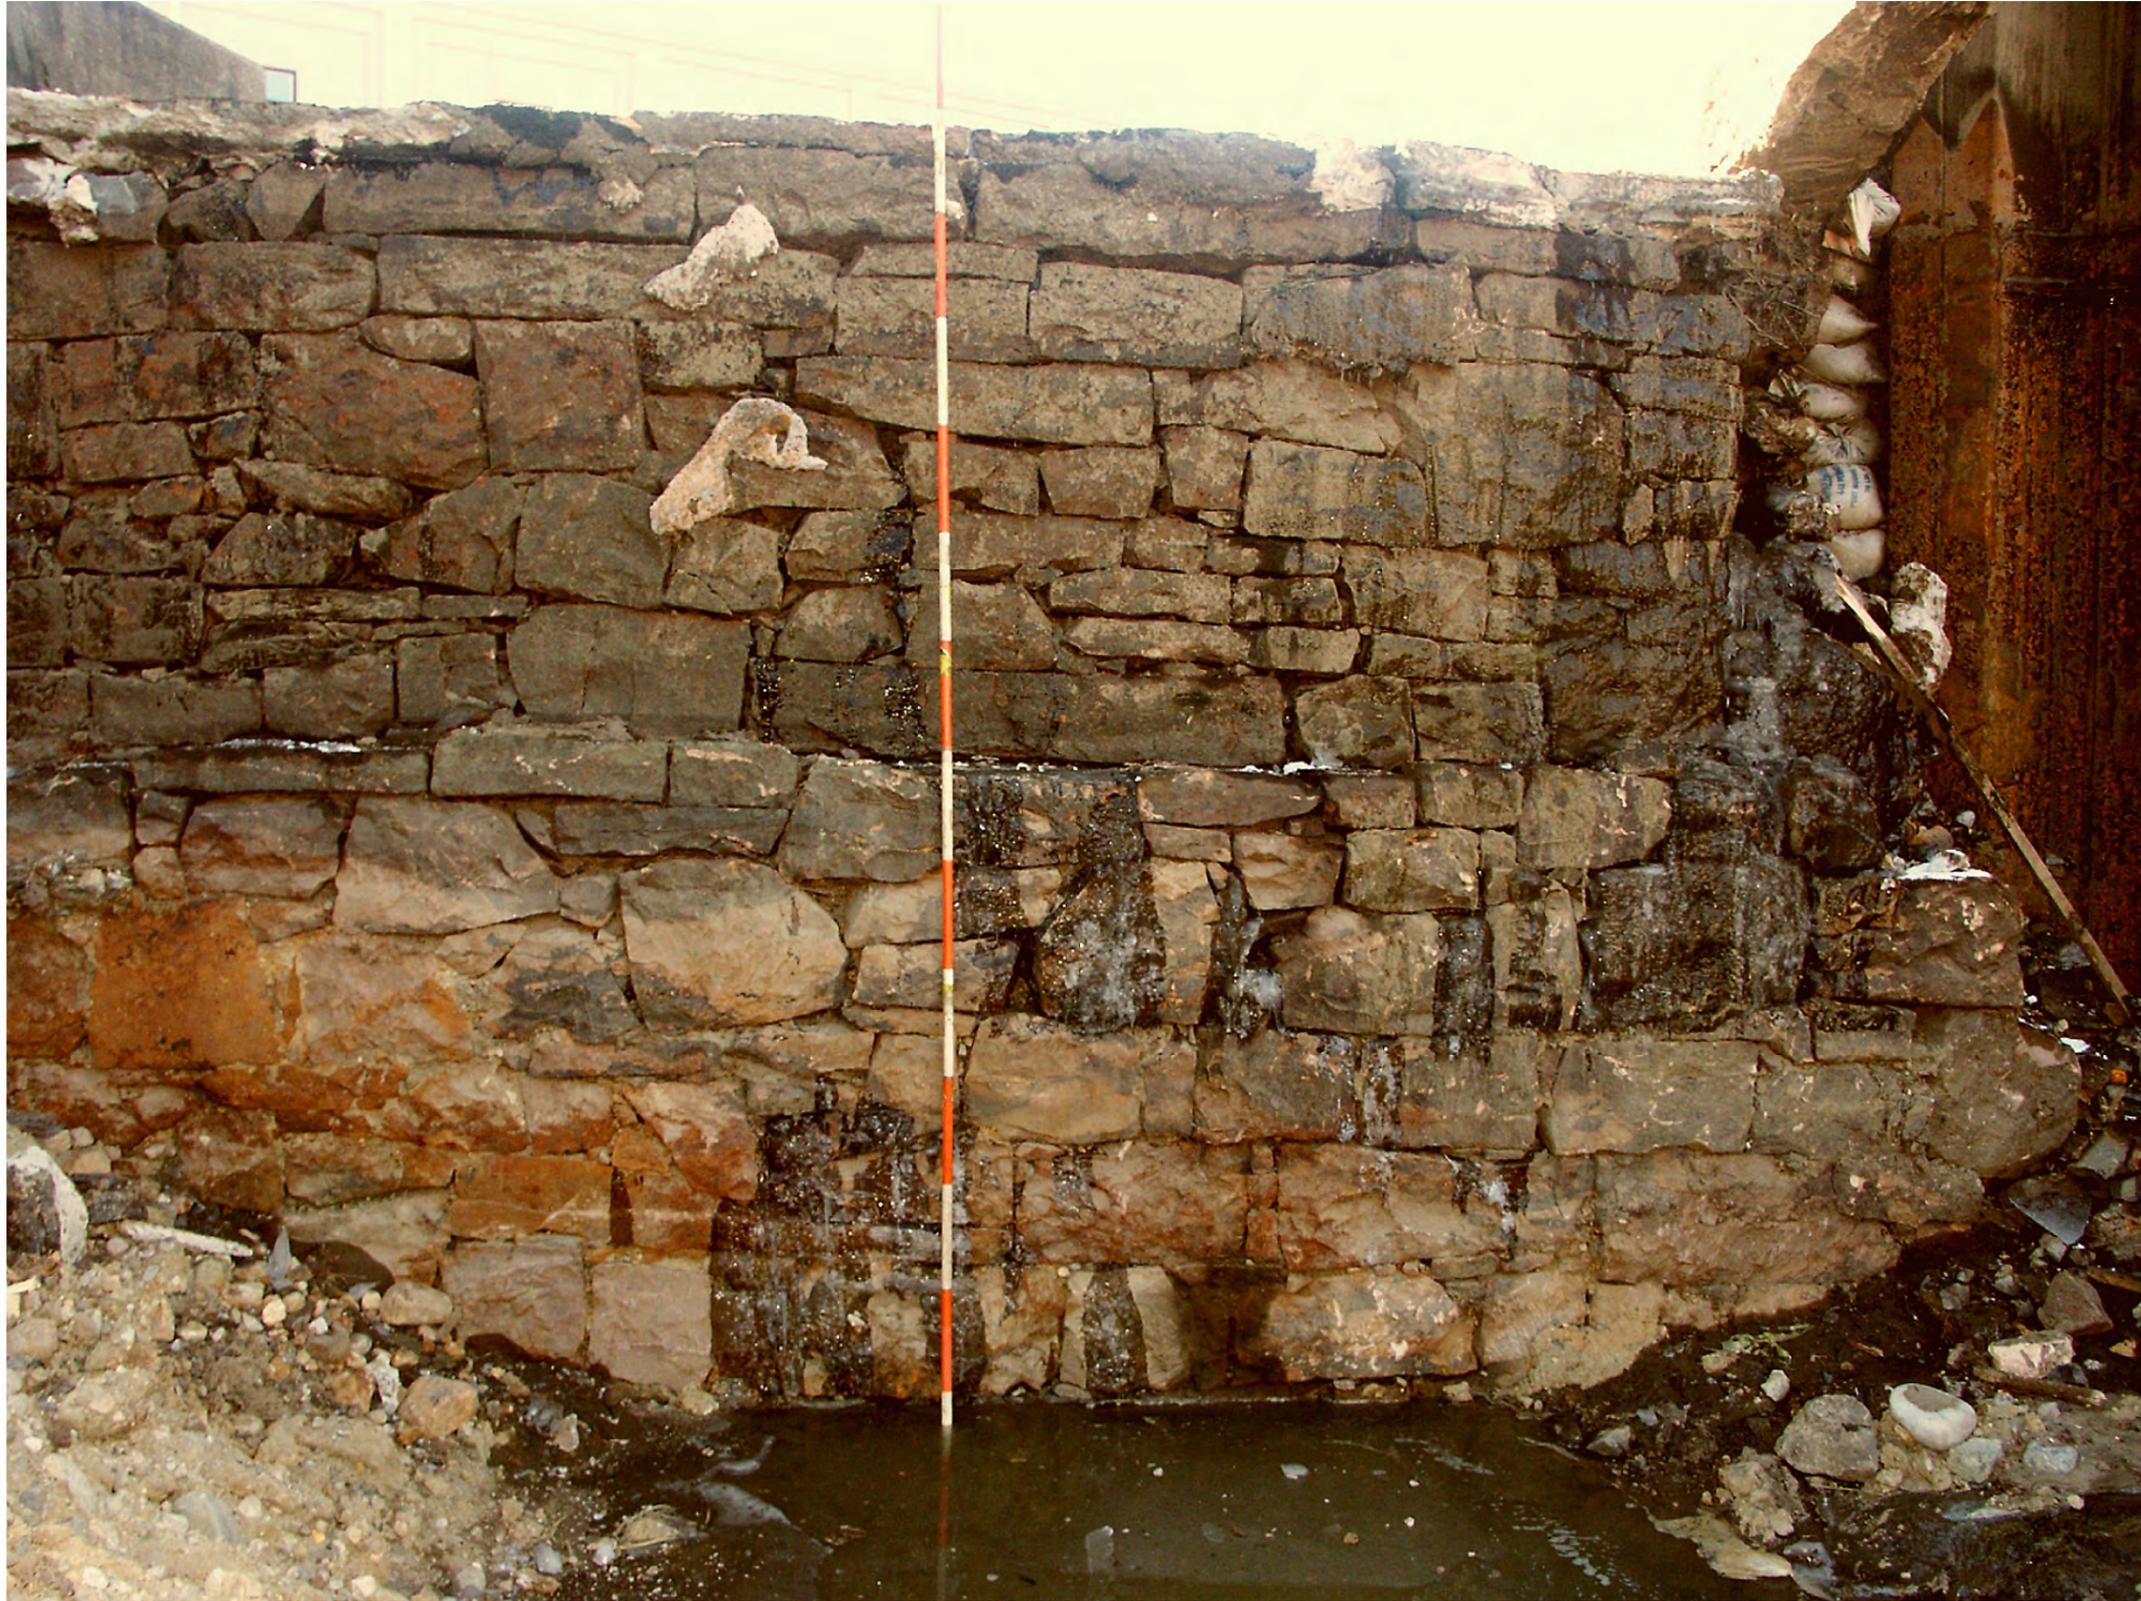
Figure 26: Digital macro photograph of east facade of Furnace Falls cut stone dam taken with natural light on afternoon of LIDAR scan, January 21, 2004. Note iron oxide stains and lighter band denoting depth of historic channel sediments.

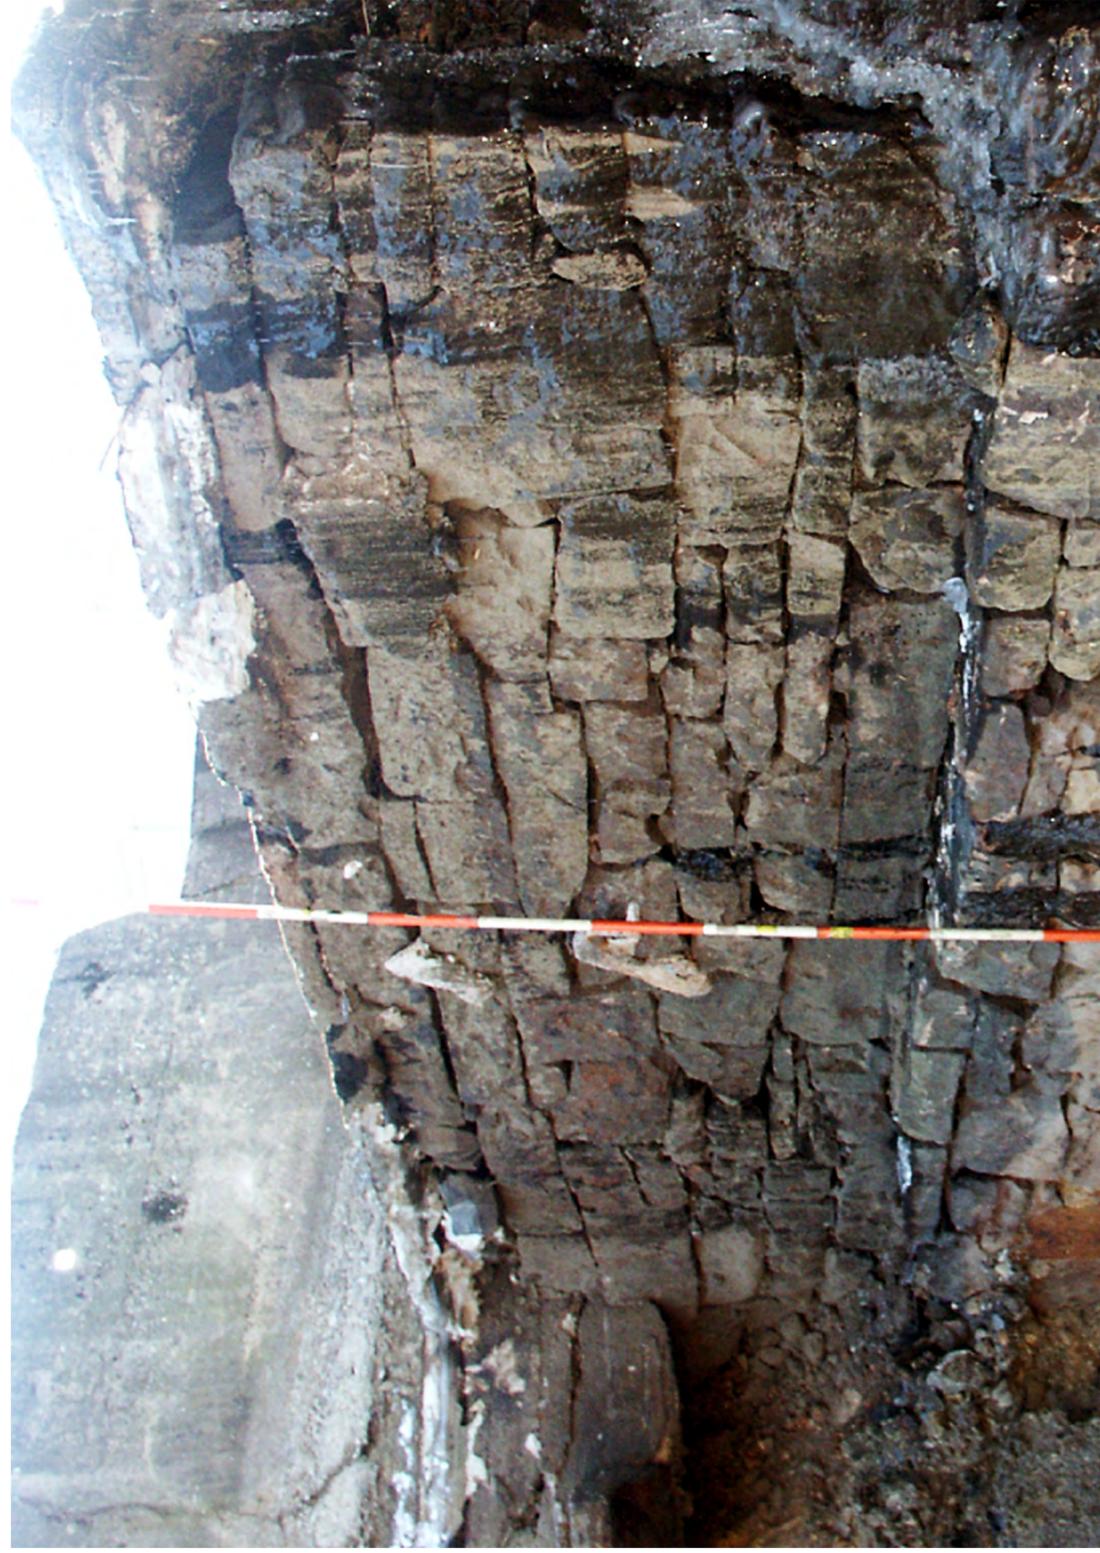
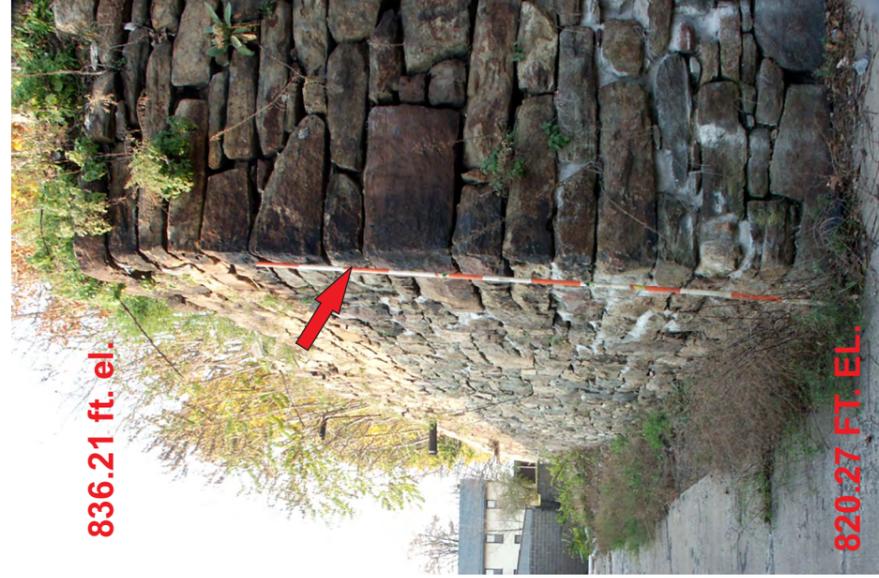
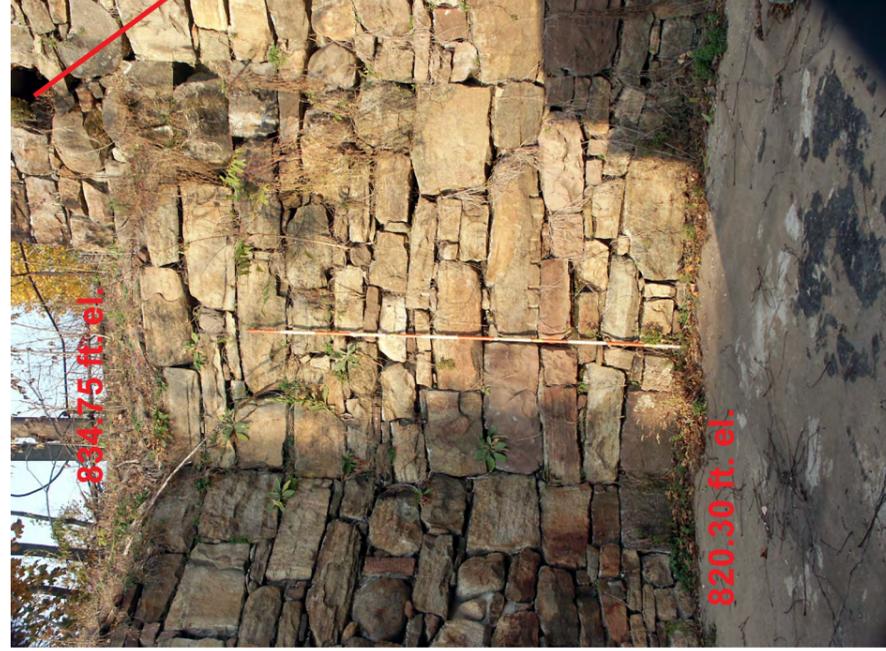
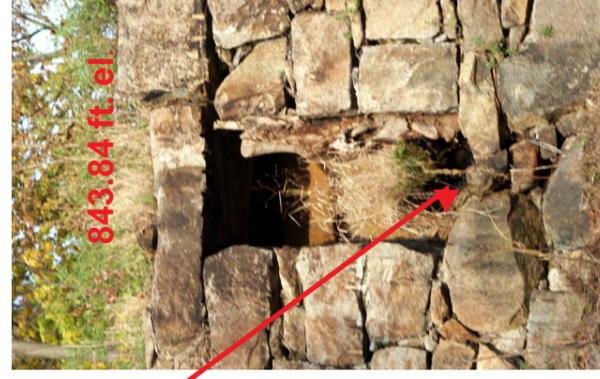
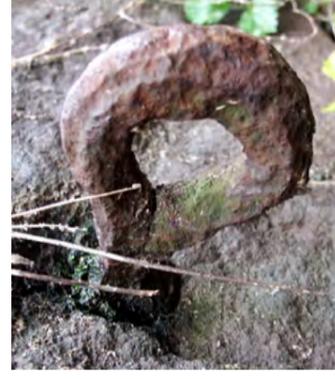
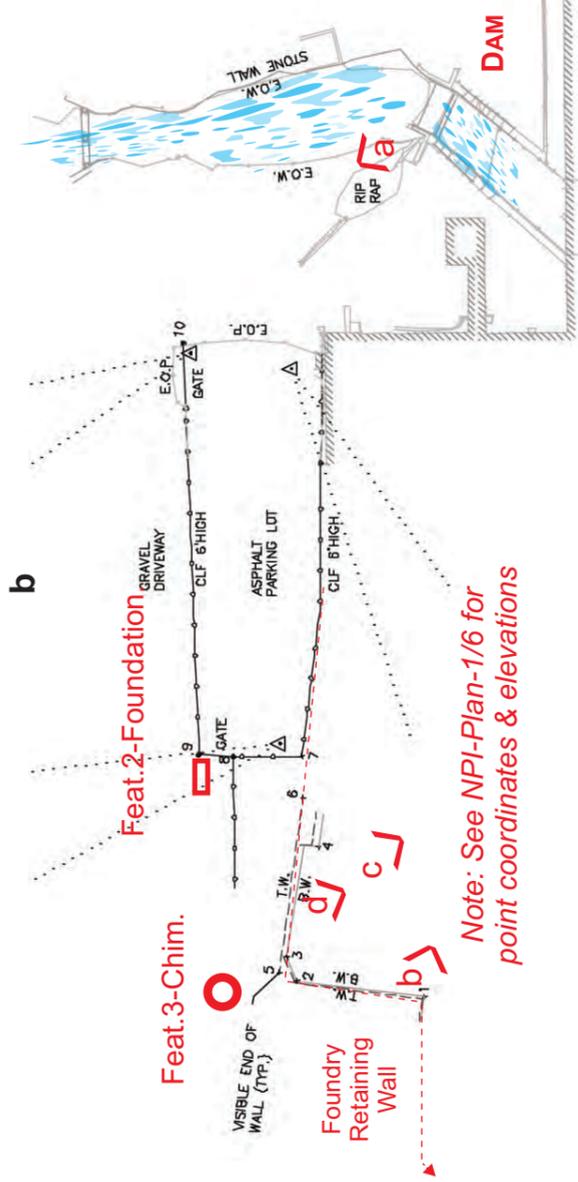
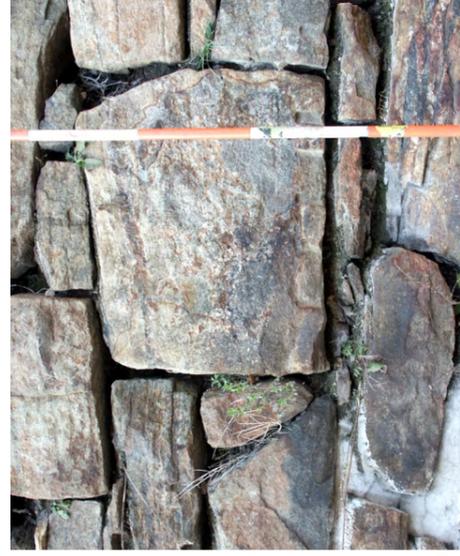
Figure 28: a) Digital photo looking southwest at eastern cut stone face and 6 ft high square finished northeast corner of the cut stone dam suggesting a former lower sluiceway (@ ca 824 ft. el) immediately north of the cement, or Singer, Spillway; b-d) Location map and structural details from the post-1840 Retaining Wall of the Musconetcong Iron Works supporting the Canal Spur Reservoir into the Foundry from the Morris Canal. The masonry of the 16 ft. high Foundry Retaining Wall has dry laid stonework comparable to that encountered in the cut stone dam. Note rust colored iron oxide stains at corner of Retaining Wall from former blast furnaces.

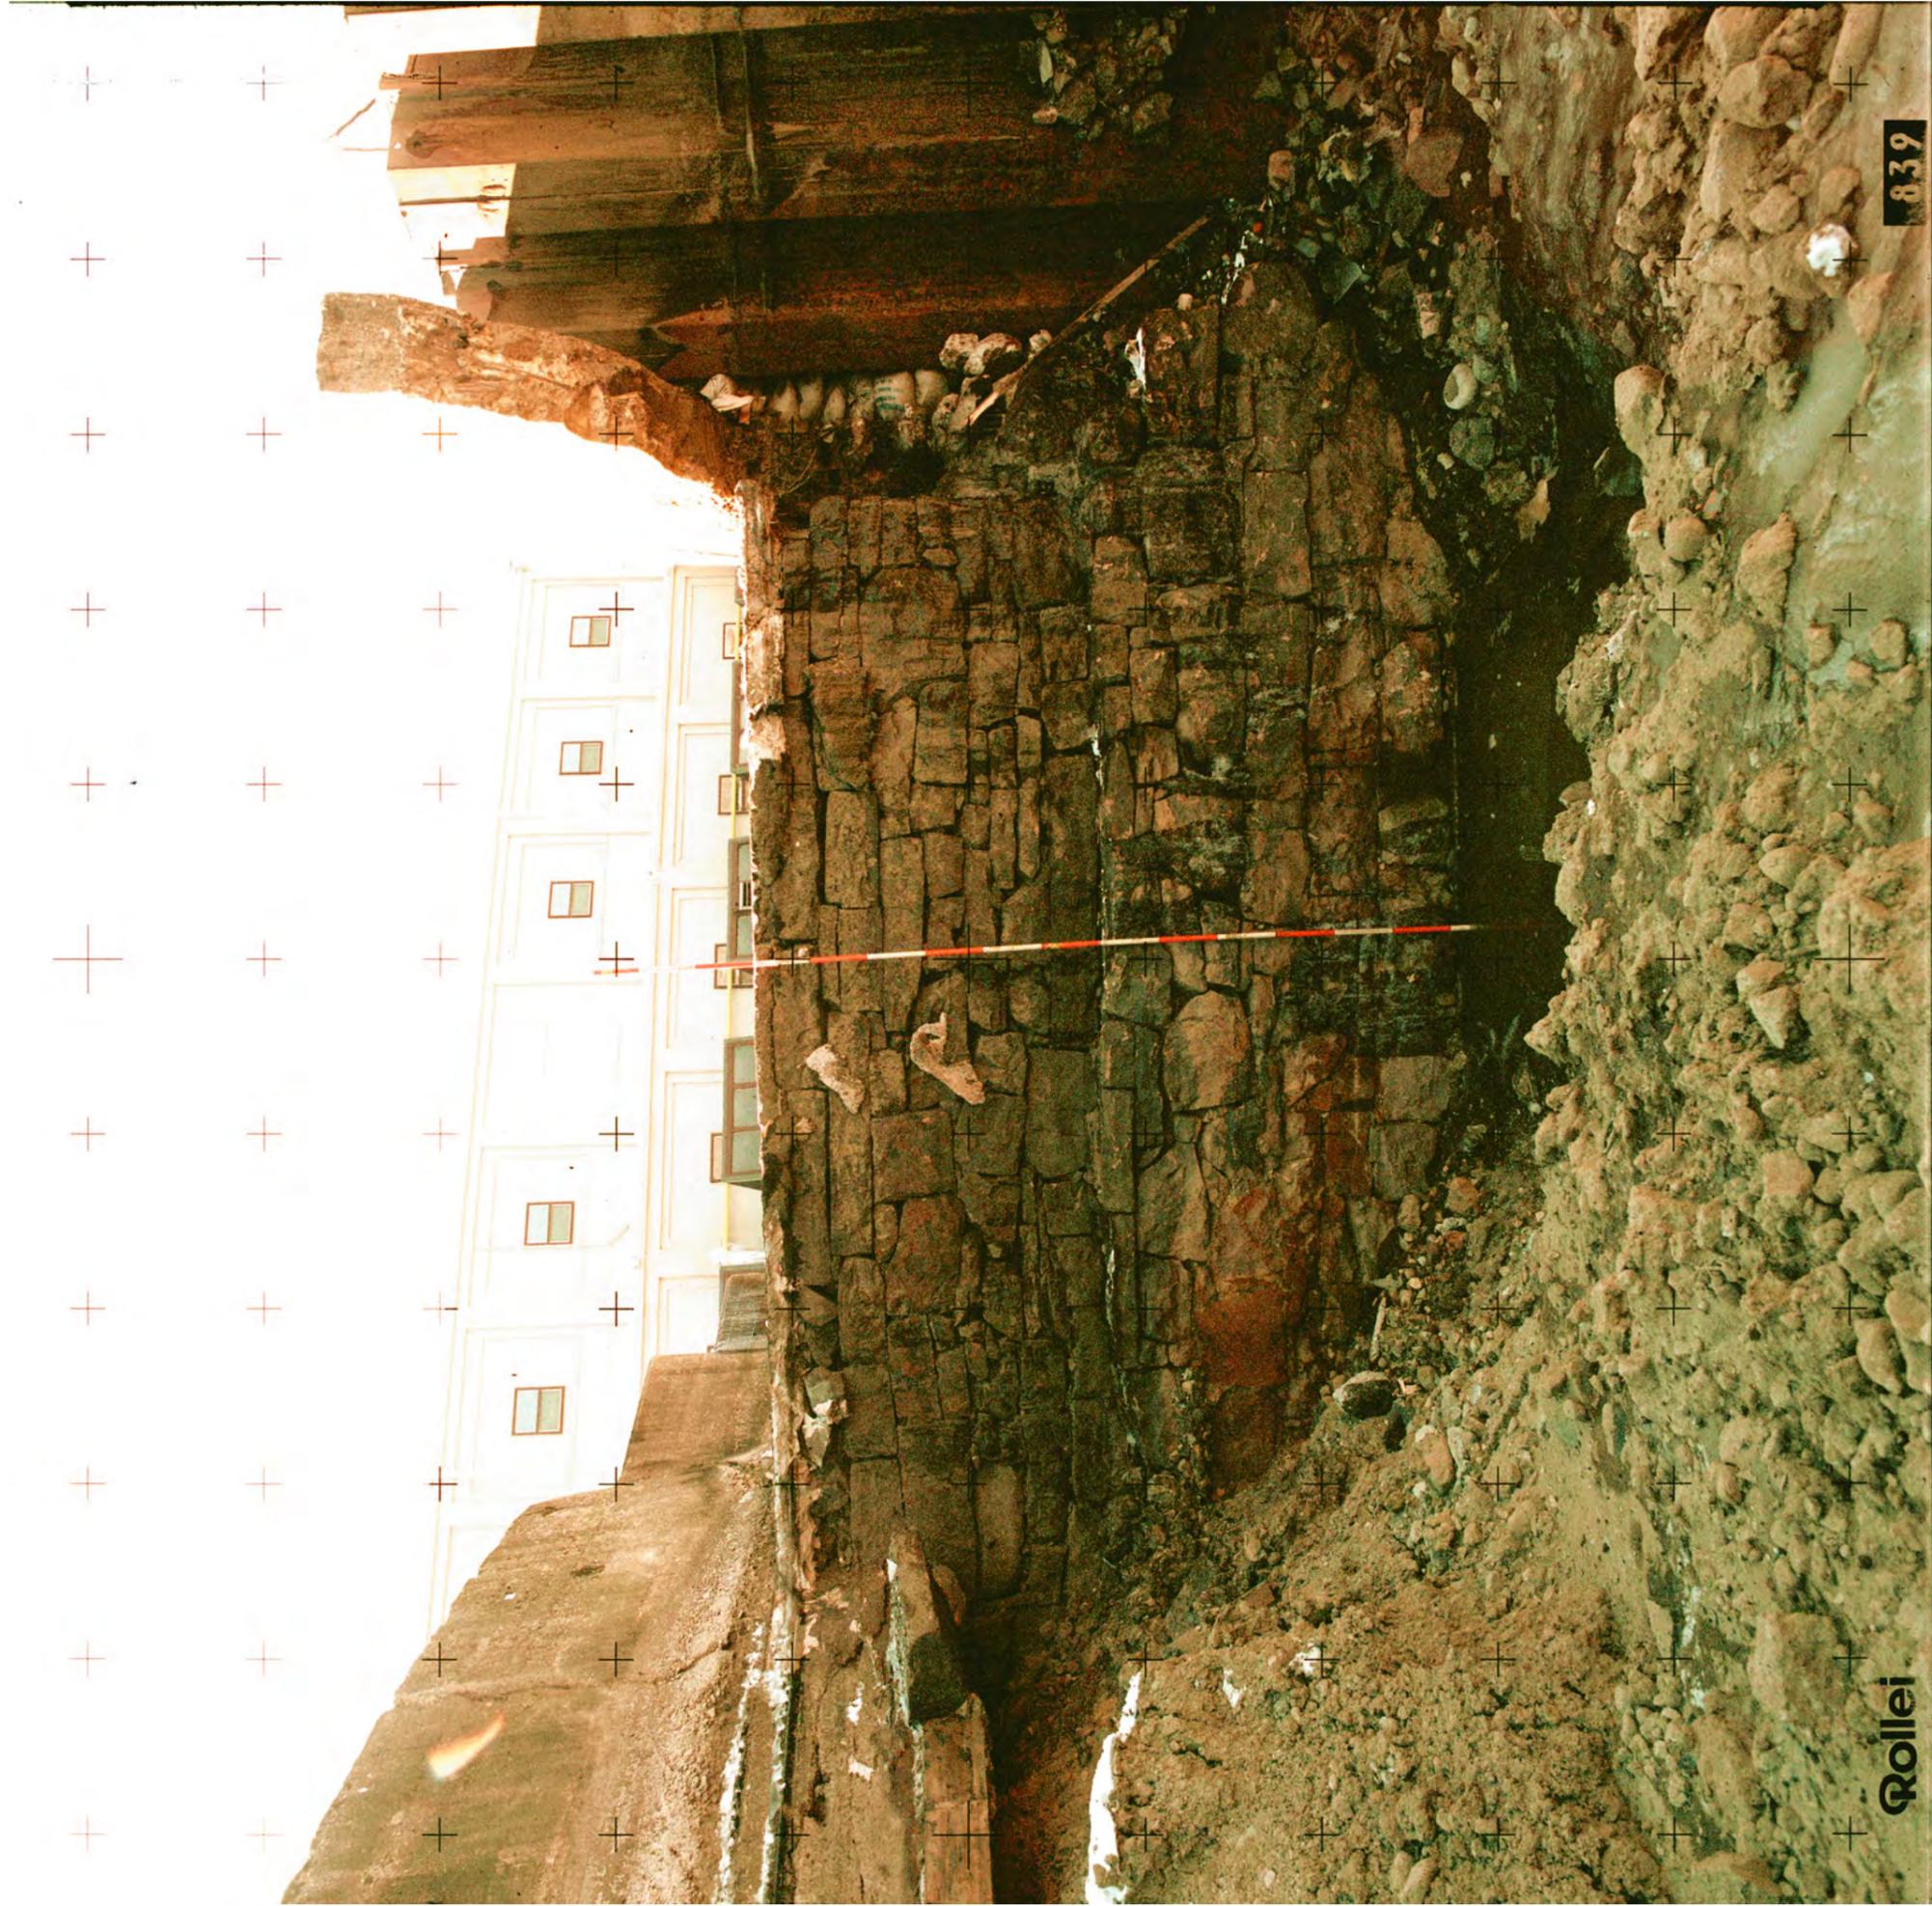
Figure 24: Rolleimetric flat field film image, looking west, at eastern face of Furnace Falls Dam exposed to 16 feet below spillway lip, January 21, 2004. Photo by Joel W. Grossman, Ph.D.
