# Emergency Geospatial Solutions and Mitigation Through Redesign and Avoidance at Furnace Falls Dam, Stanhope, New Jersey

**Joint Engineering and Archaeological  
Mitigation Plan for the Furnace Falls Pond Dam,  
Weir, Spillway and Channel  
Stanhope/Netcong,  
Morris and Sussex Counties, New Jersey**

*Draft-Final Mitigation Plan-  
Compac Corporation – Furnace Falls Dam*

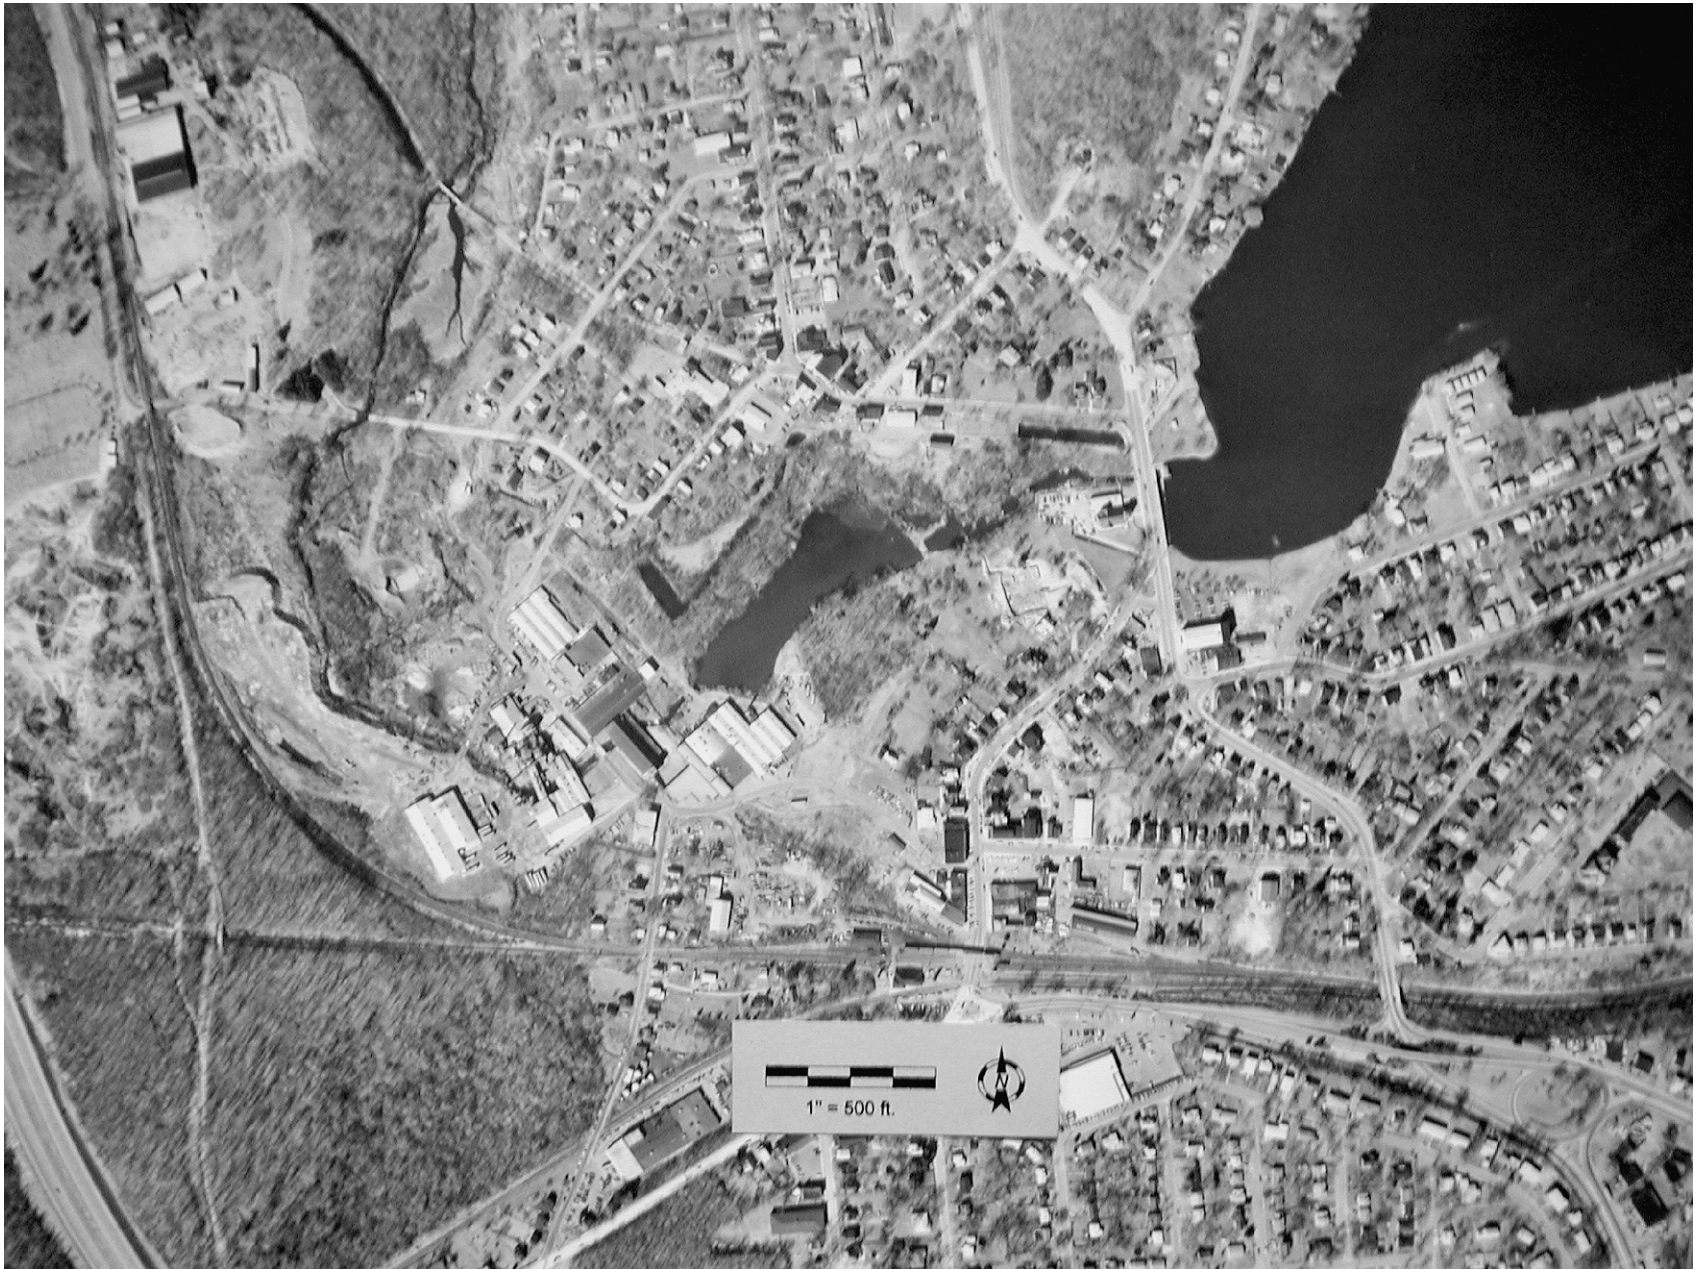
Figure 3. Digital image of 1974 air photo of project area (Robinson Aerial).

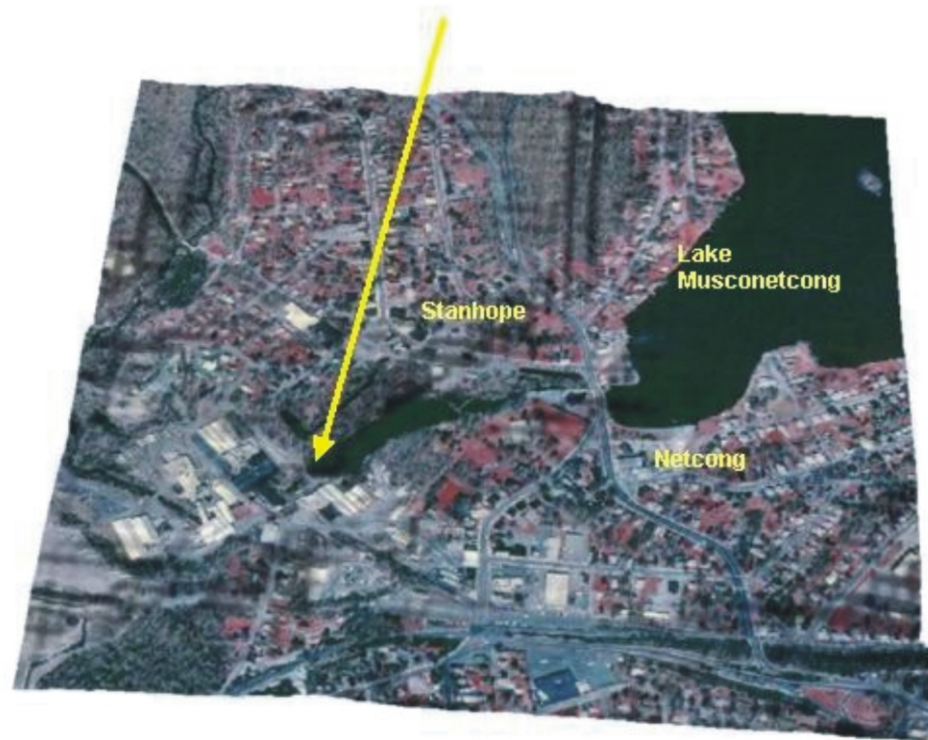
Figure 6 . Computer generated 2D and 3D terrain models derived from radar D.E.M data, draped and surface mapped with the NJDEP infrared orthophotos of the project area (3D GIS surface mapping courtesy of Davis Associates, Inc. 2002) .

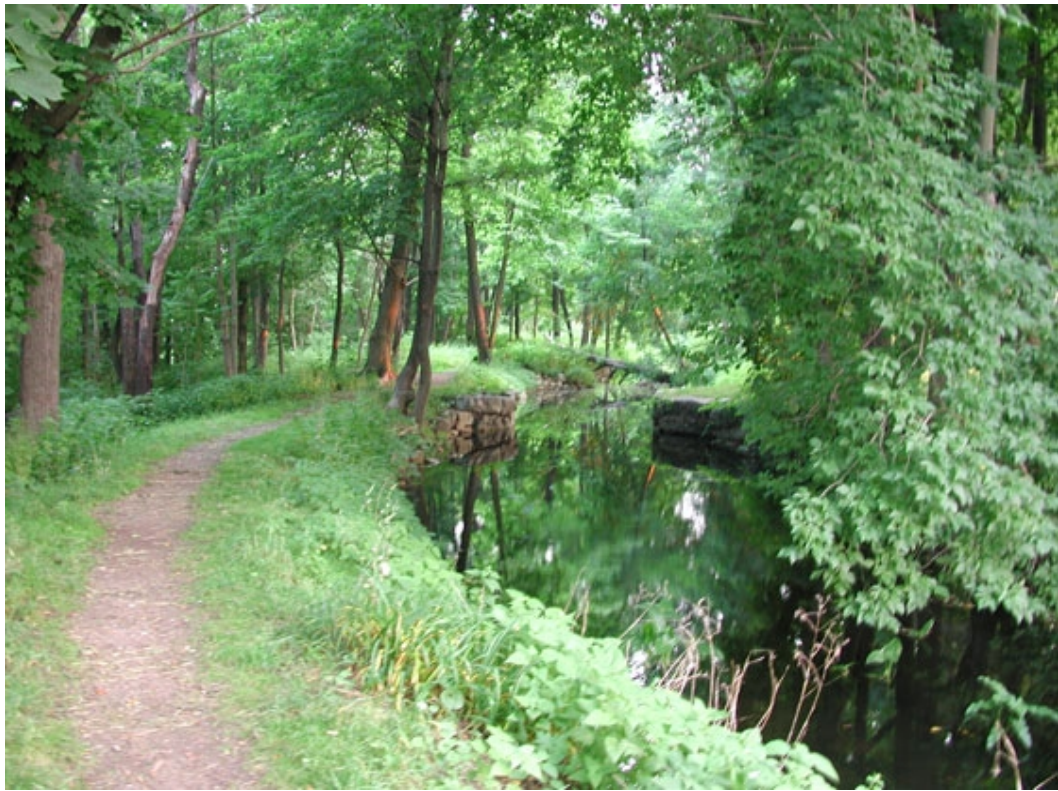
Figure 8. Modern view looking west, towards the foundry, along the L-shaped Morris Canal Spur, or “Raceway to the Works”. Note cut stone lined channel like the foundry retaining wall below. *Photo By Joel W. Grossman, Ph.D., June 23, 2002.*

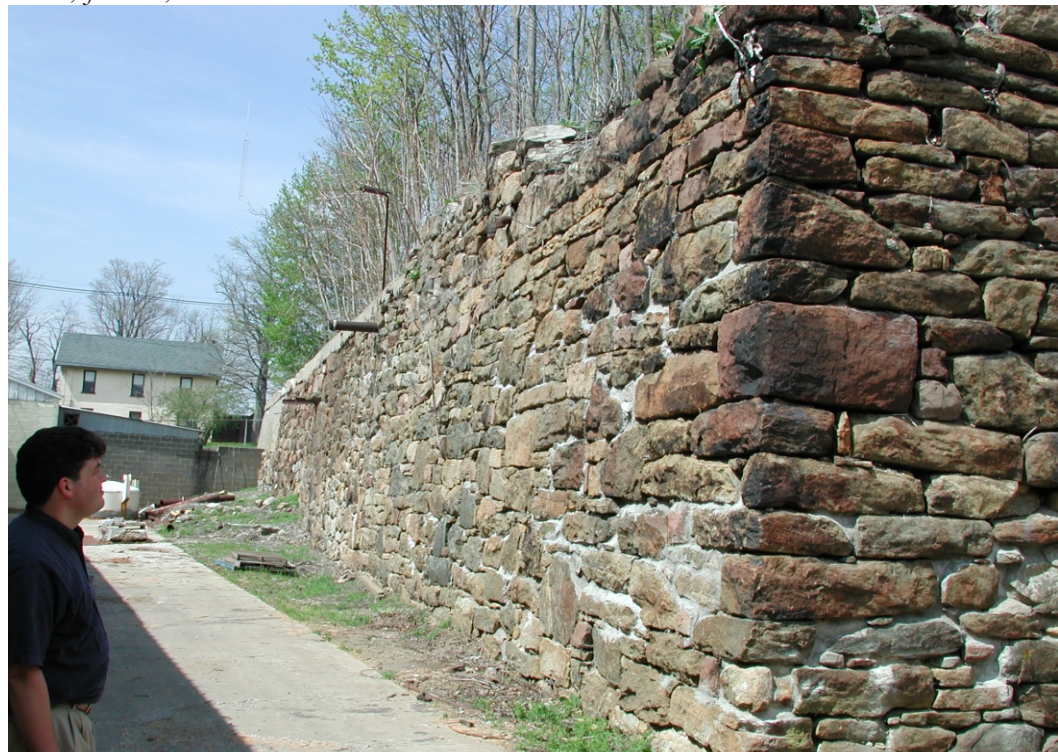
Figure 9. Modern view looking north along 16 ft. high, post-1840 stone retaining wall supporting interior blast furnaces and “L” shaped Morris Canal spur to the Foundry. Note fire reddened stones from former furnaces. *(Photo By Joel W. Grossman, Ph.D., April 19, 2002).*

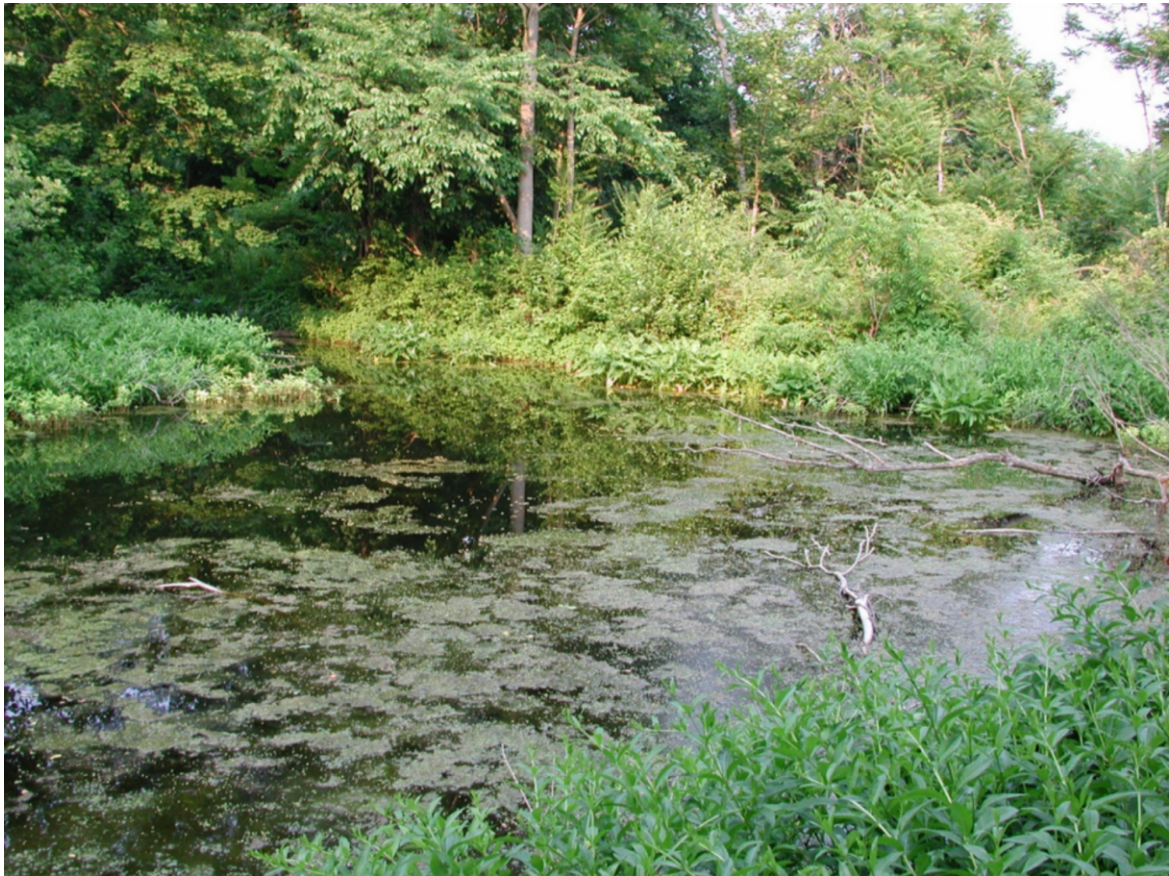
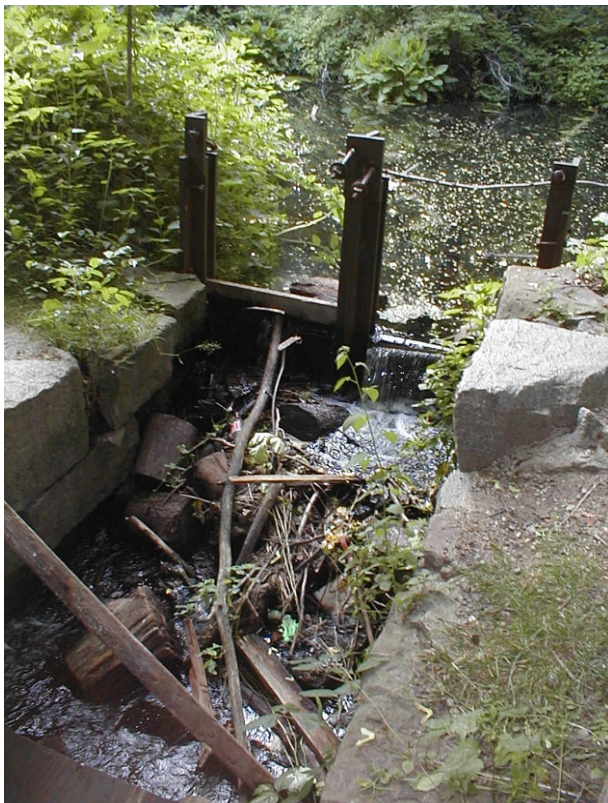
Figure 10. Contemporary field views of “Foot” of 1840’s L-shaped Spur, or “*Raceway to the Works*”, above the Foundry, looking south in the direction of Furnace Pond (*Top*); Detail looking north, towards south bank of the L-Shaped Spur, at mid-19th century cut stone and iron Sluice Gate, which regulated water discharge to both the Foundry and Furnace Pond below (*Bottom*) (Photos by Joel W. Grossman, Ph.D., June 23, 2002).

The canal spur, the weir, and spillway of Furnace Falls Pond below it, and the series of overflow water level control valves along the “raceway to works” (Figures 10, 16) all exhibit multiple functions and technological interconnections between blast furnaces, anthracite coal for fuel, the advent of canal and rail transport, and the availability of adequate water supply for the foundry after the canal was opened. As illustrated by a period citation from the American Cyclopedia of 1873, these associations and correlations were well understood by foundry experts and owners of the period.

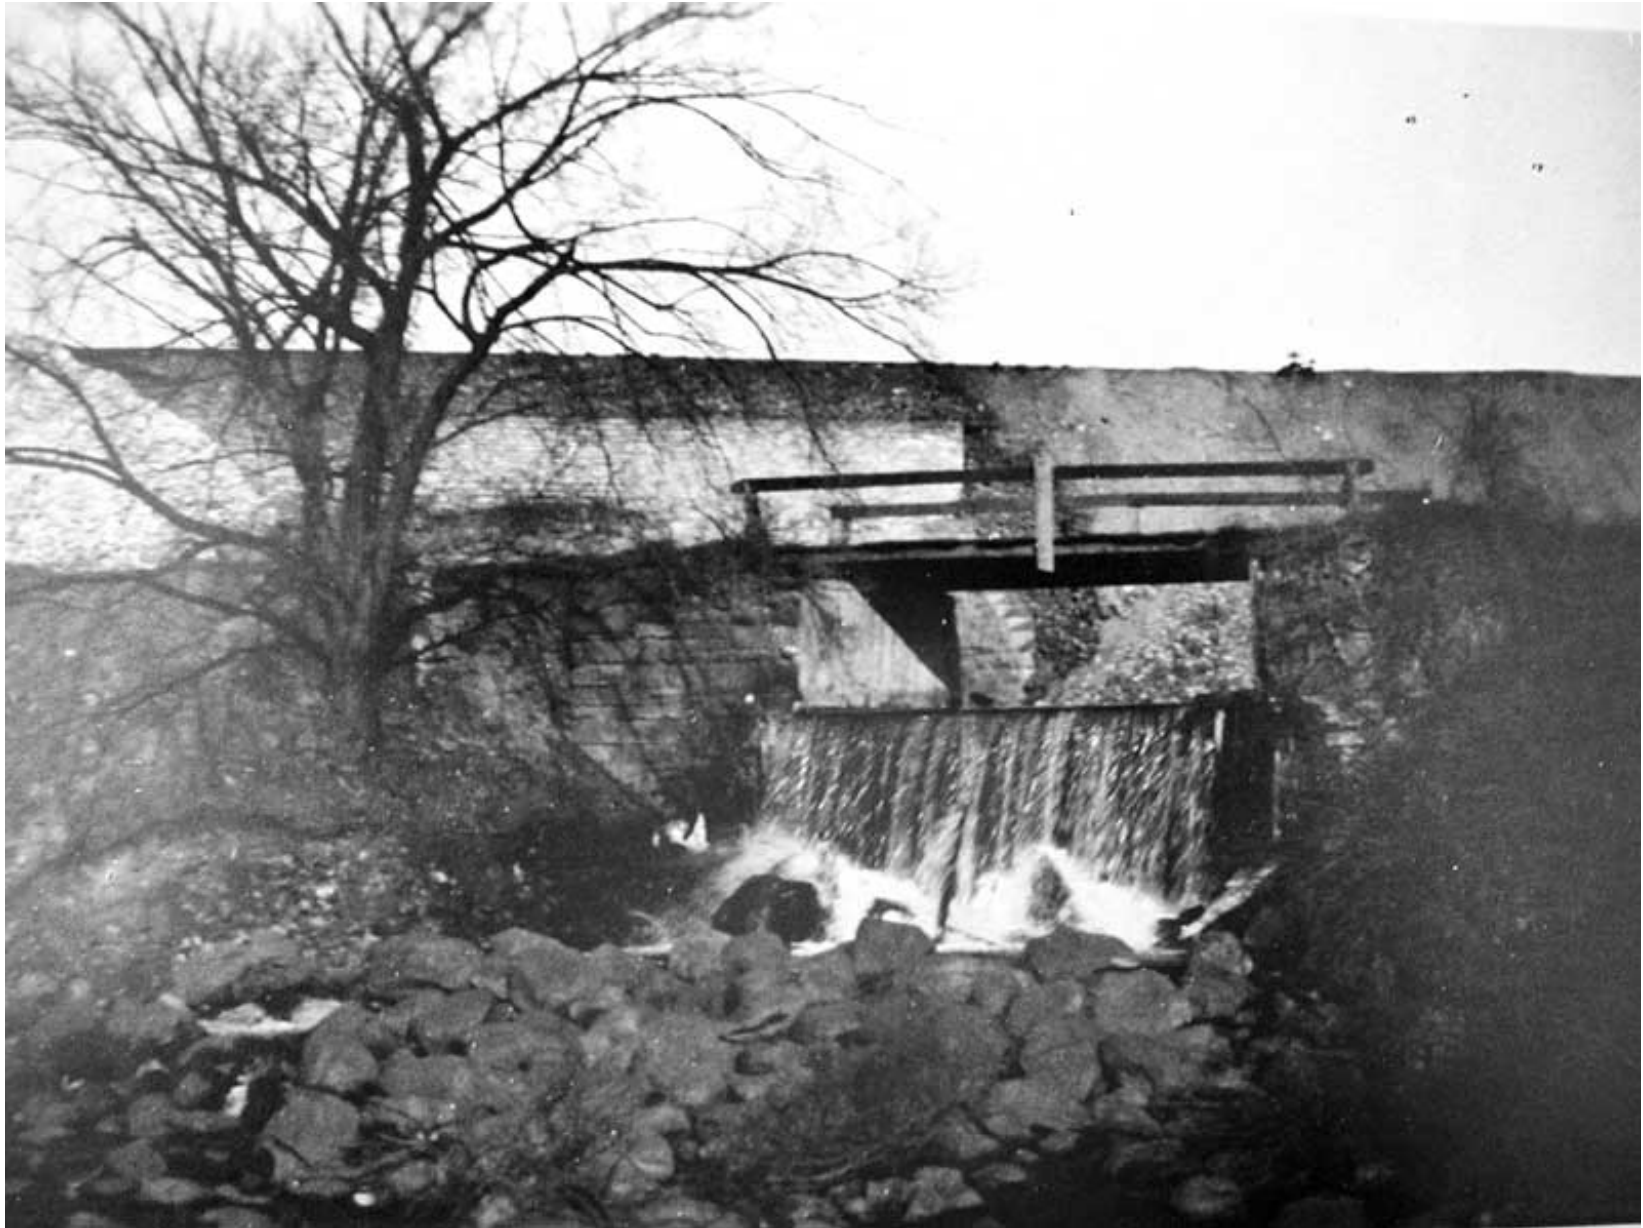
Figure 13. Undated (pre 1927) historic photograph of the “Singer Lower Spillway” showing 19th century motored stone abutment and wing wall supporting former footbridge (*Photo courtesy of Musconetcong Foundrymen Historical Society*)

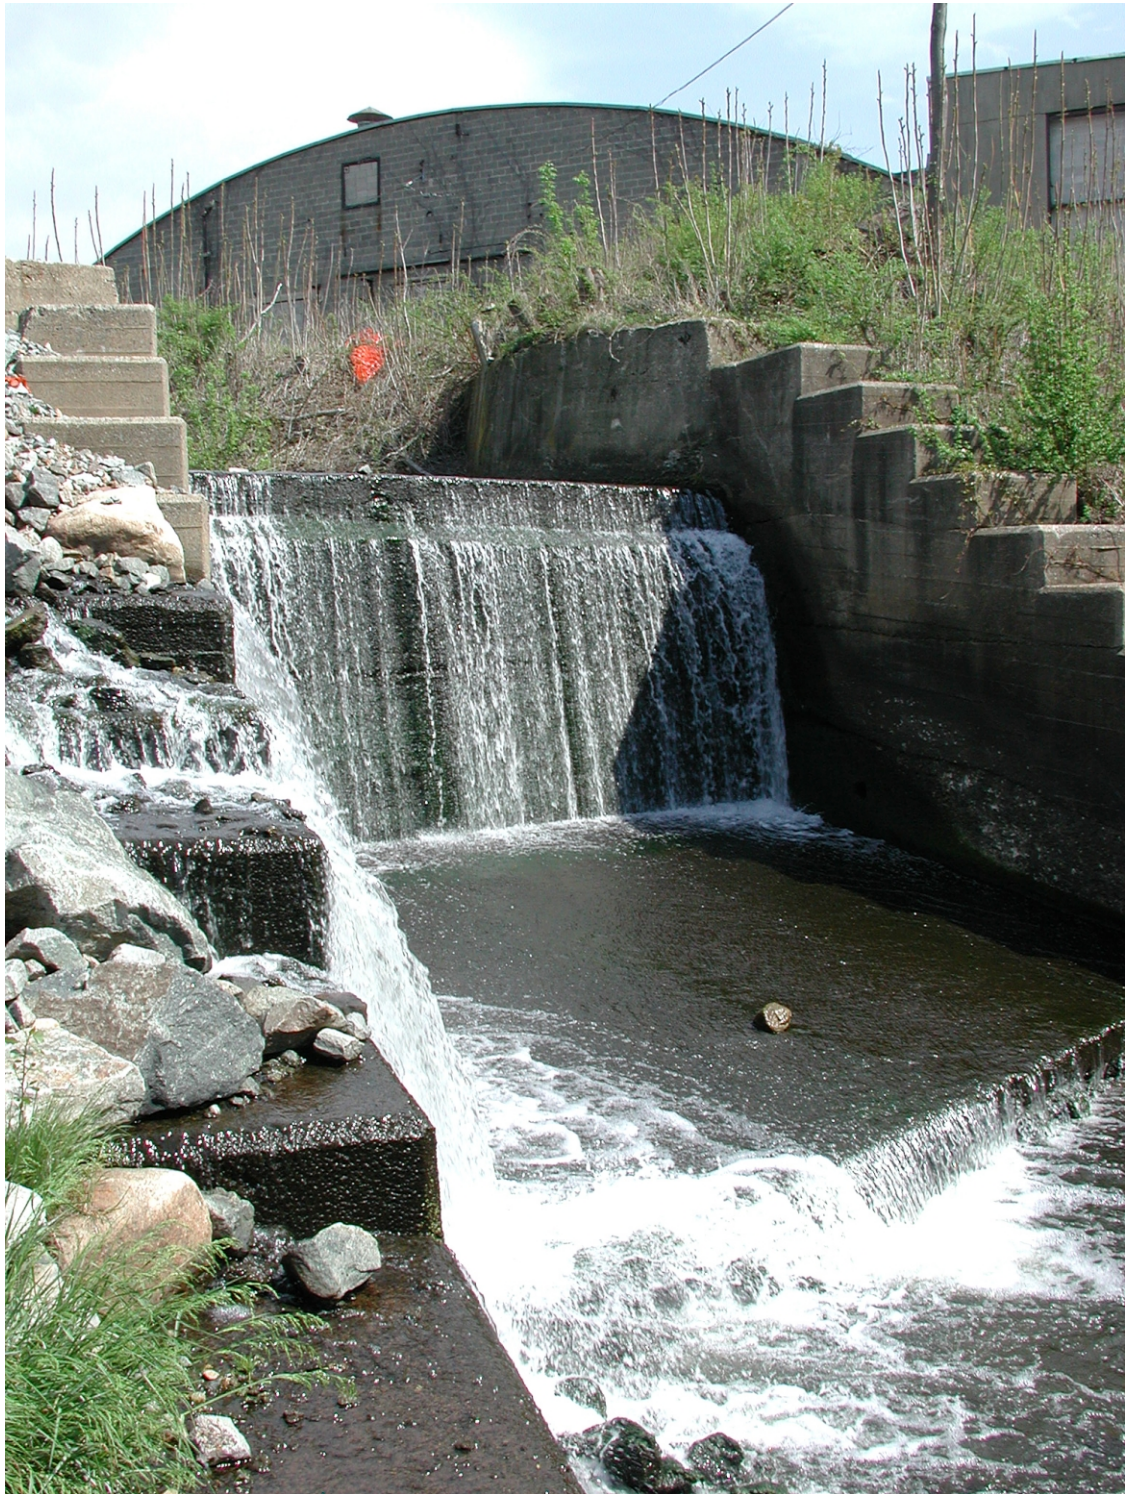
Figure 14. View looking east, up stream, at modern Lower Spillway Dam of Furnace Pond Falls, Stanhope/Netcong, New Jersey, June 23, 2002 (*Photo by Joel W. Grossman, Ph.D.*)

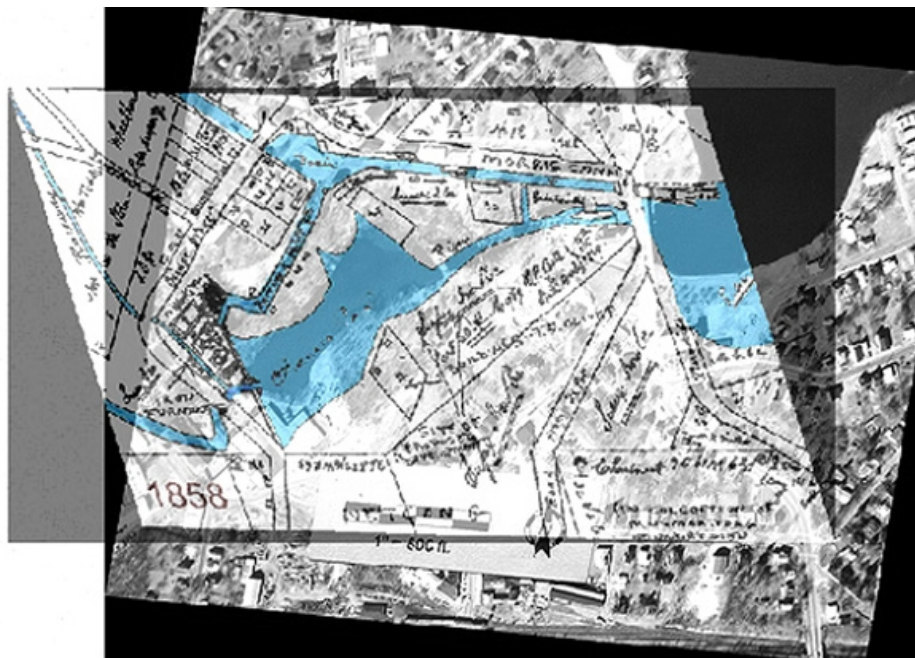
Figure 17. 1858 “Map of Lands Lying in Stanhope, New Jersey and Vicinity” .after being georeferenced and overlaid to scale over modern orth photo of project area. Screen shot of variable transparency GIS image off of Web. (Image courtesy of Davis Associates, July 2002).

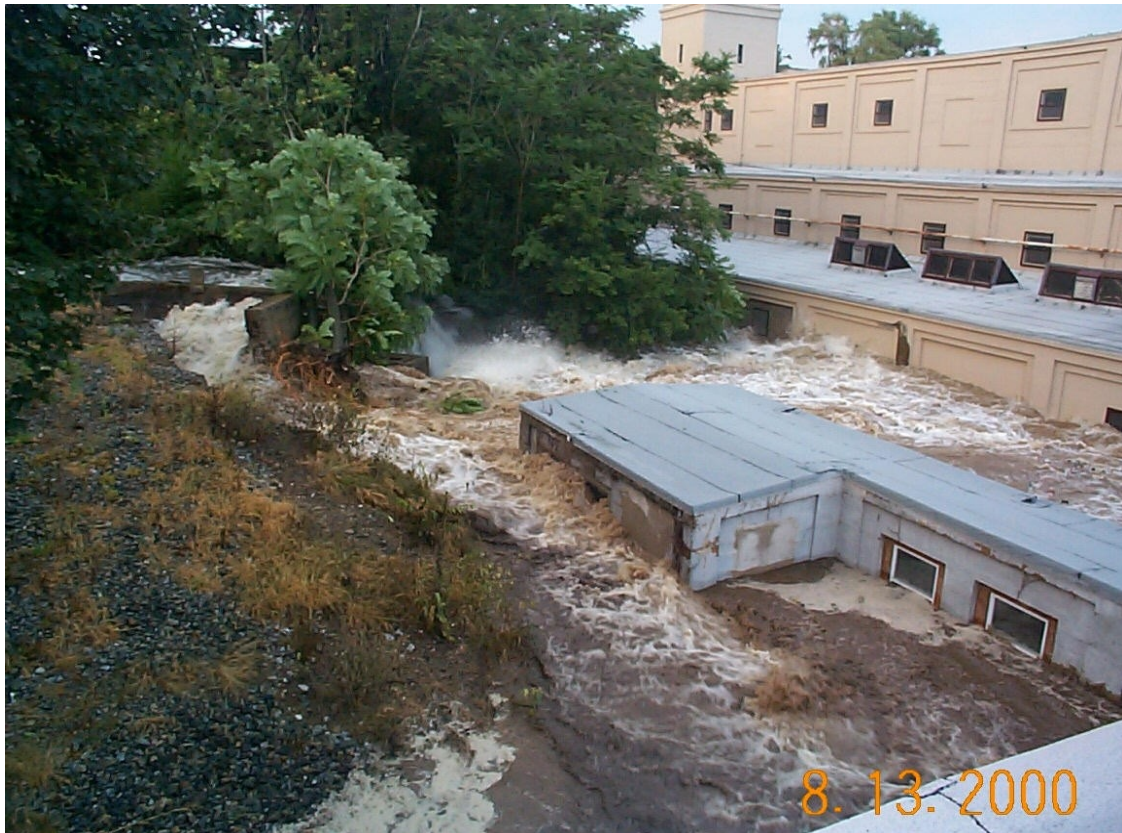
Figure 20. Field shot looking south-east towards Lower Spillway during August 2000 dam breach and flood at the Compact Corporation site in Stanhope/Netcong, New Jersey (Photo courtesy of *Compac Corporation*).

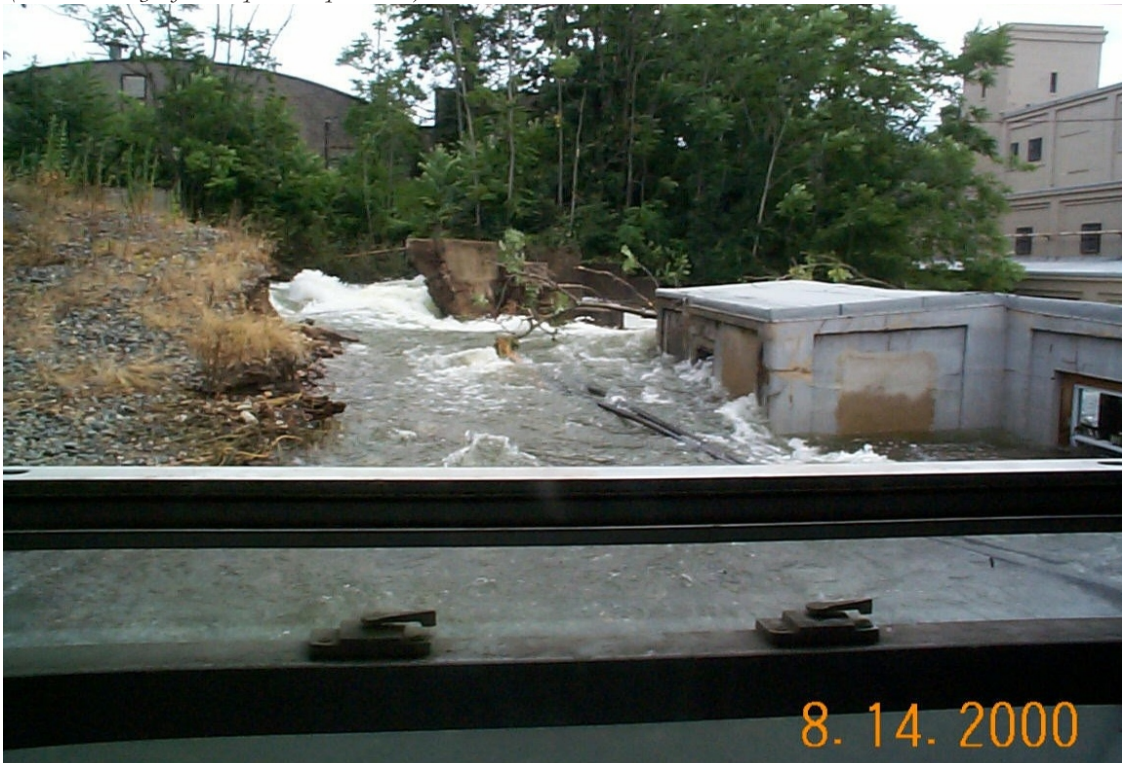
Figure 21. Field shot looking due south at Lower Spillway documenting extent and depth of scour erosion during August 2000 dam breach and flood at the Compact Corporation site in Stanhope/Netcong, New Jersey (Photo courtesy of *Compac Corporation*).

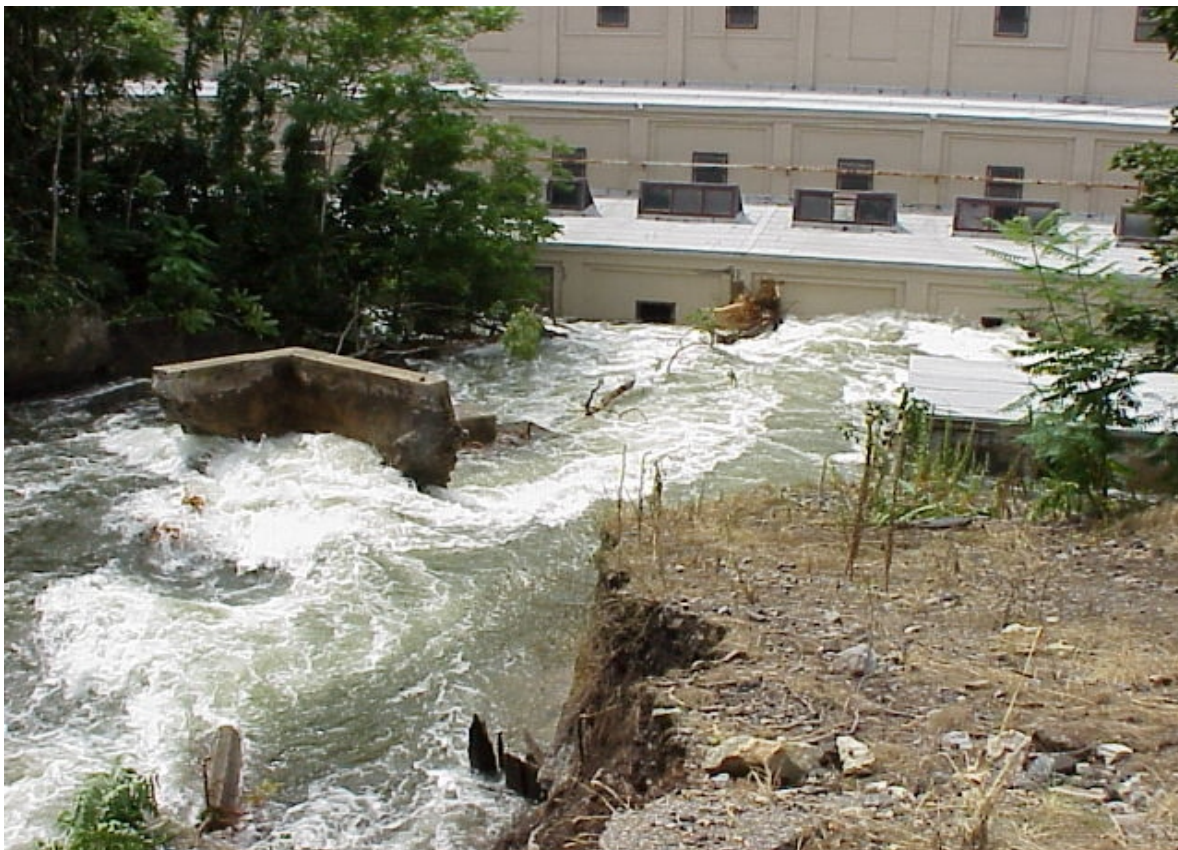
Figure 22. Field shot looking west, downstream, at Lower Spillway showing north-south extent and depth of scour erosion during 2000 Musconetcong flood at the Compact Corporation site in Stanhope/Netcong, New Jersey (*Photo courtesy of NJDEP*).

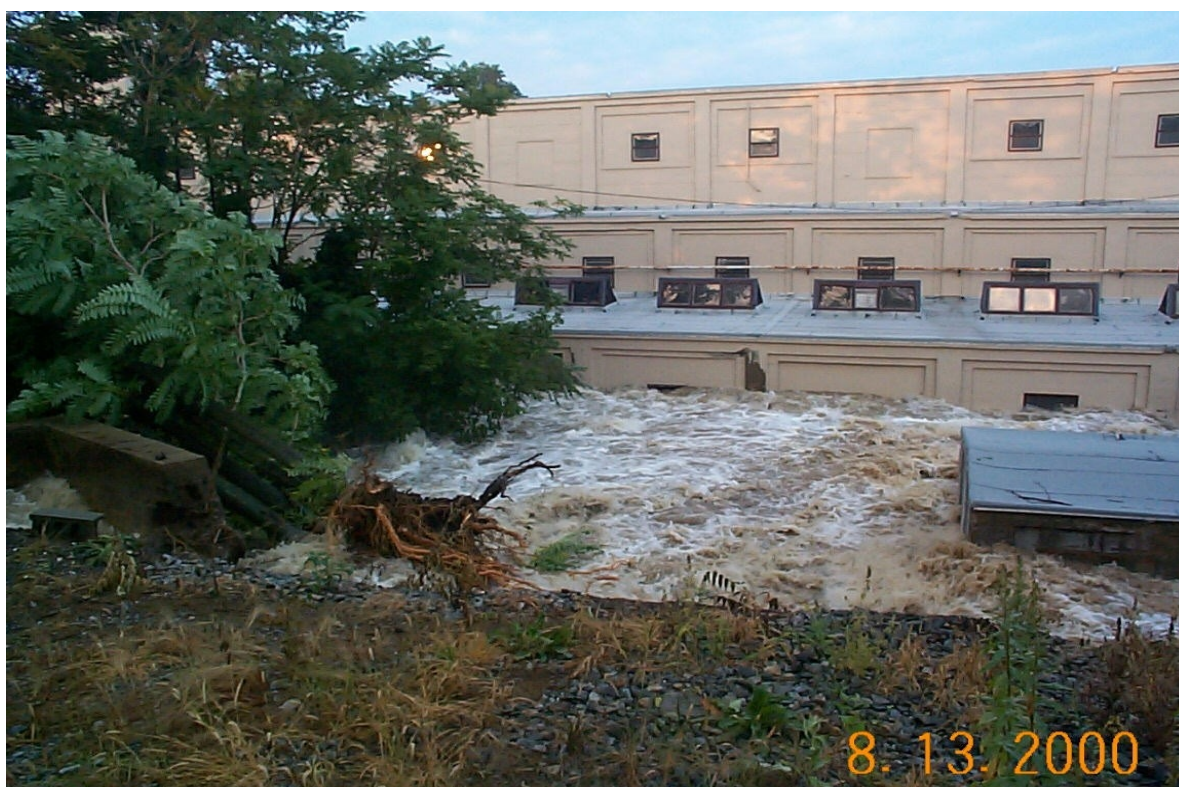
Figure 23. Field shot looking west, downstream, at Lower Spillway showing depth of scour erosion in Stanhope/Netcong, New Jersey (*Photo courtesy of Compac Corporation*).

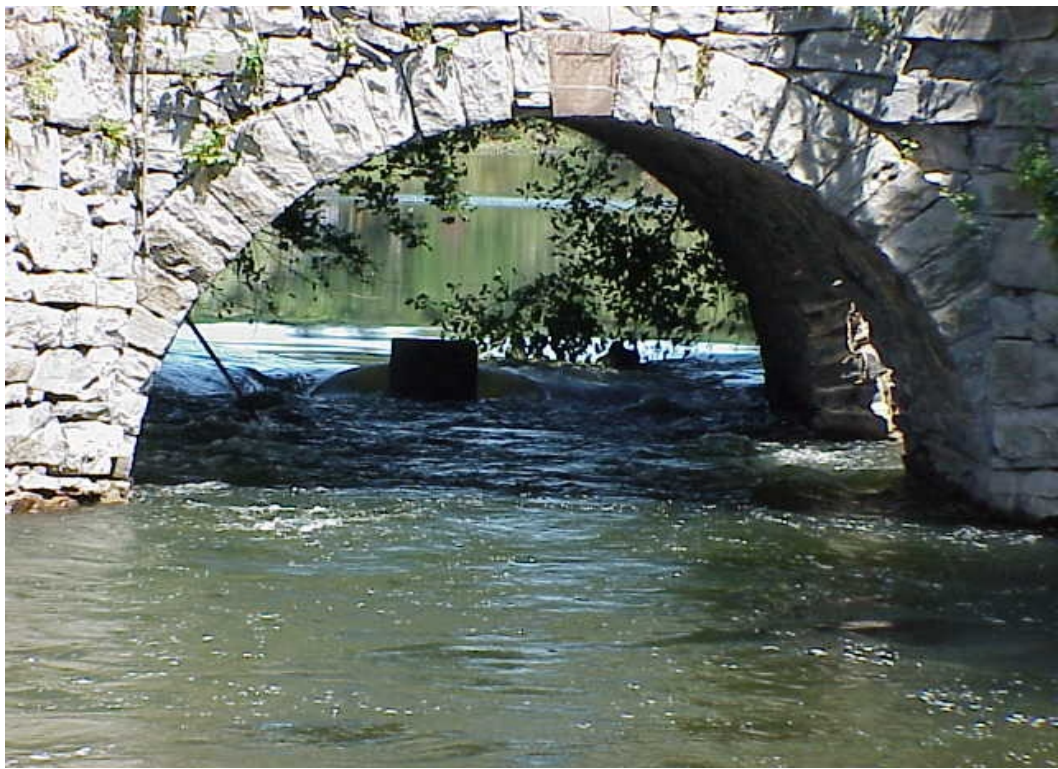
Figure 24. Field shot looking east, upstream, through arch of cut stone bridge showing collapsed earth filled core on right interior at the Compact Corporation site in Stanhope/Netcong, New Jersey (*Photo courtesy of NJDEP*).

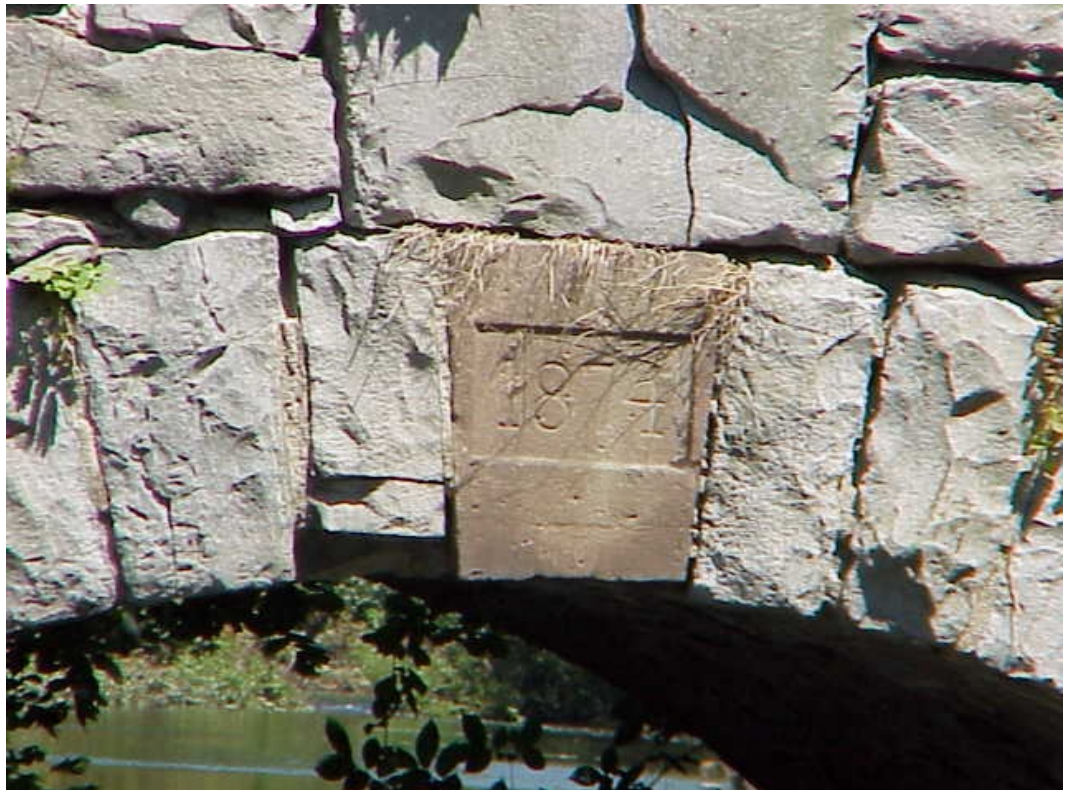
Figure 25. Detail of 1874 capstone in former cut stone arched bridge at Furnace Pond (*Photo courtesy of NJDEP*)

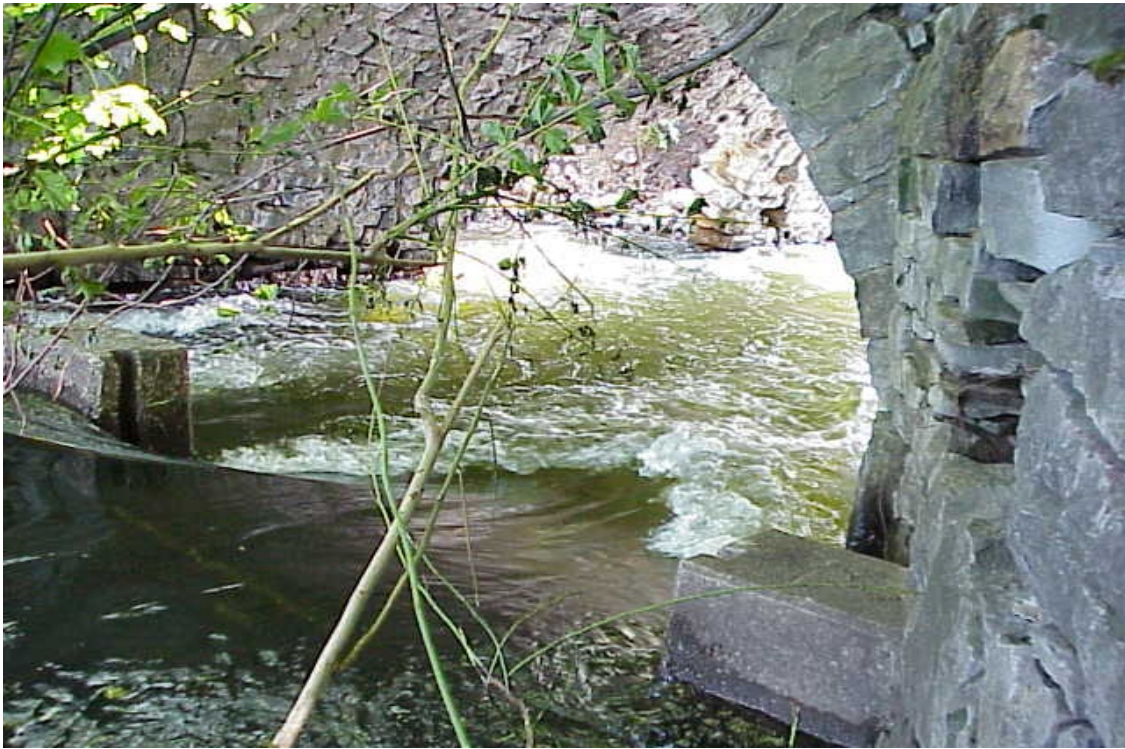
Figure 26. View looking south, across 1927 cement weir pods, into interior arch of former cut stone bridge at Furnace Pond showing partial collapse from flooding of central core of earth filled structure (*Photo courtesy of NJDEP*).

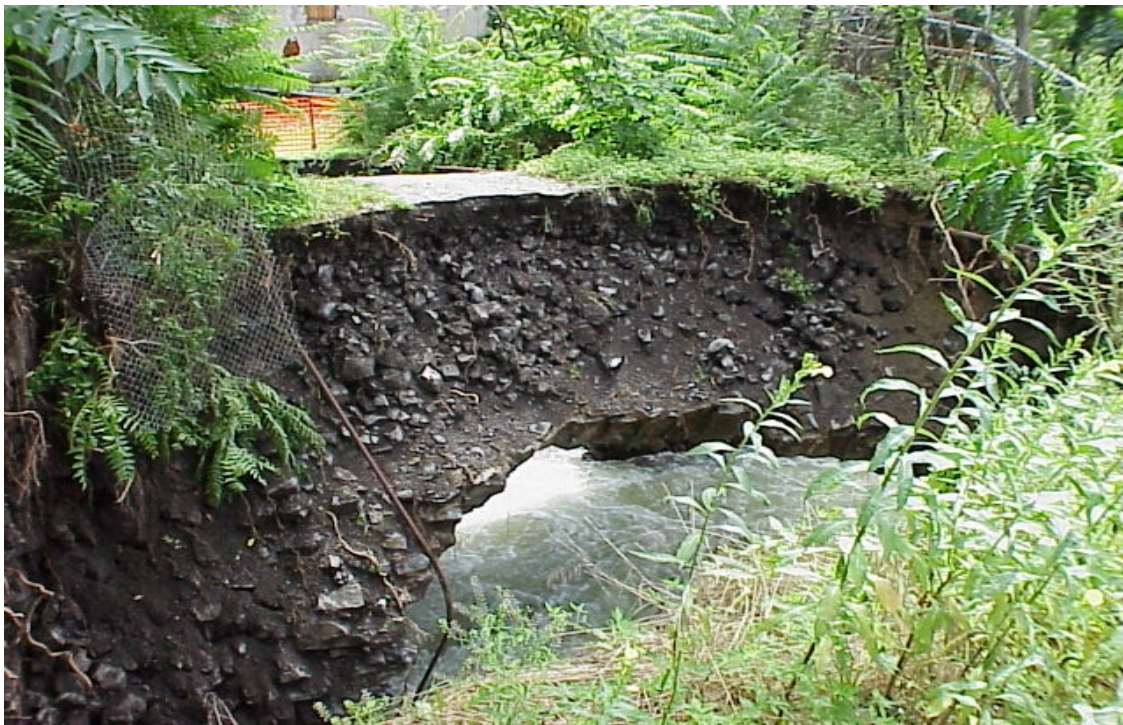
Figure 27. View looking south at deep scour channel through northern half of earth filled cut stone clad arched bridge at Furnace Pond (*Photo courtesy of NJDEP*)

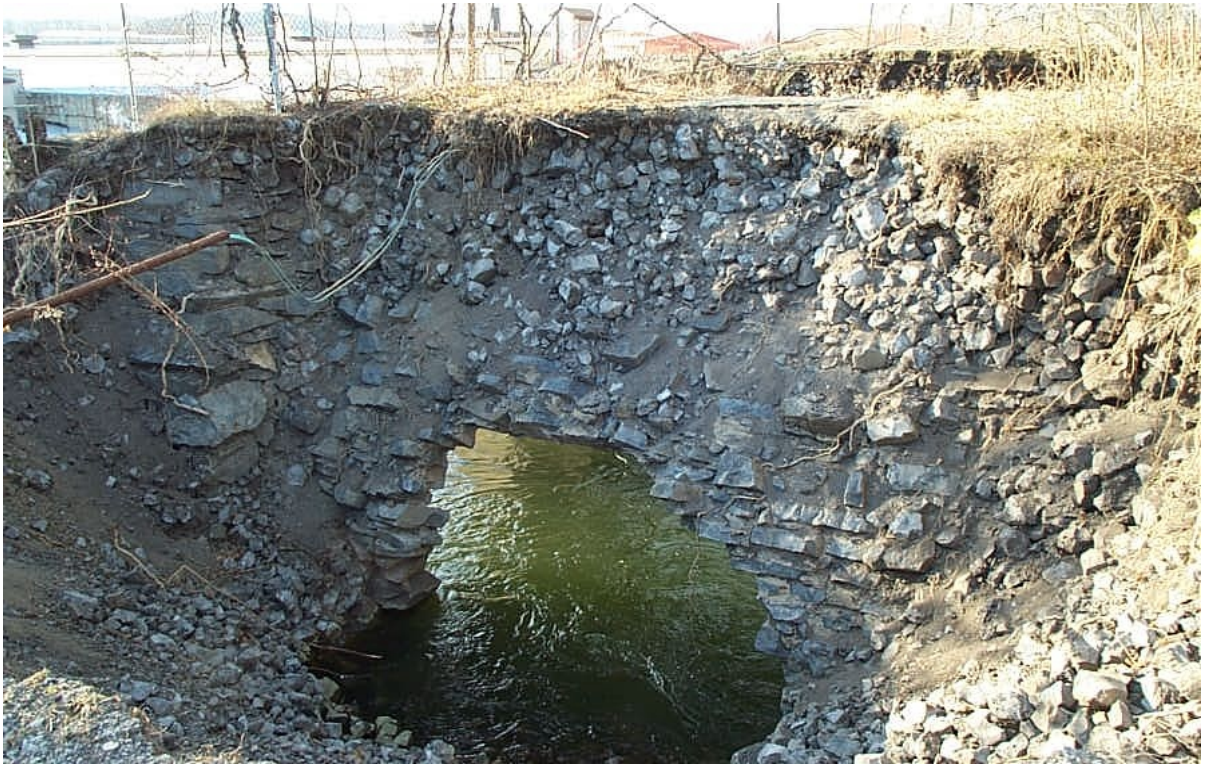
Figure 28. View looking north-west at deep erosion induced collapse of southern half of earth filled and cut stone clad 1874 arched bridge at Furnace Pond Dam(*Photo courtesy of NJDEP*)

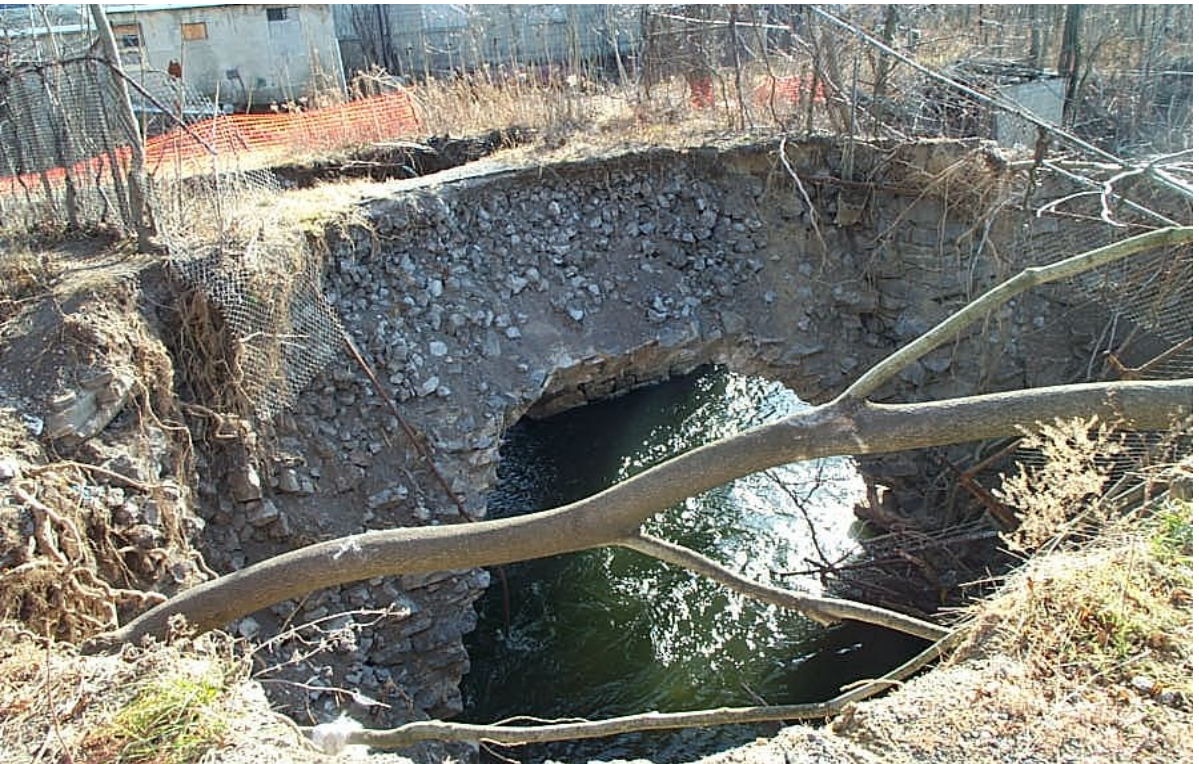
Figure 28. View looking north-west at deep erosion induced collapse of northern half of earth filled and cut stone clad 1874 arched bridge at Furnace Pond Dam(*Photo courtesy of NJDEP*)

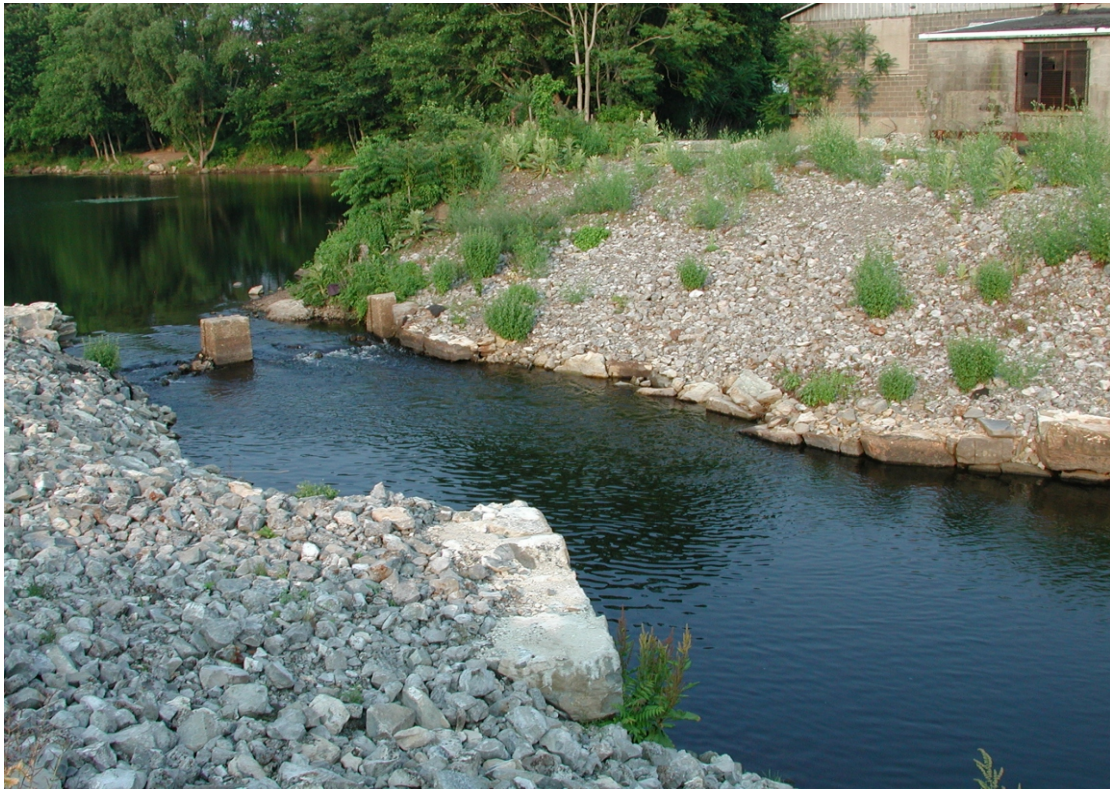
Figure 30. View looking south-east, towards Furnace Pond, along mid-19th century cut stone lined raceway of historic channel (Photo by Joel W, Grossman, Ph.D.).

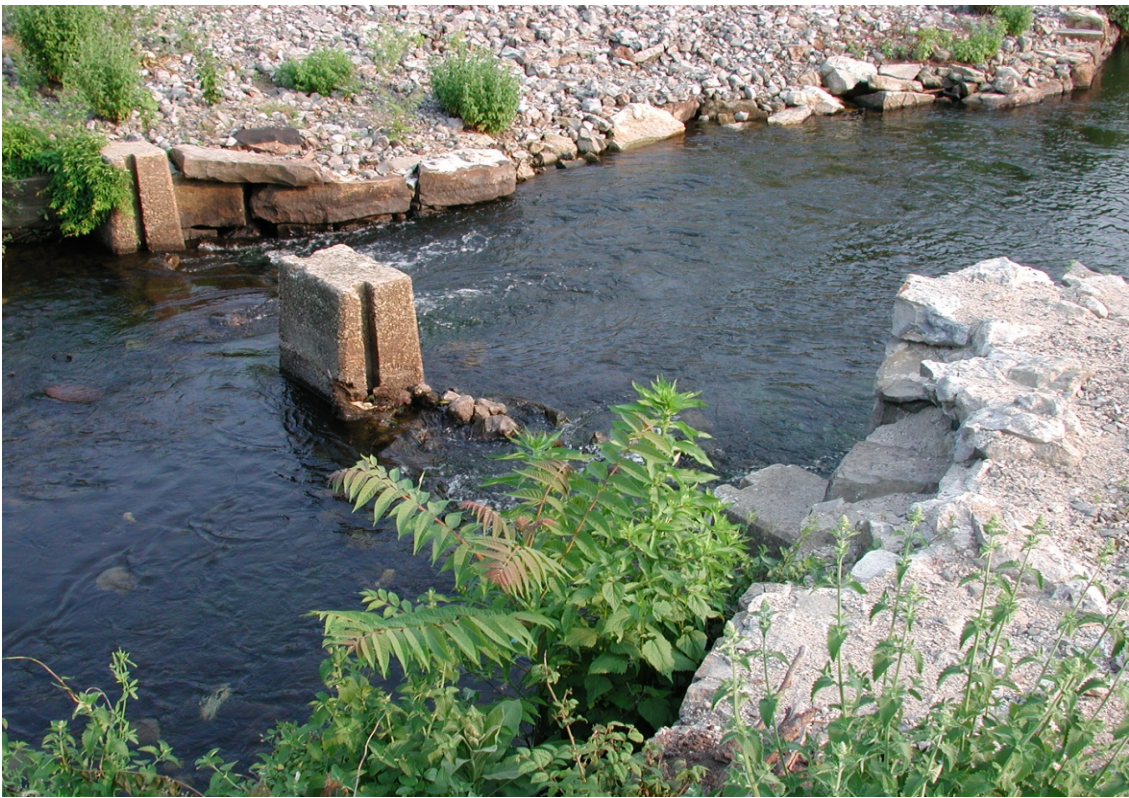
Figure 31. View looking, downstream, south-west across protruding and slotted post-1927 cement pods immediately upstream from former stone arched bridge (Photo by Joel W, Grossman, Ph.D.).

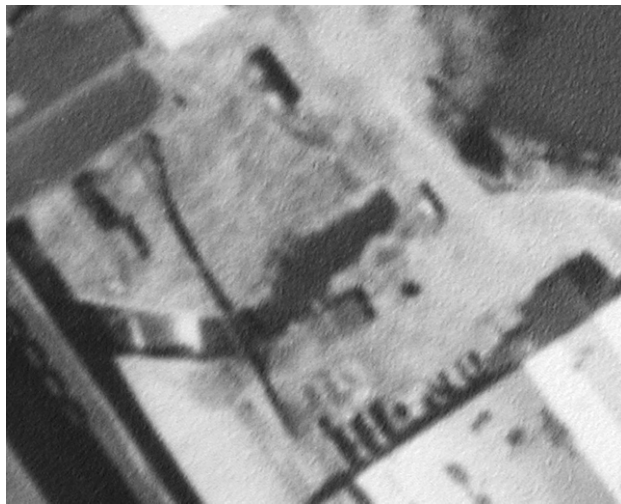
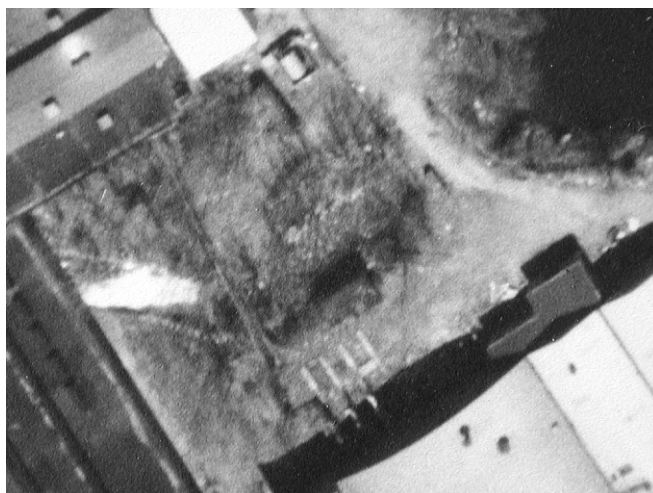
**1974**

Figure 32. Air photo record of changes in channel alignment and condition between 1958 and 1986.  
(Photos by Robinson Aerial, image enhancement by Joel W. Grossman, Ph.D.).
