# Emergency Geospatial Solutions and Mitigation Through Redesign and Avoidance at Furnace Falls Dam, Stanhope, New Jersey

**Joint Engineering and Archaeological  
Mitigation Plan for the Furnace Falls Pond Dam,  
Weir, Spillway and Channel  
Stanhope/Netcong,  
Morris and Sussex Counties, New Jersey**

*Draft-Final Mitigation Plan-  
Compac Corporation – Furnace Falls Dam*

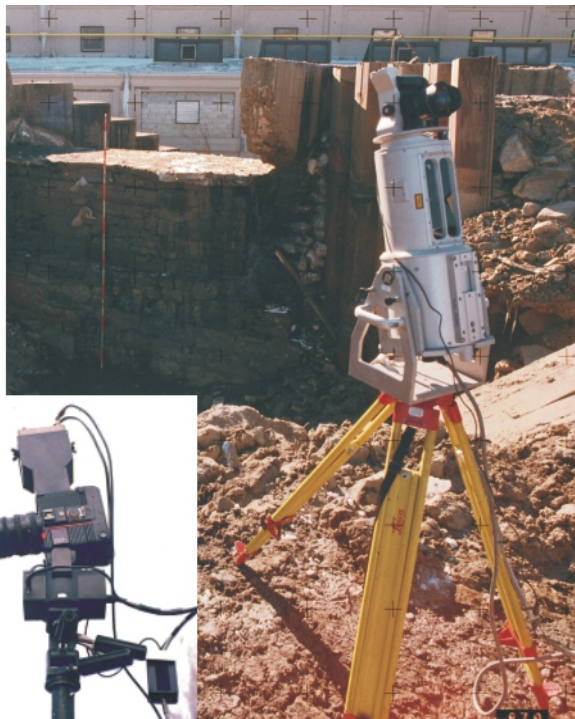
**360°  
Riegl  
LIDAR  
Scanner &  
Rolleimetric  
Camera  
(Inset)**

GIS was used to scale and overlay historic maps onto modern digital and geo-referenced air photos to pinpoint the location of buried and submerged historic features (Grossman 2003a; 2004-Appendix A). Single-camera, Rolleiometric photogrammetry was used to quickly and remotely capture high precision coordinate information for later data extraction once fieldwork was done. High resolution, satellite-linked, GPS established real time grid control as the site was being exposed. High magnification digital video was applied from safe distances to record inaccessible areas.

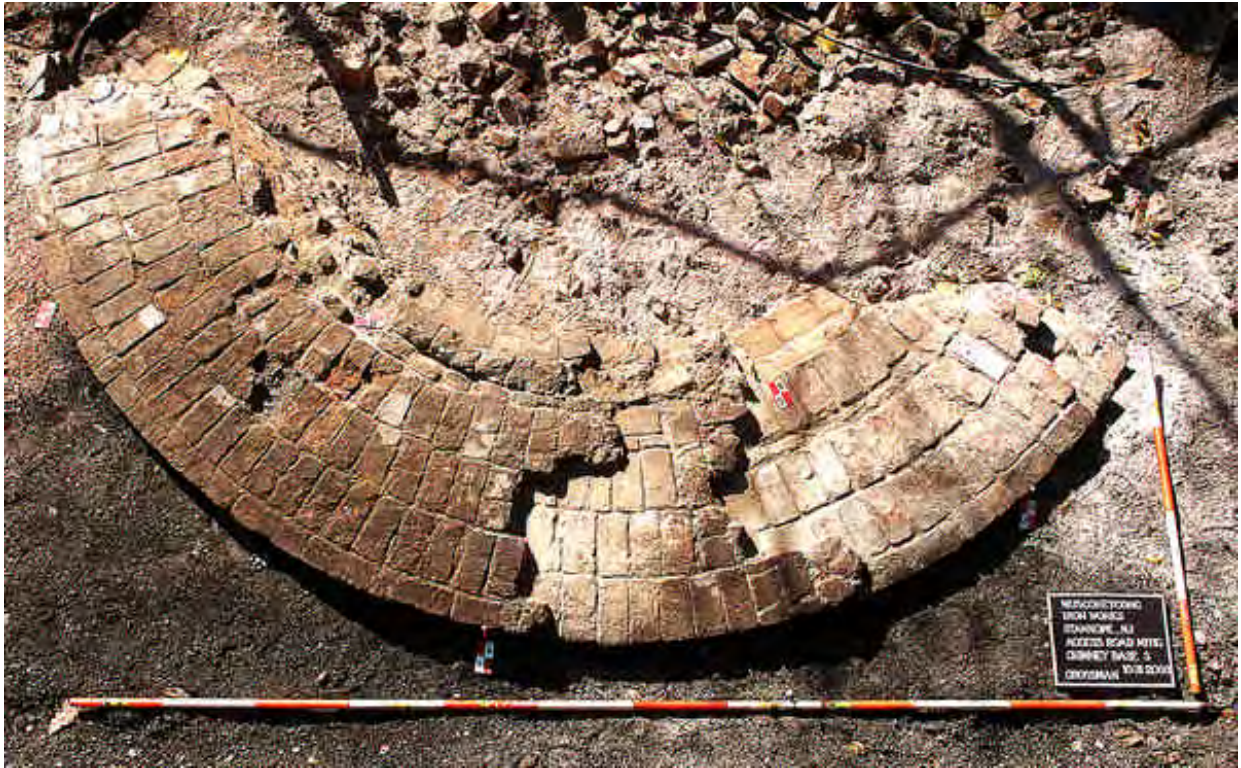
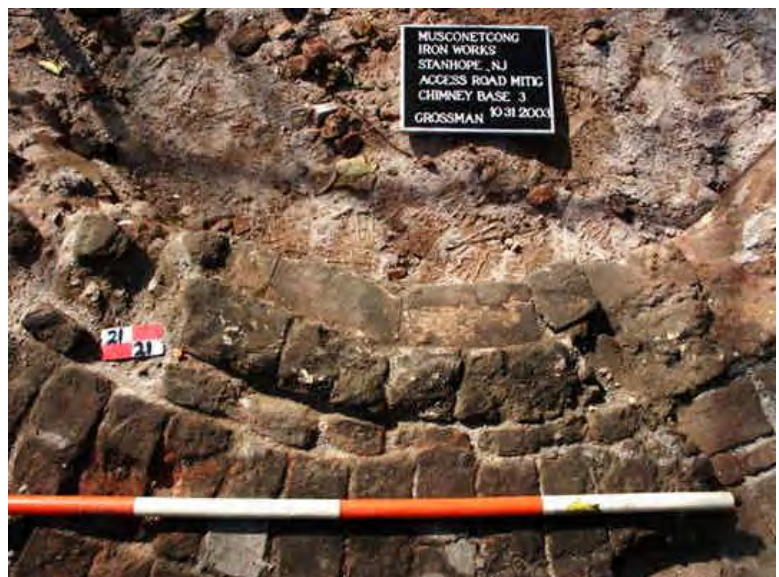
Half of the first feature, **Feature III – Stack 3**, the base of the 125 ft. circular brick and fire brick stack had survived as a surface outcrop in the road. The western half of the chimney base had been previously destroyed by unrelated remediation activities within the last 15 to 20 years. Enough of its form was exposed and recorded to reconstruct its original diameter and construction.

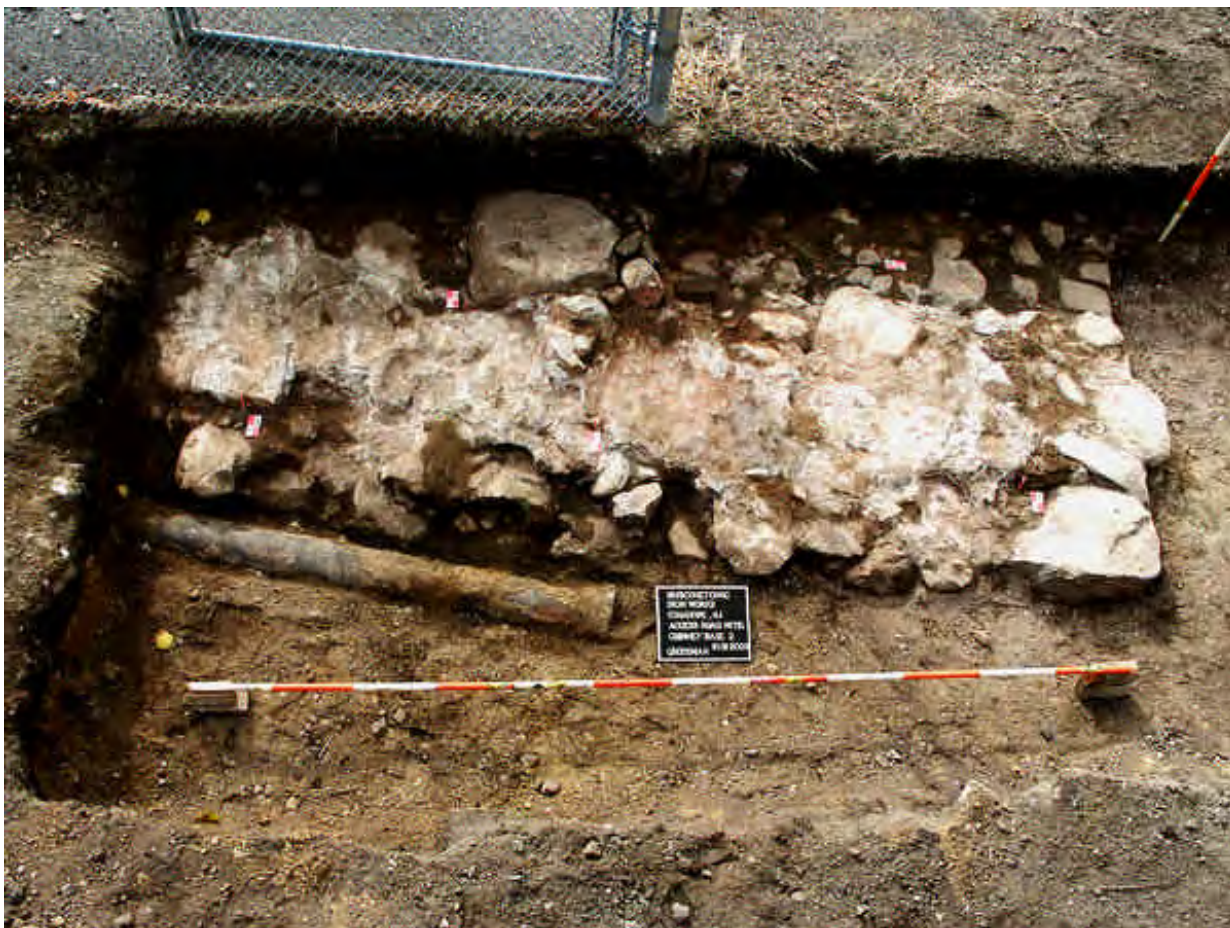
The second feature, **Feature II – Cobble Platform - Stack 2**, consisted of a large rectangular stone boulder and mortar foundation matrix exposed within the Access Road at a depth of 14 inches below grade. Approximately  $\frac{1}{4}$  to  $\frac{1}{2}$  of its original size was exposed in a ca. 10 by 15 ft wide-area trench, sufficient to document its original size, shape and orientation.

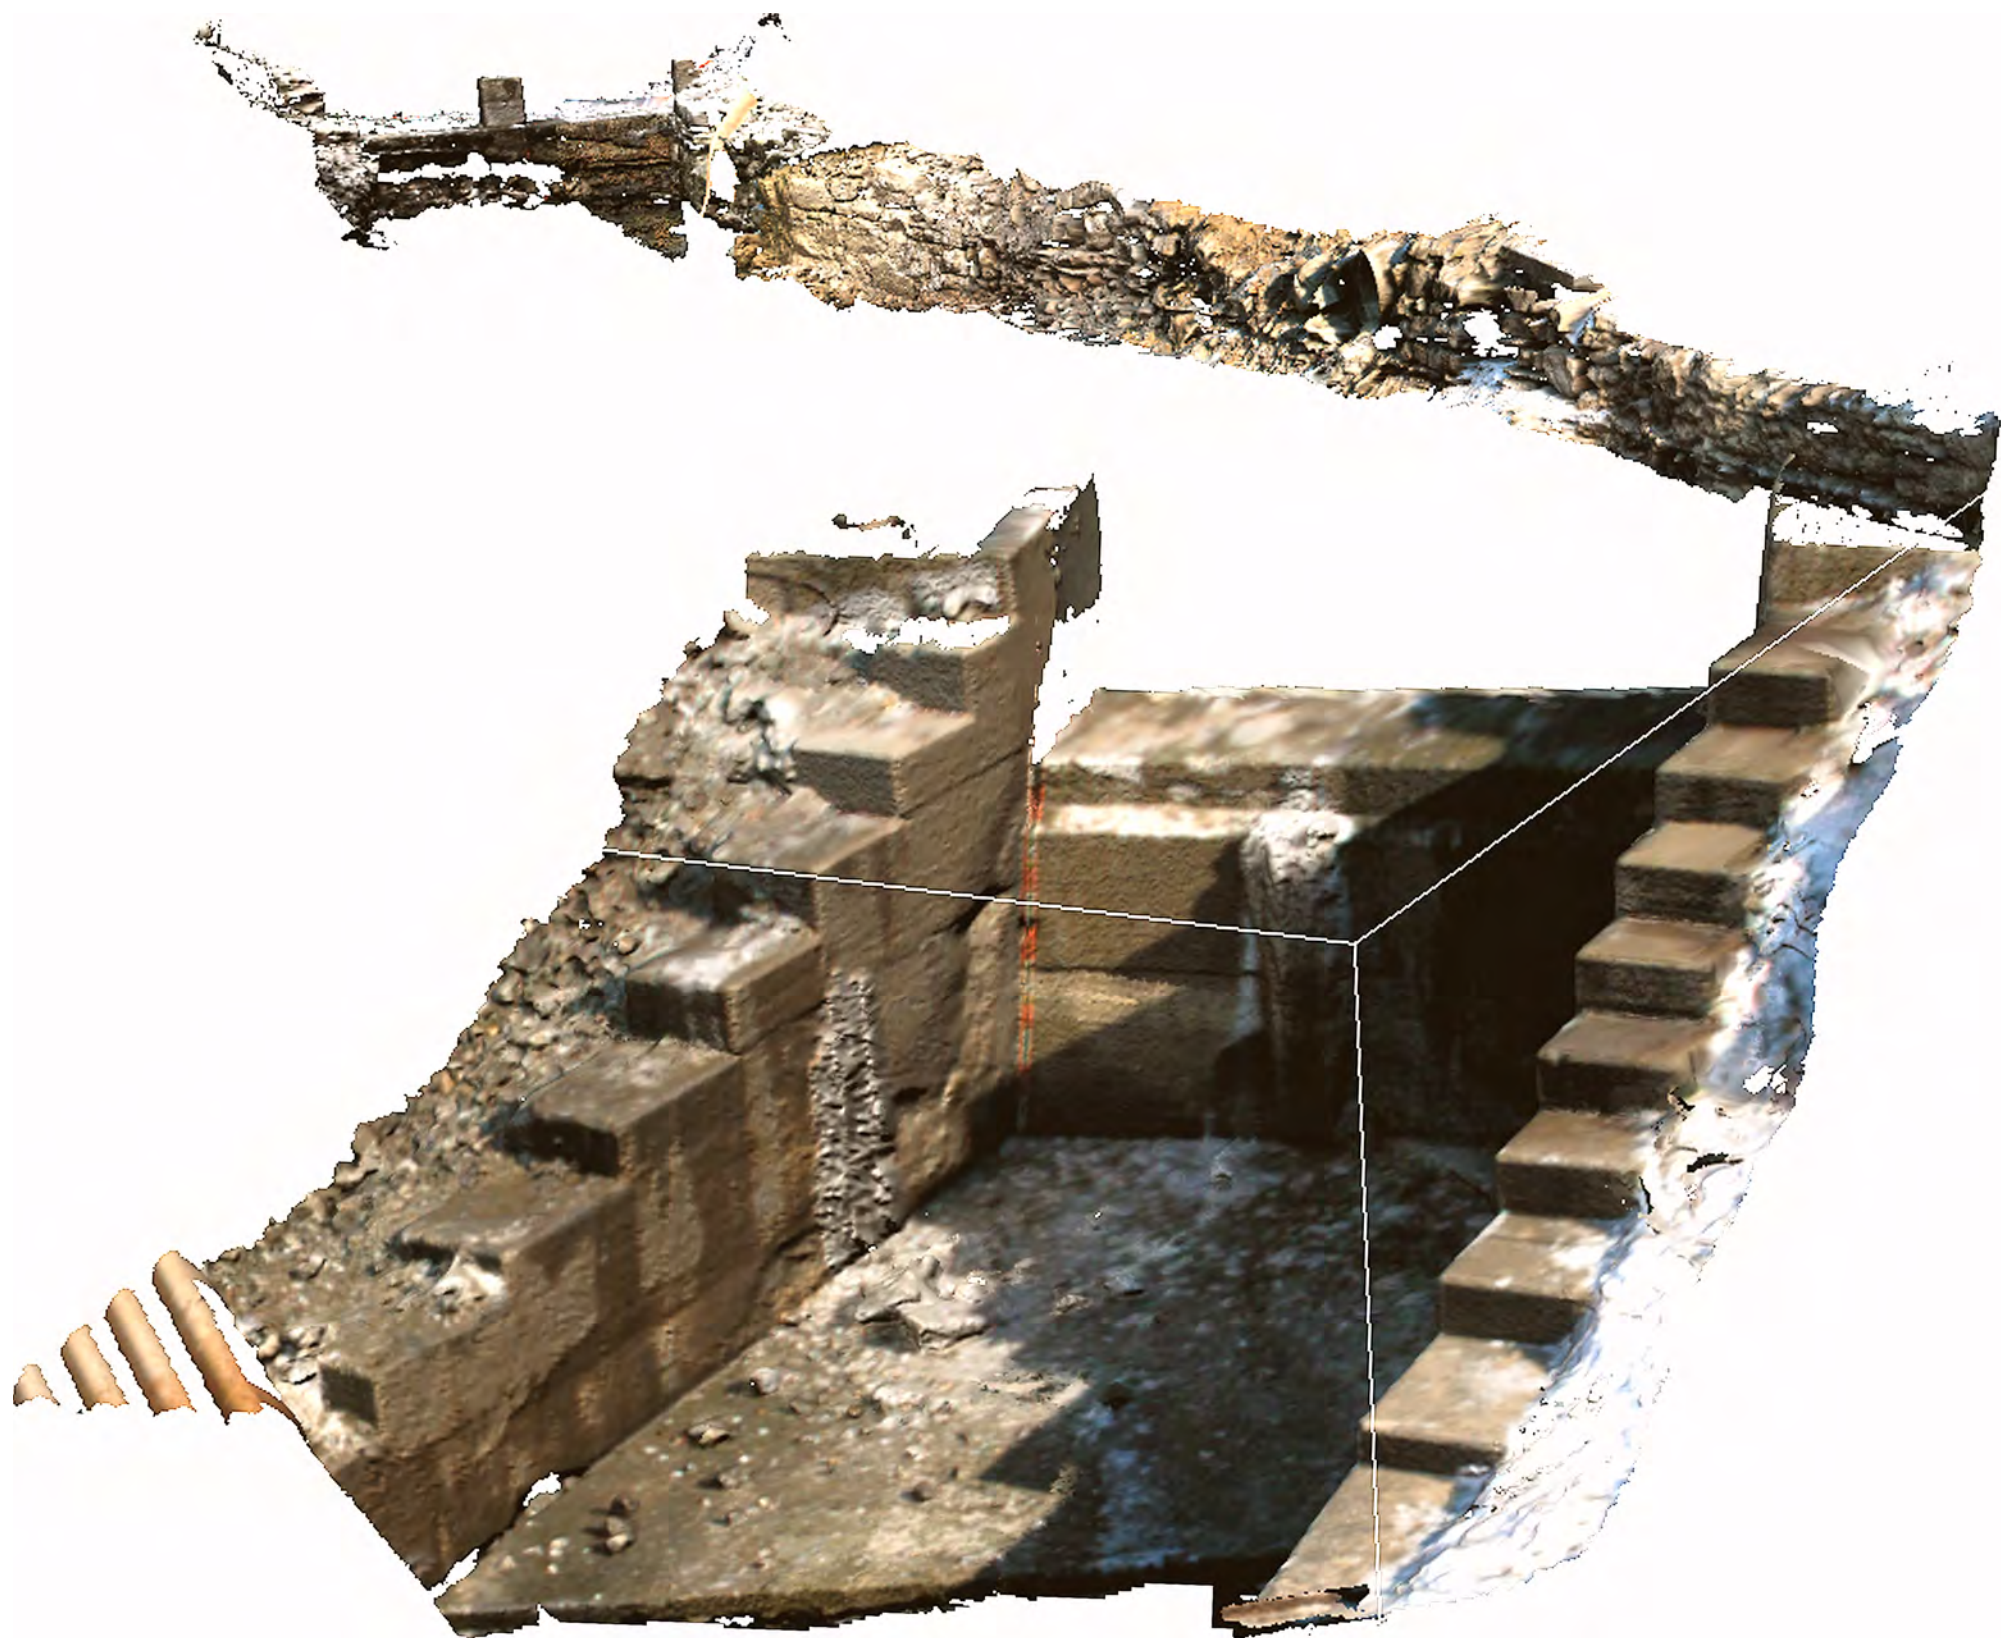
Figure 47: Virtual 3D color LIDAR overhead perspective view looking east at western cement face of Singer Spillway, with southern bank of channel and weir to the rear.

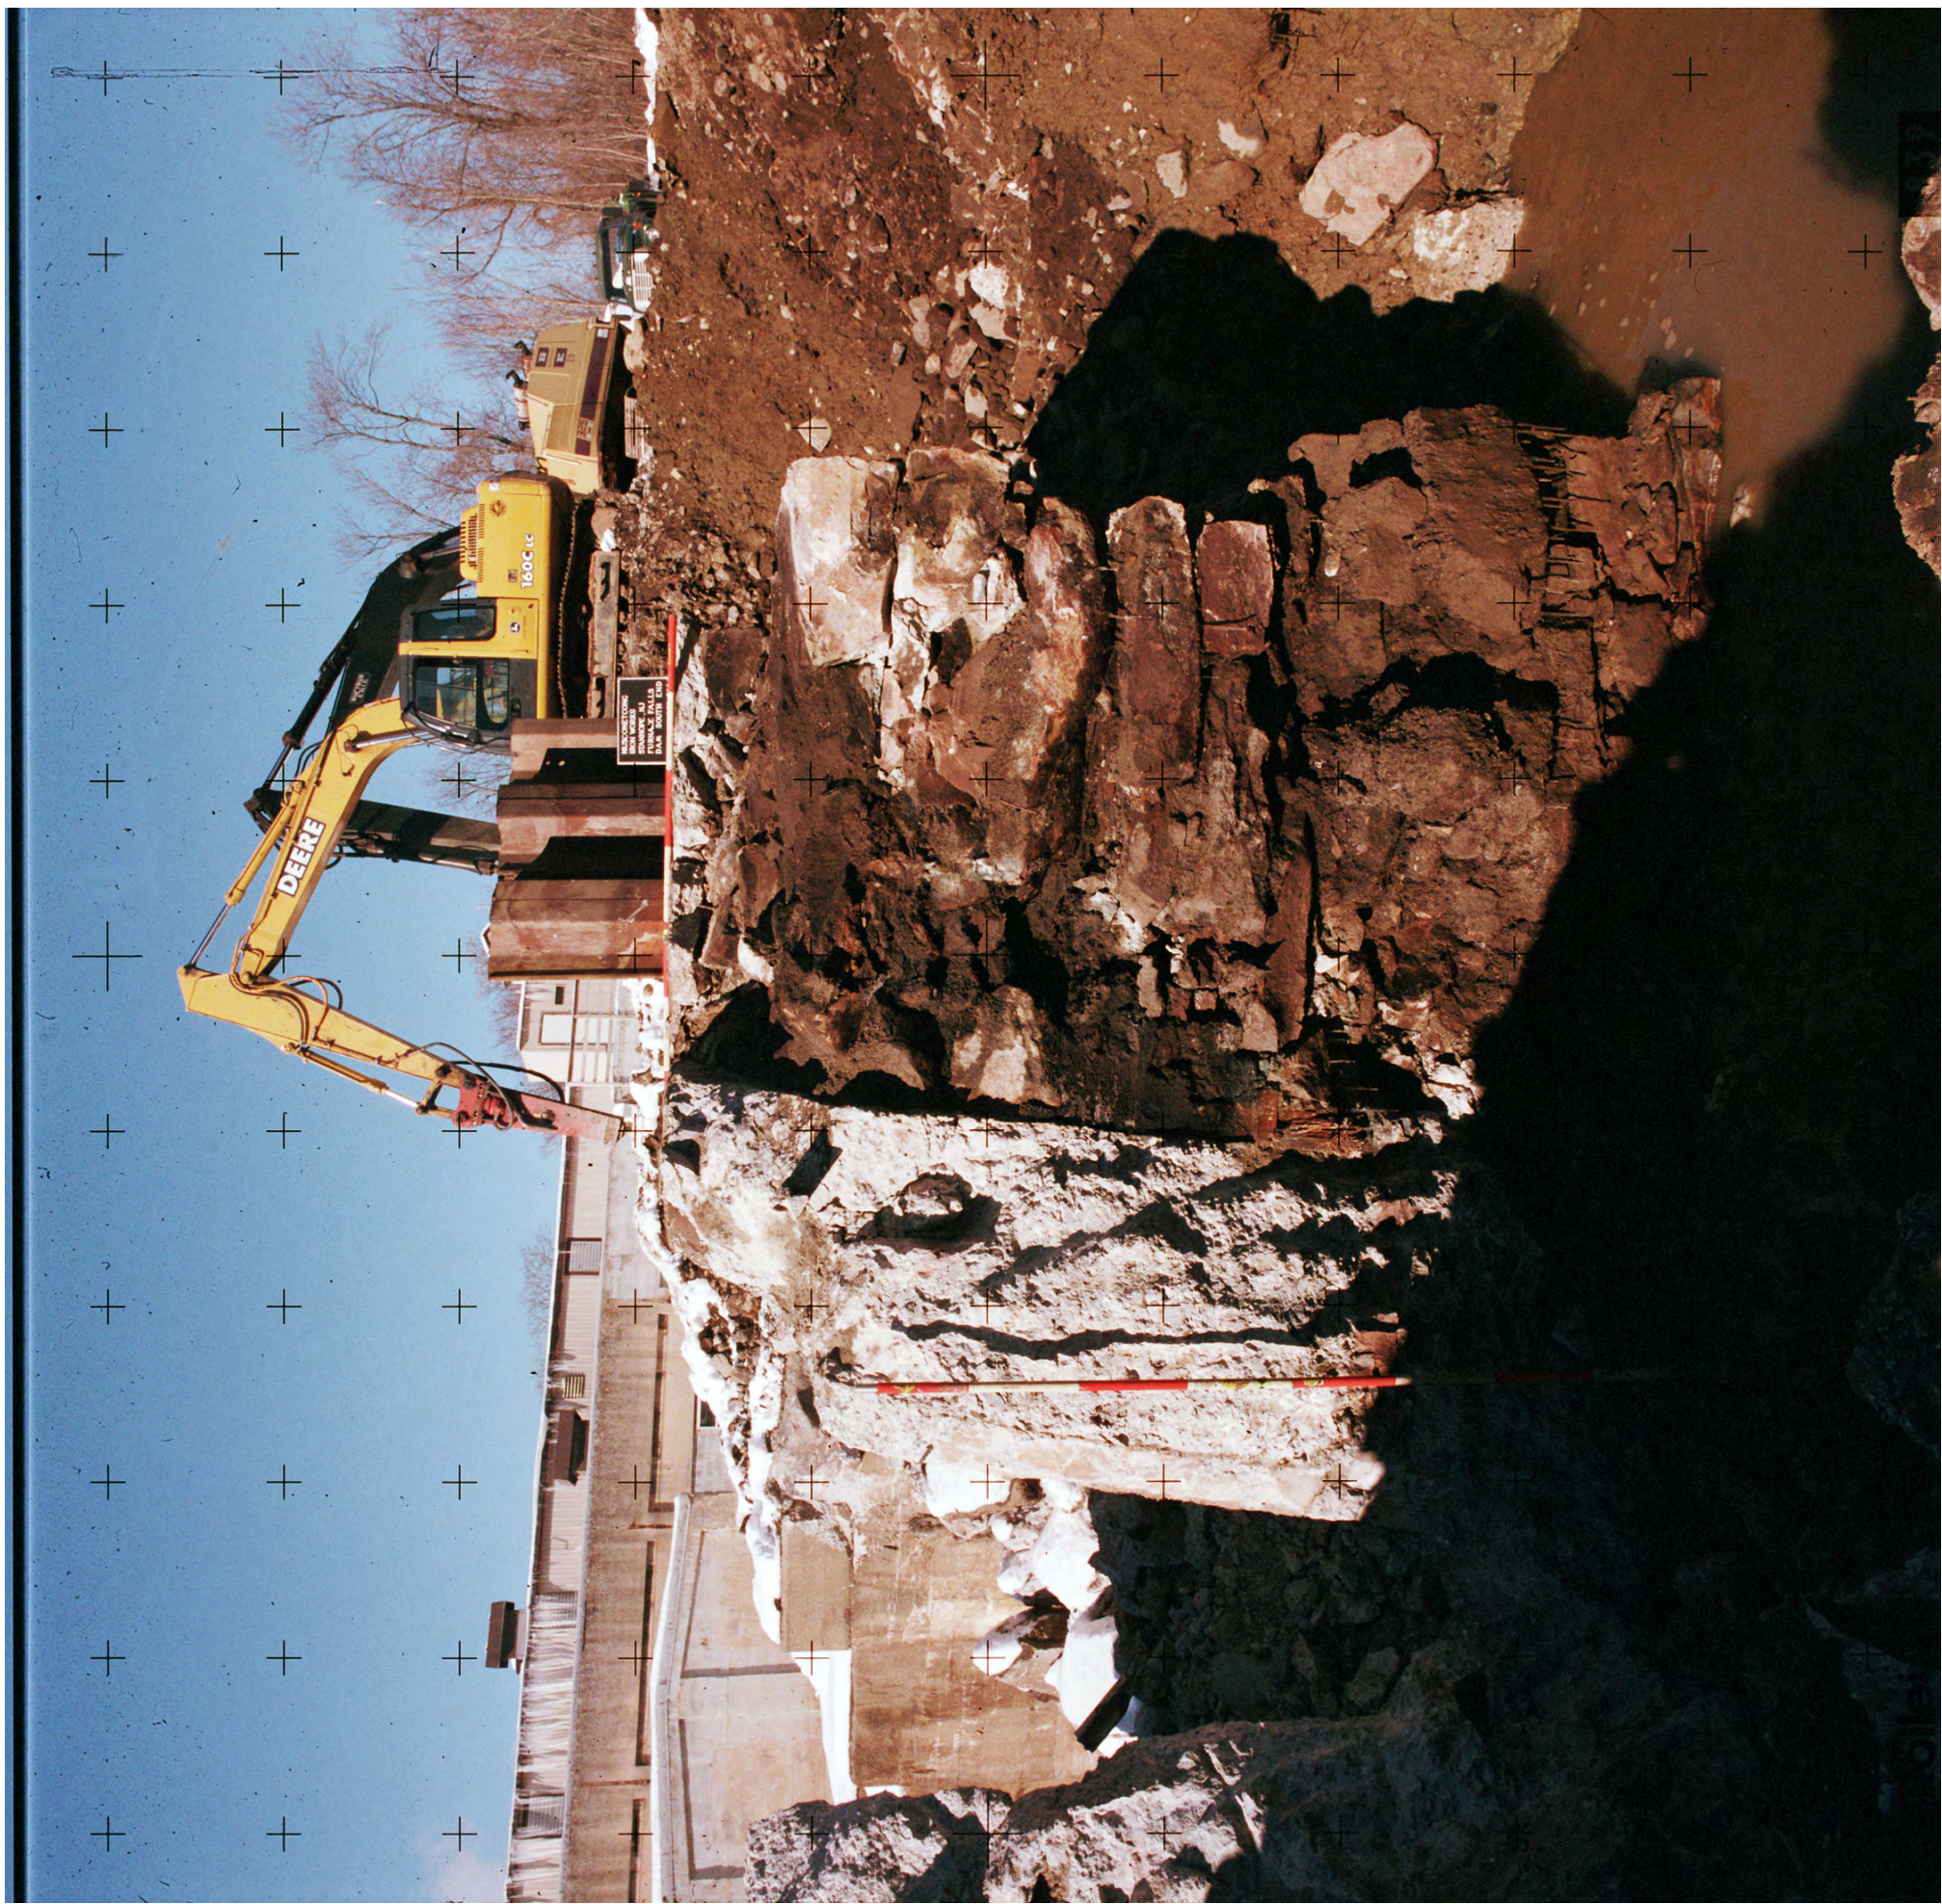
Figure 31: Rolleimetric film-based macro flat field photograph of southern profile of Furnace Falls Dam exposed to 11 feet (el: 819 ft.) below lip of spillway(@ 830 ft.). Note imbedded calibration marks for photogrammetric image rectification. *Photo by Joel W. Grossman, Ph.D.*

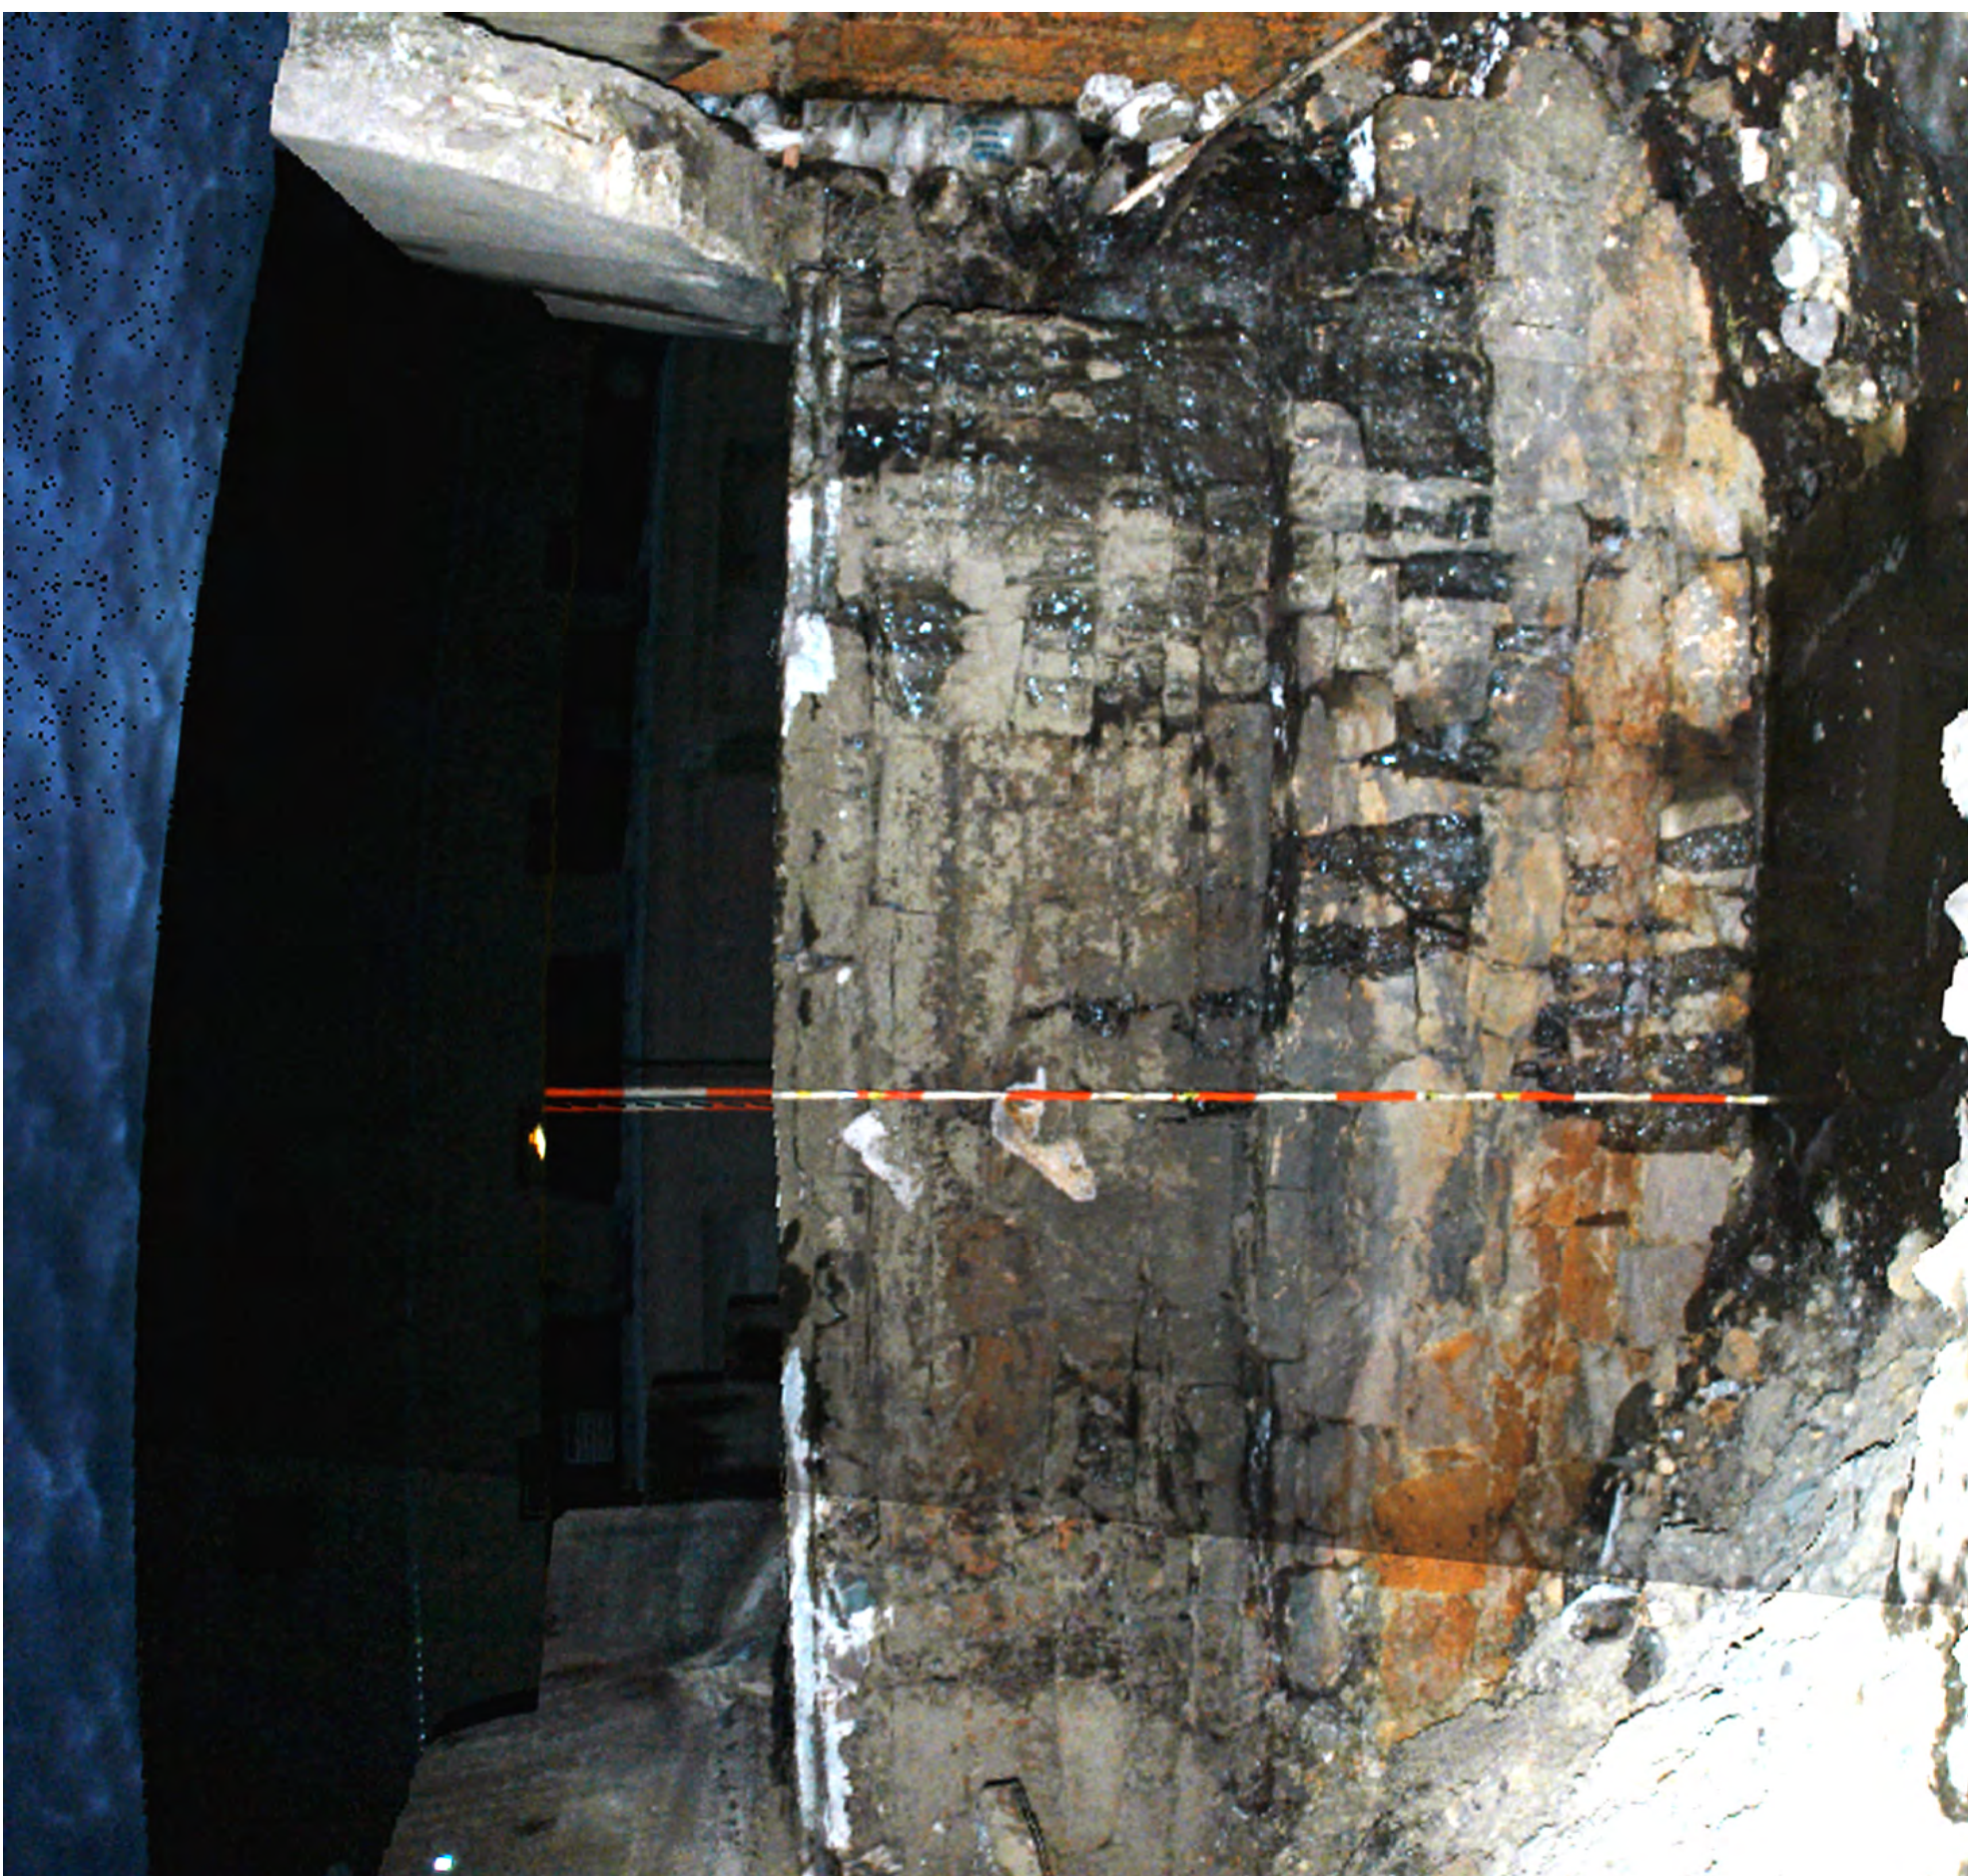
Figure 27: Panoramic composite, looking west at the exposed eastern face of the 1830 era Furnace Falls dam, taken by integrated, computer controlled, Nikon digital camera mounted on the Riegl LIDAR scanner. The “seamed” digital picture, which shows the scanner’s field of view (what it “saw” ), was matched, pixel by pixel, to the 6 mm. precise LIDAR scanner-derived coordinate points, to render the true color 3D data captures of the formerly submerged dam. Overlapping digital photo series were taken with flash after sunset during final LIDAR scan of dam on January 21, 2004. Temperature range: 10 - 14 degrees F.

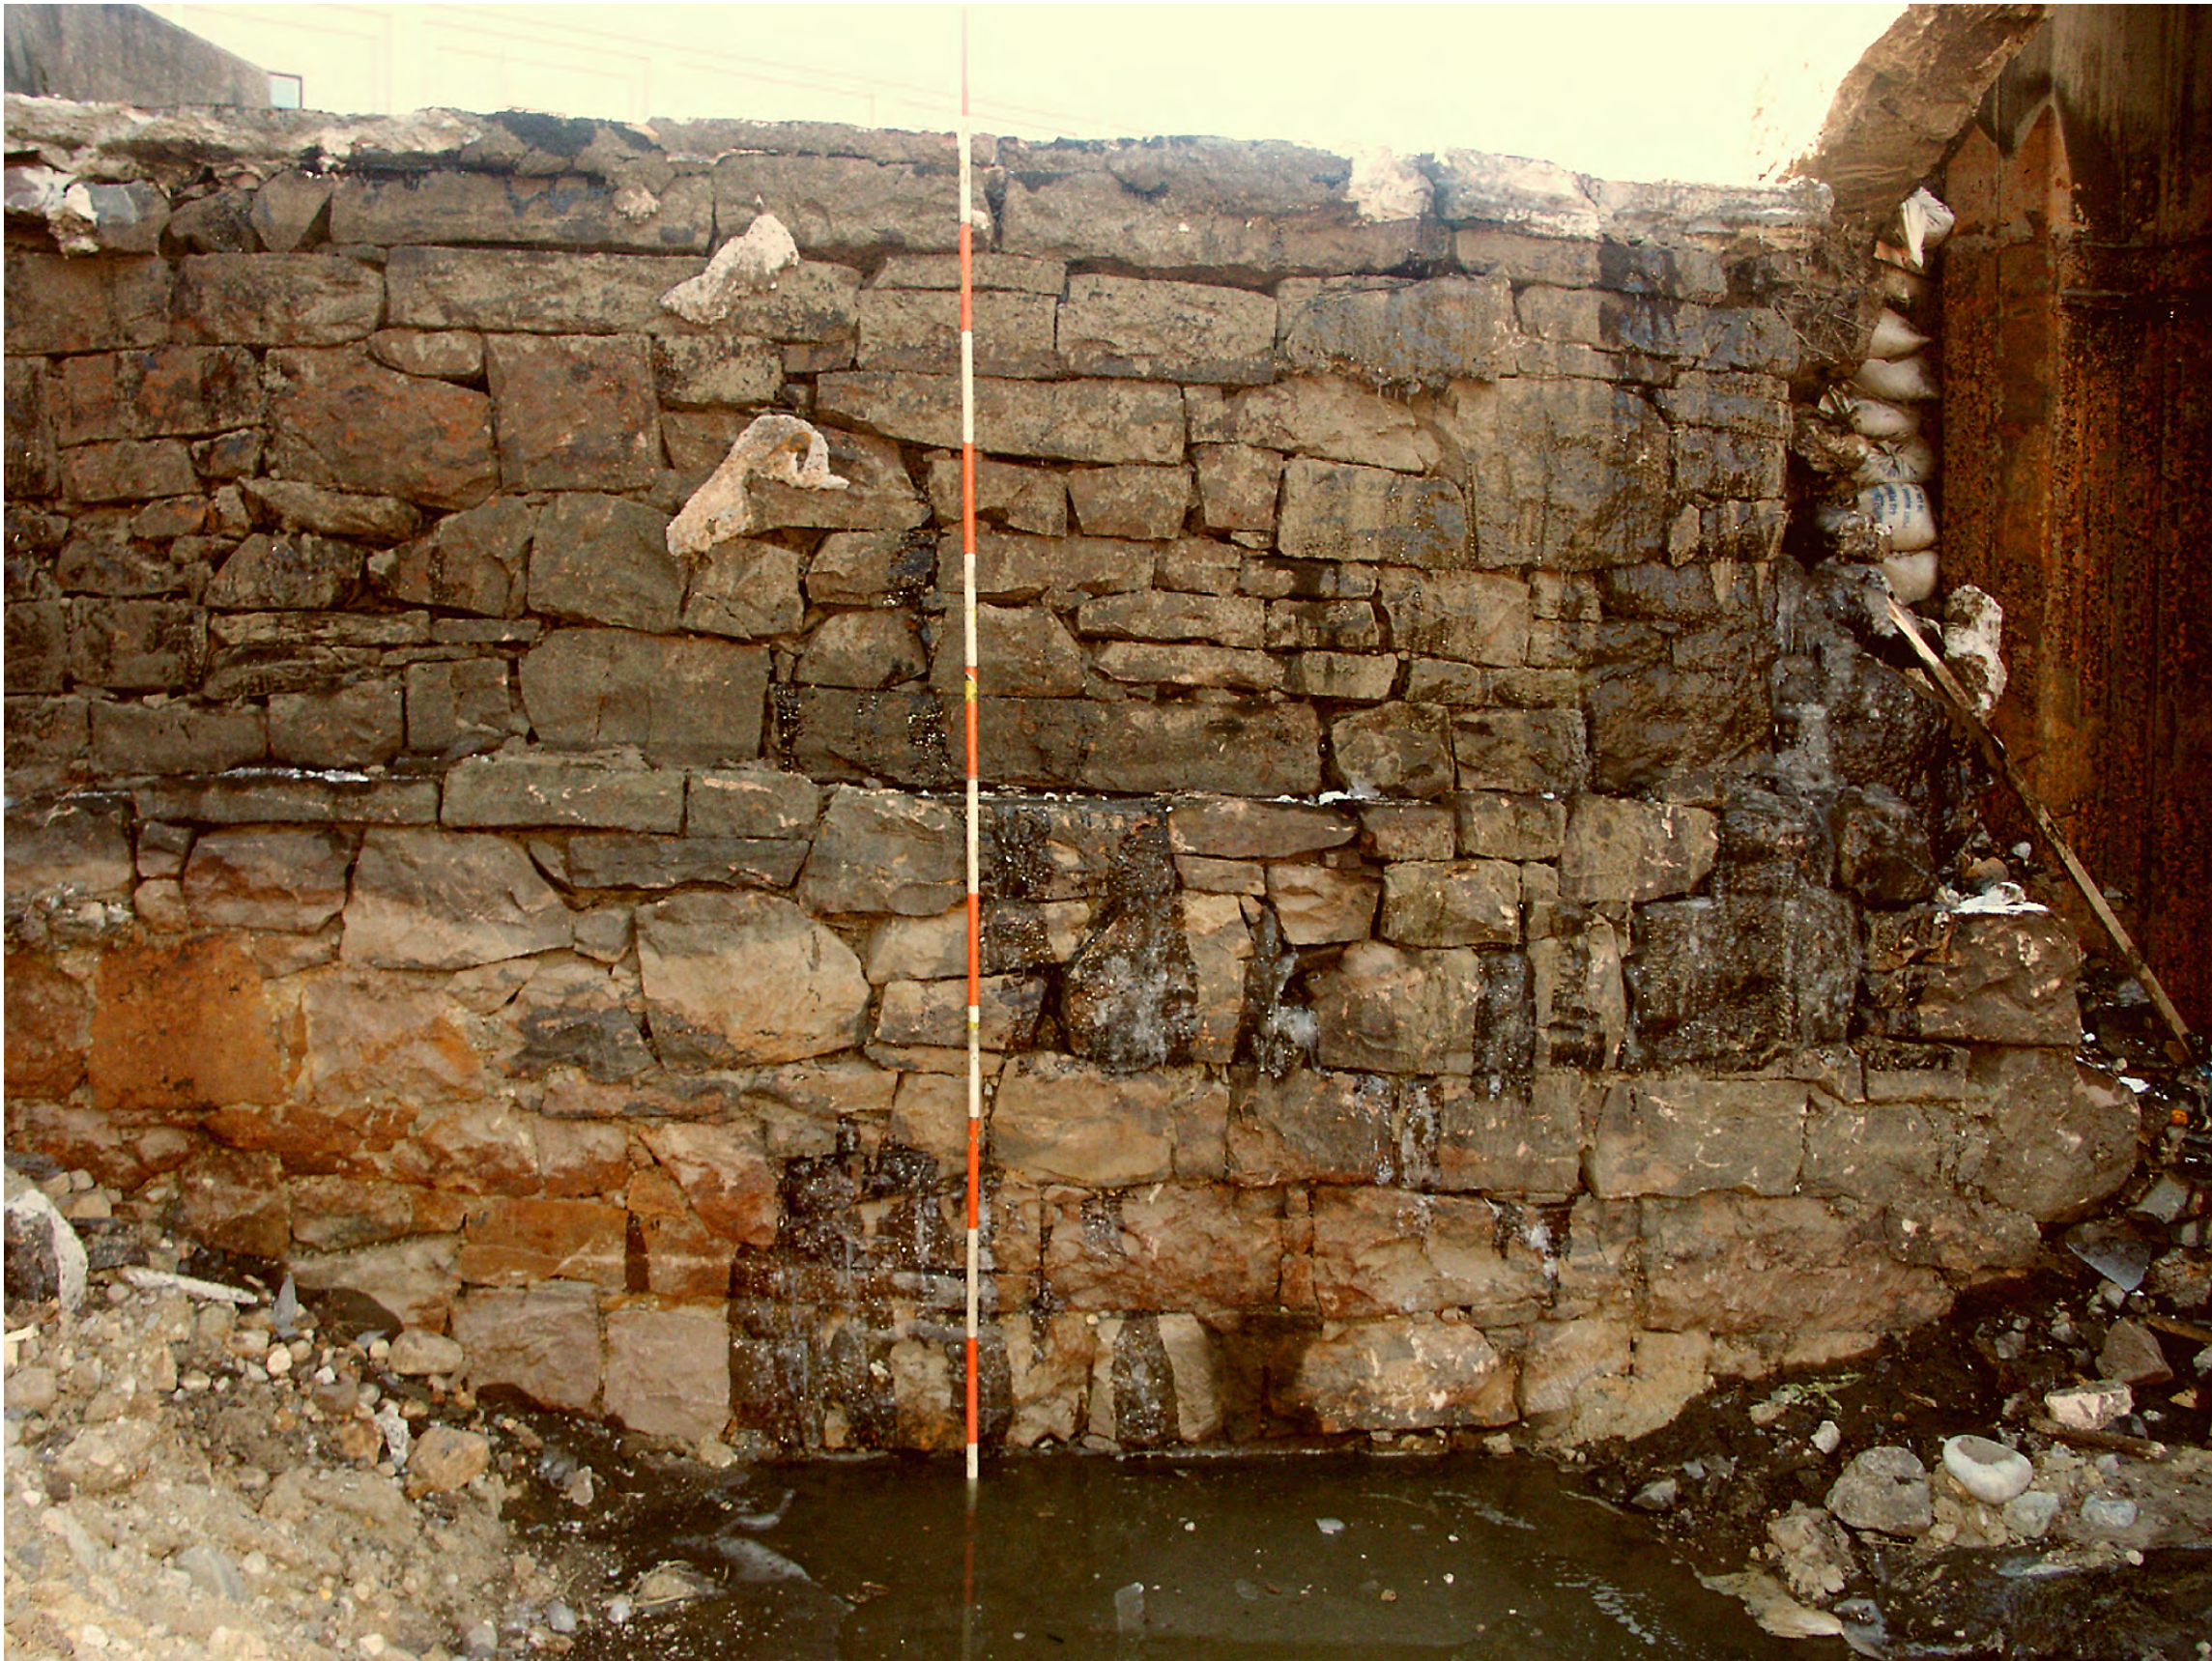
Figure 26: Digital macro photograph of east facade of Furnace Falls cut stone dam taken with natural light on afternoon of LIDAR scan, January 21, 2004. Note iron oxide stains and lighter band denoting depth of historic channel sediments.

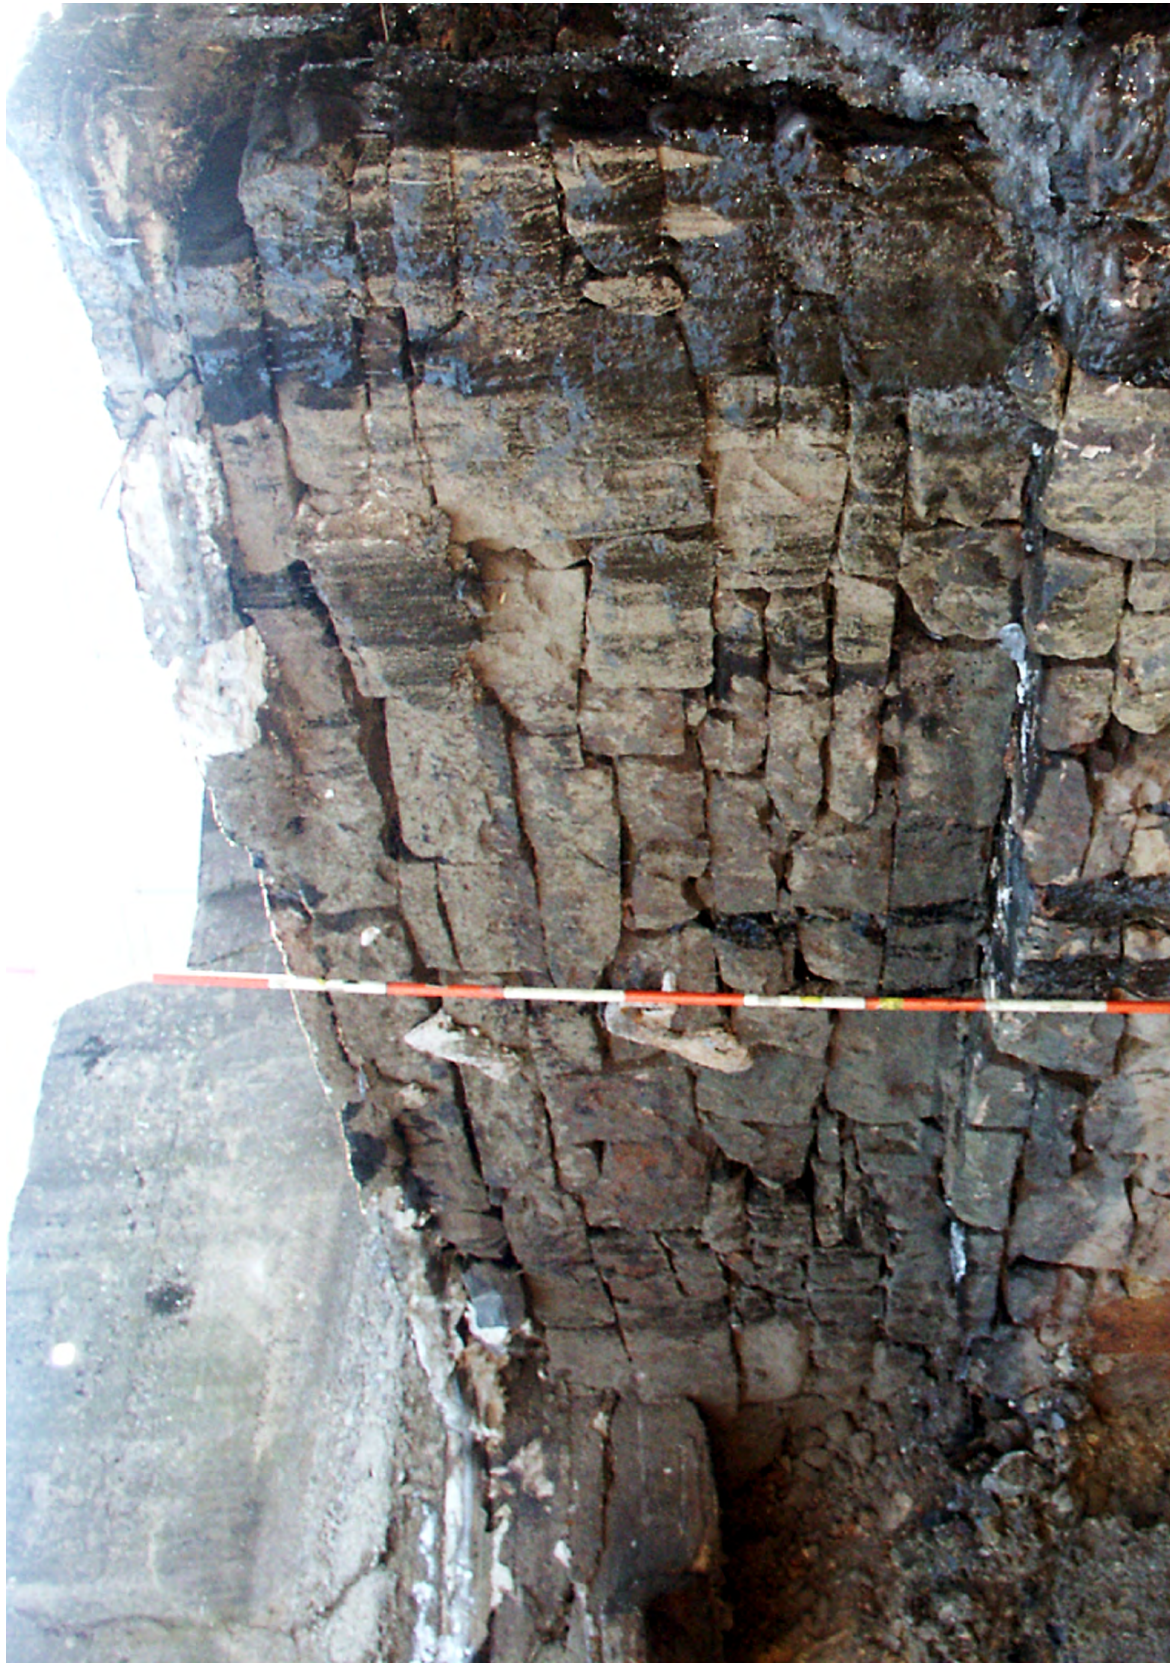
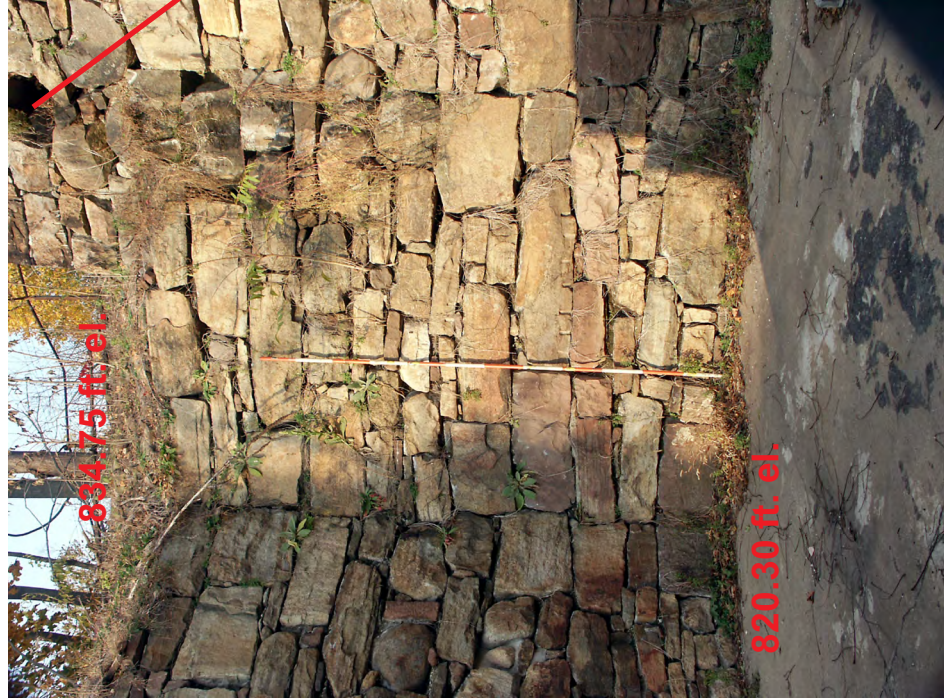
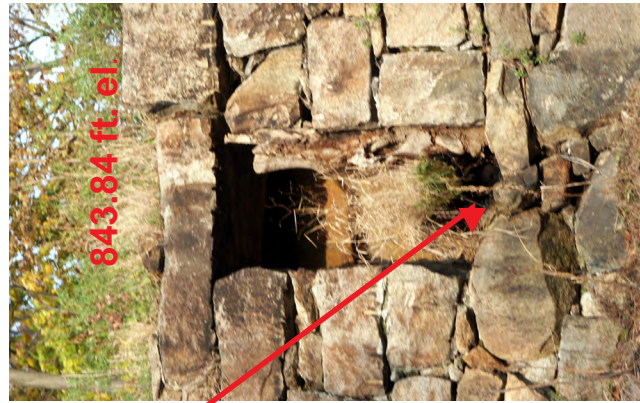
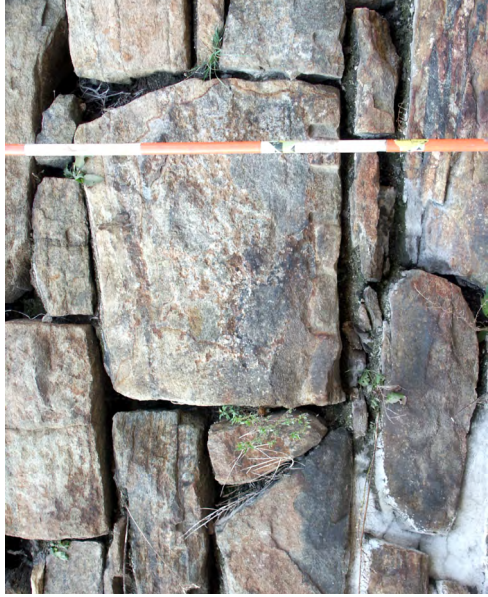
Figure 28: a) Digital photo looking southwest at eastern cut stone face and 6 ft high square finished northeast corner of the cut stone dam suggesting a former lower sluiceway(@ ca 824 ft. el) immediately north of the cement, or Singer, Spillway; b-d) Location map and structural details from the post-1840 Retaining Wall of the Musconetcong Iron Works supporting the Canal Spur Reservoir into the Foundry from the Morris Canal. The masonry of the 16 ft. high Foundry Retaining Wall has dry laid stonework comparable to that encountered in the cut stone dam. Note rust colored iron oxide stains at corner of Retaining Wall from former blast furnaces.
