# Emergency Geospatial Solutions and Mitigation Through Redesign and Avoidance at Furnace Falls Dam, Stanhope, New Jersey

**Joint Engineering and Archaeological  
Mitigation Plan for the Furnace Falls Pond Dam,  
Weir, Spillway and Channel  
Stanhope/Netcong,  
Morris and Sussex Counties, New Jersey**

*Draft-Final Mitigation Plan-  
Compac Corporation – Furnace Falls Dam*

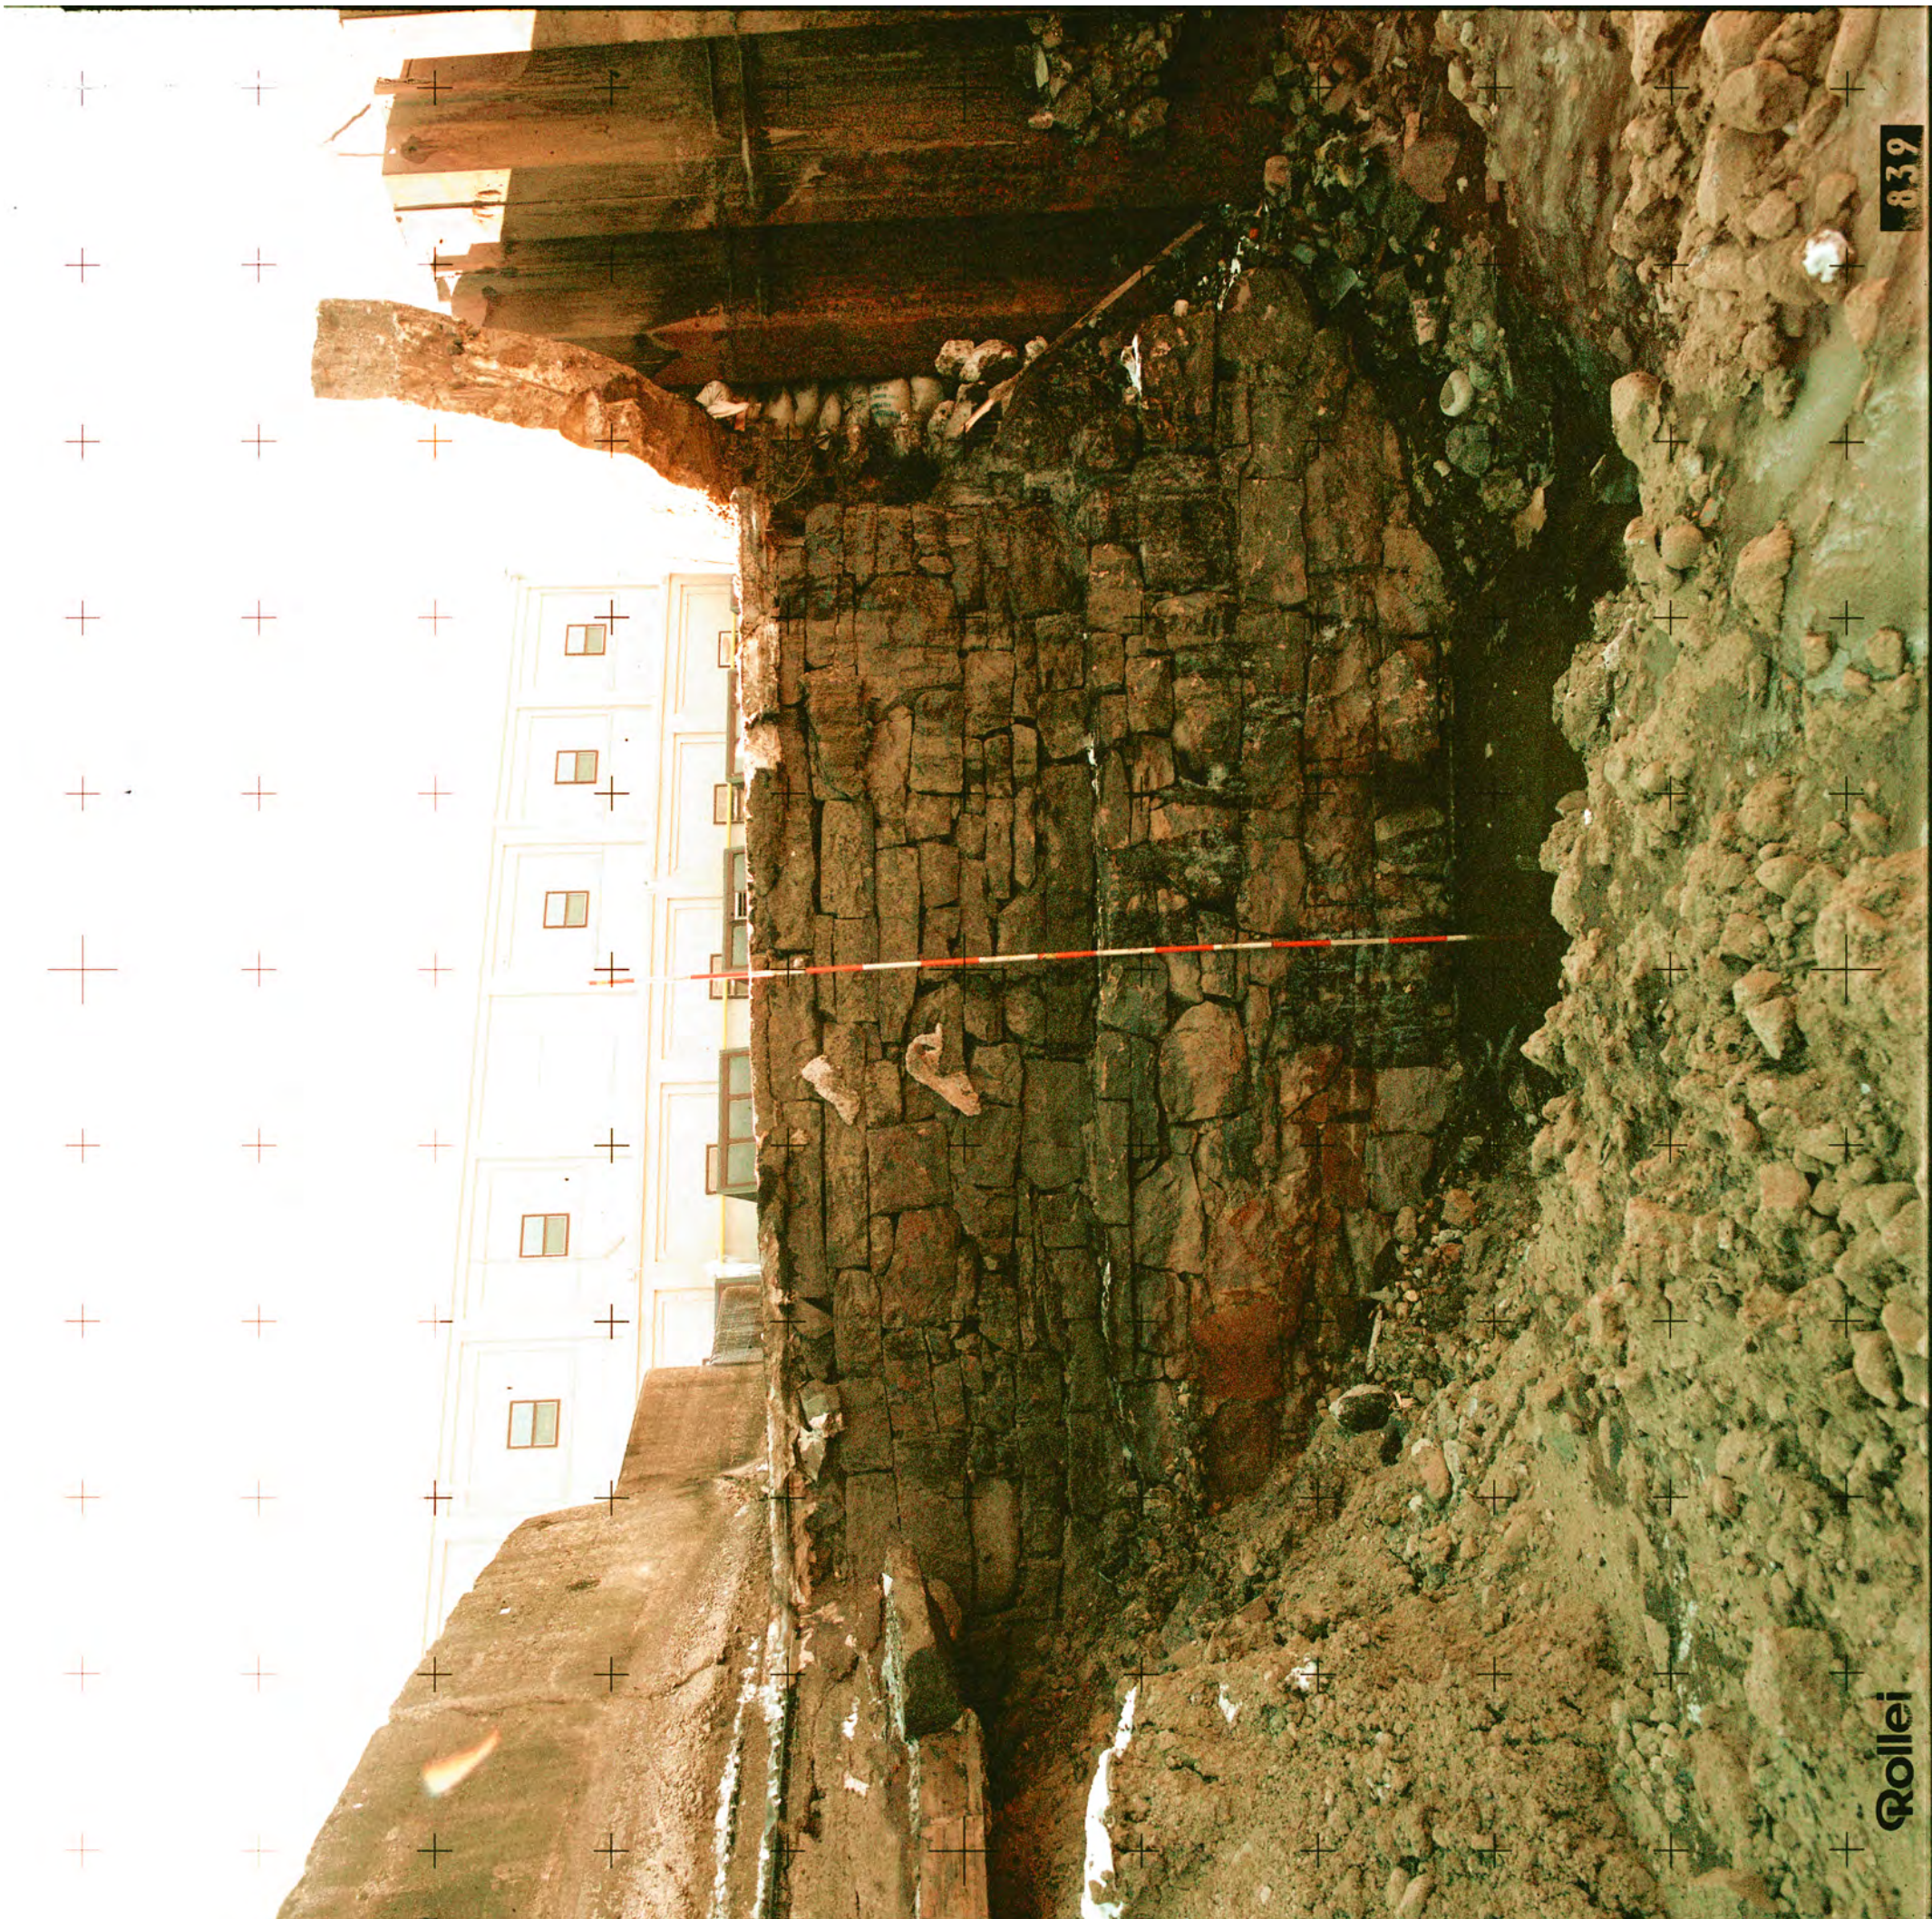
Figure 24: Rolleimetric flat field film image, looking west, at eastern face of Furnace Falls Dam exposed to 16 feet below spillway lip, January 21, 2004. Photo by Joel W. Grossman, Ph.D.
