The Archaeology of Furnace Falls:

A Mitigation Report on the Use of GIS, GPS & LIDAR
for the Definition & Documentation of Furnace Falls
Dam, Spillway, Weir & Channel

Stanhope/Netcong
Morris & Sussex Counties, New Jersey

Final Report to NJDEP - June, 2004

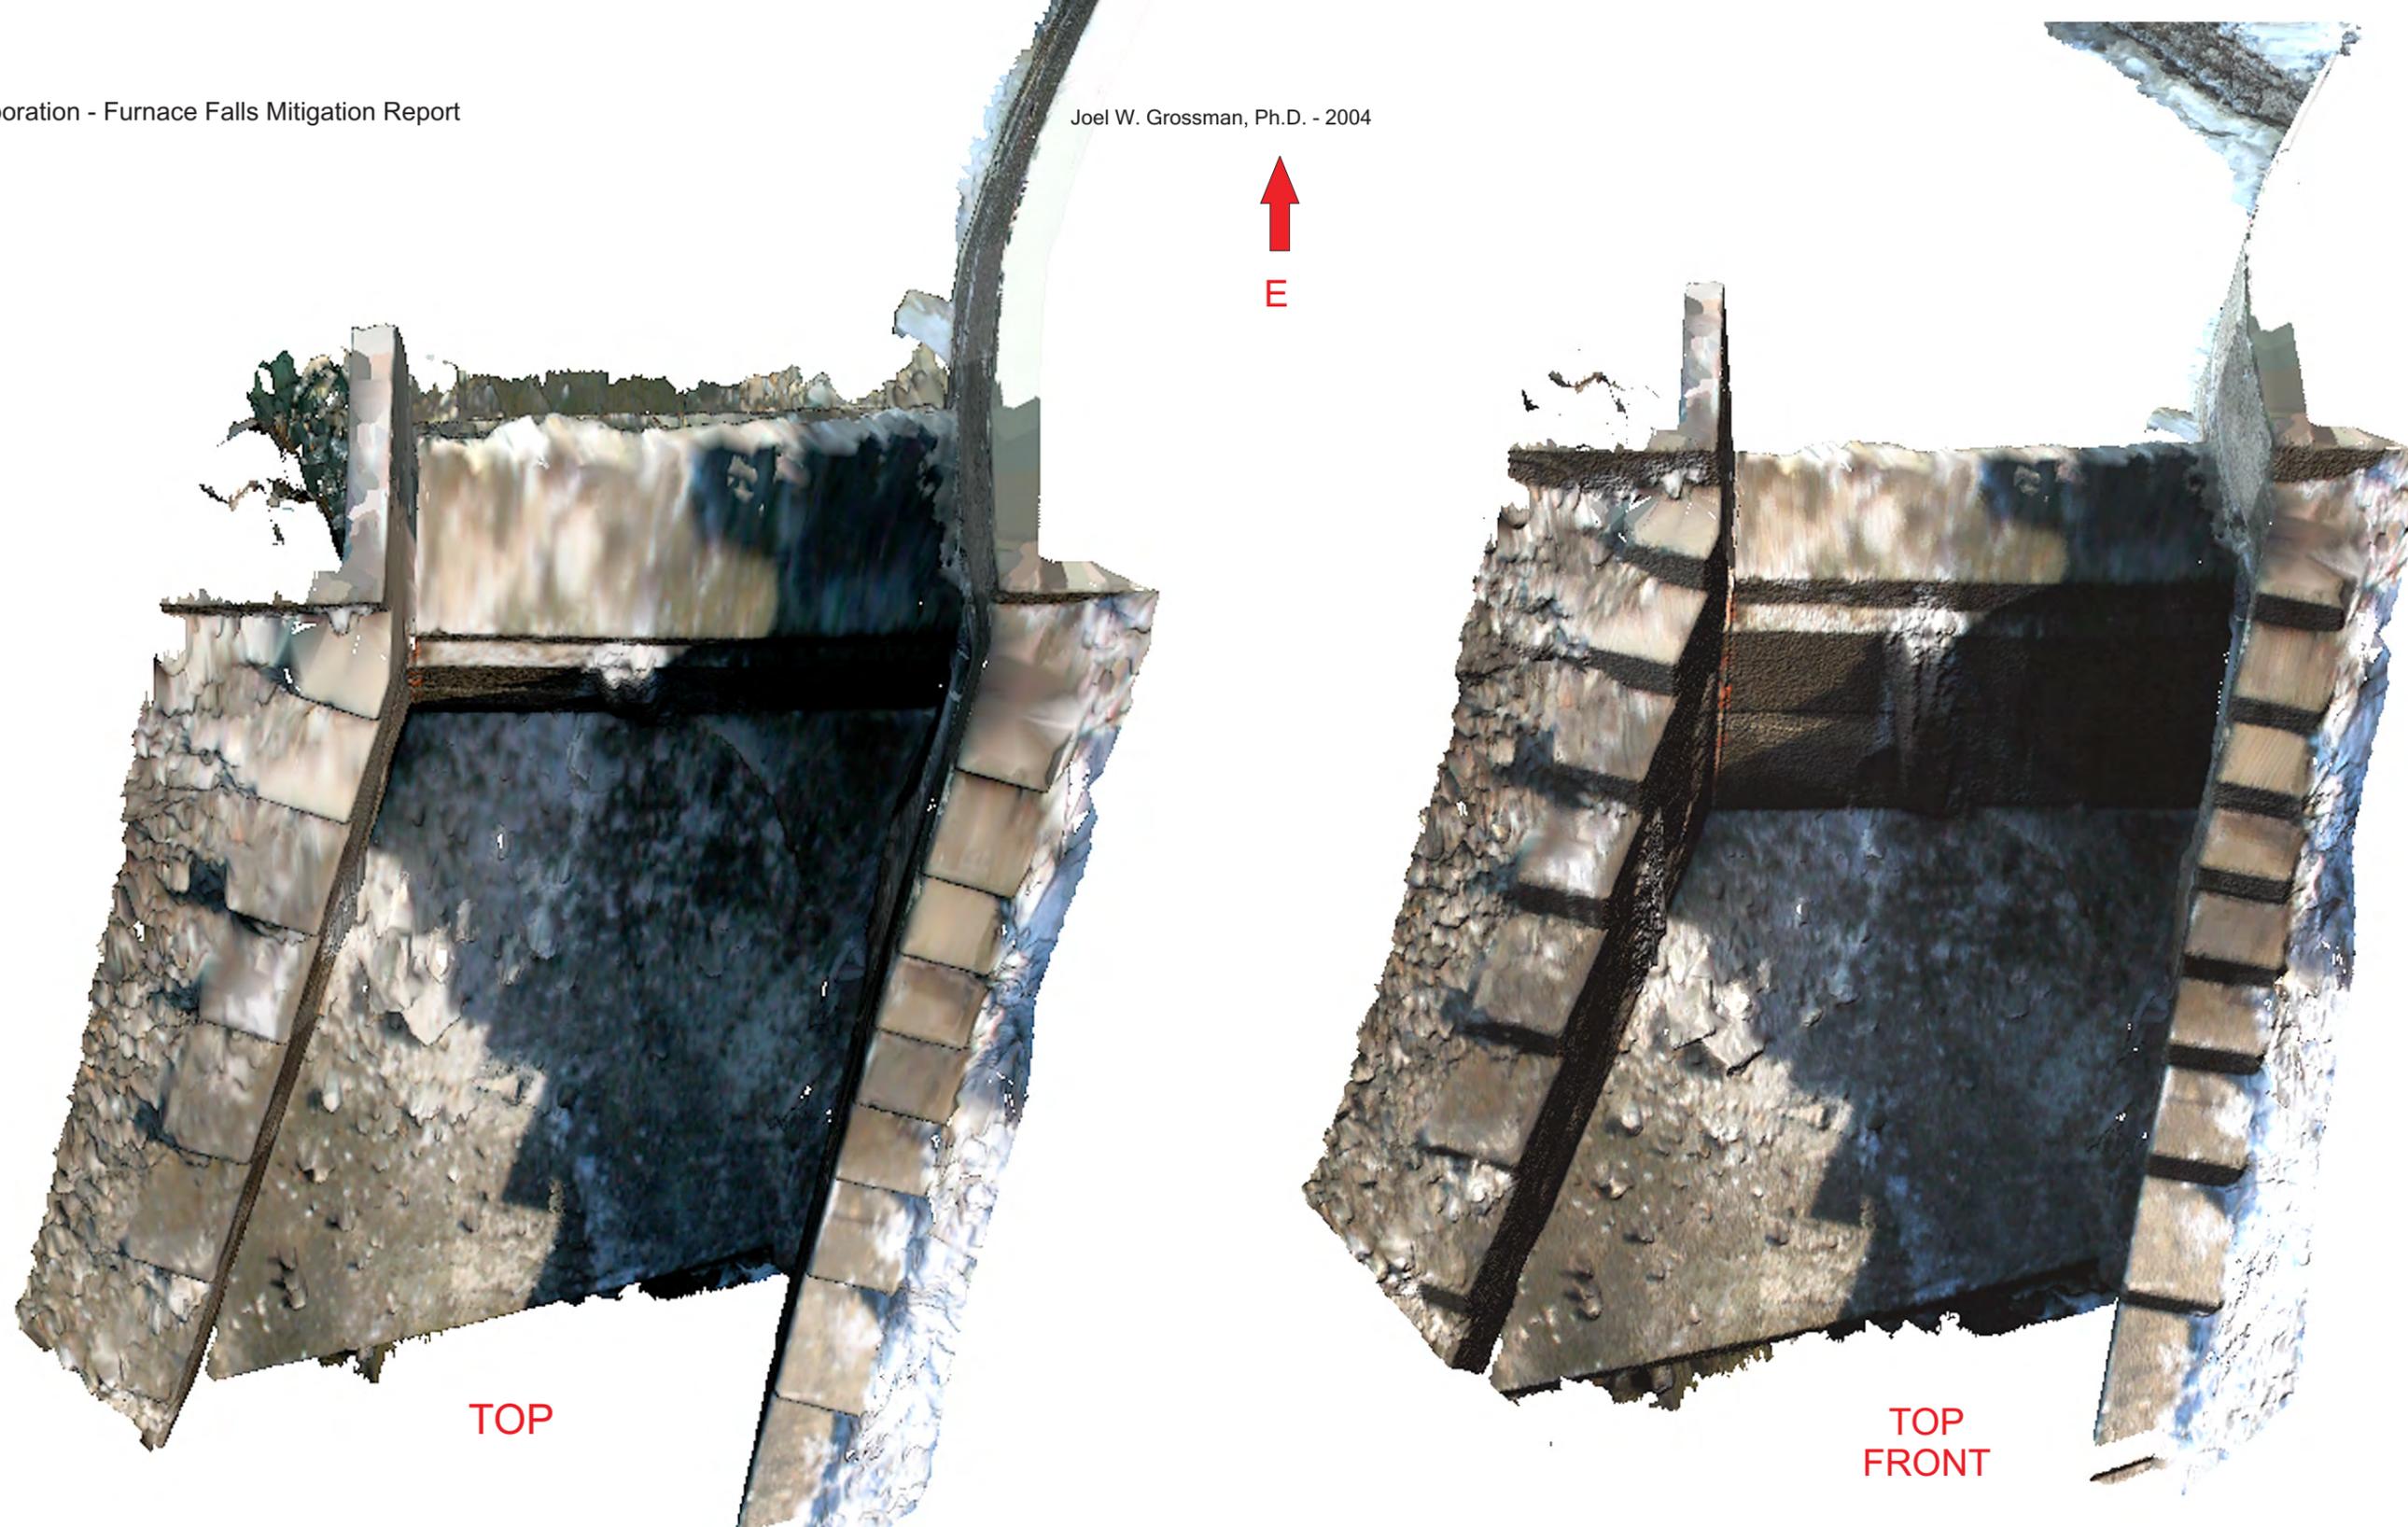
Figure 47: Virtual 3D color LIDAR overhead perspective view looking east at western cement face of Singer Spillway, with southern bank of channel and weir to the rear.

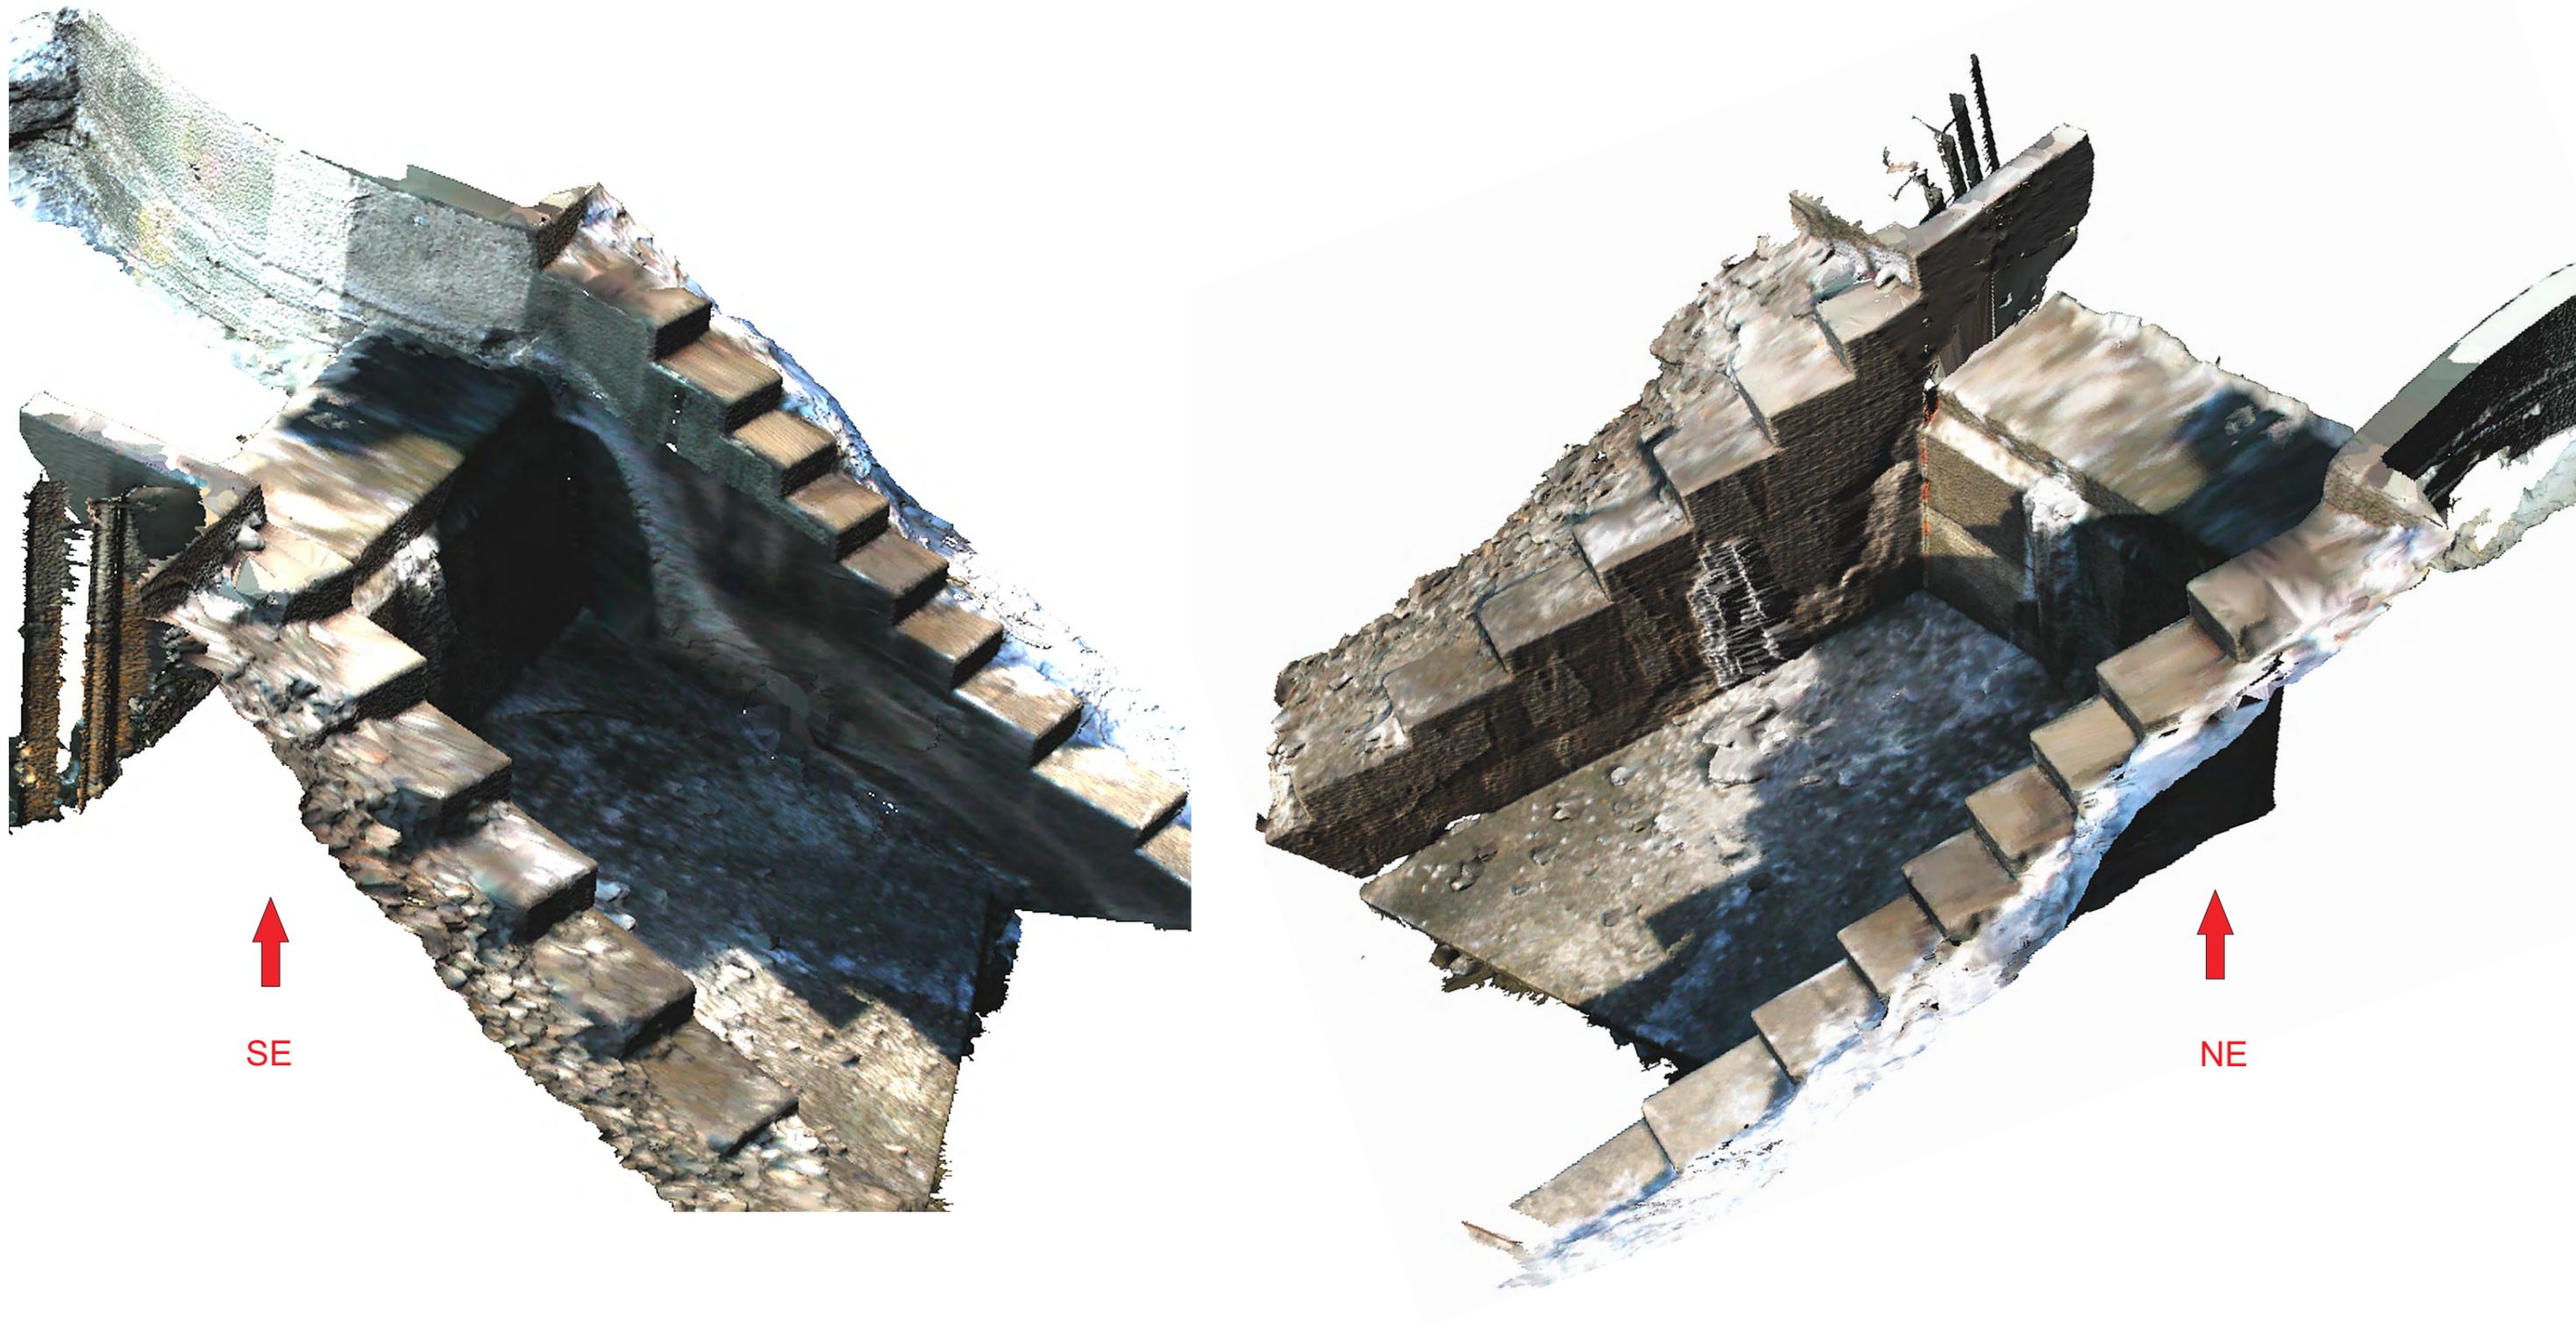
The first indication, as recorded by the LIDAR scan and by the digital video and photography, is that the outside face had a horizontal seam line at 5.9 ft. below the crest (el 824+), at the same elevation as, and parallel to, the eastern stone step on the opposite façade (Figures 48 & 49, NPI Plan 5/6 - Section F).

Figure 48: Two virtual 3D overhead views of the top and front (western) face of the recent cement Spillway additions to underlying early 1830 era cut stone dam.

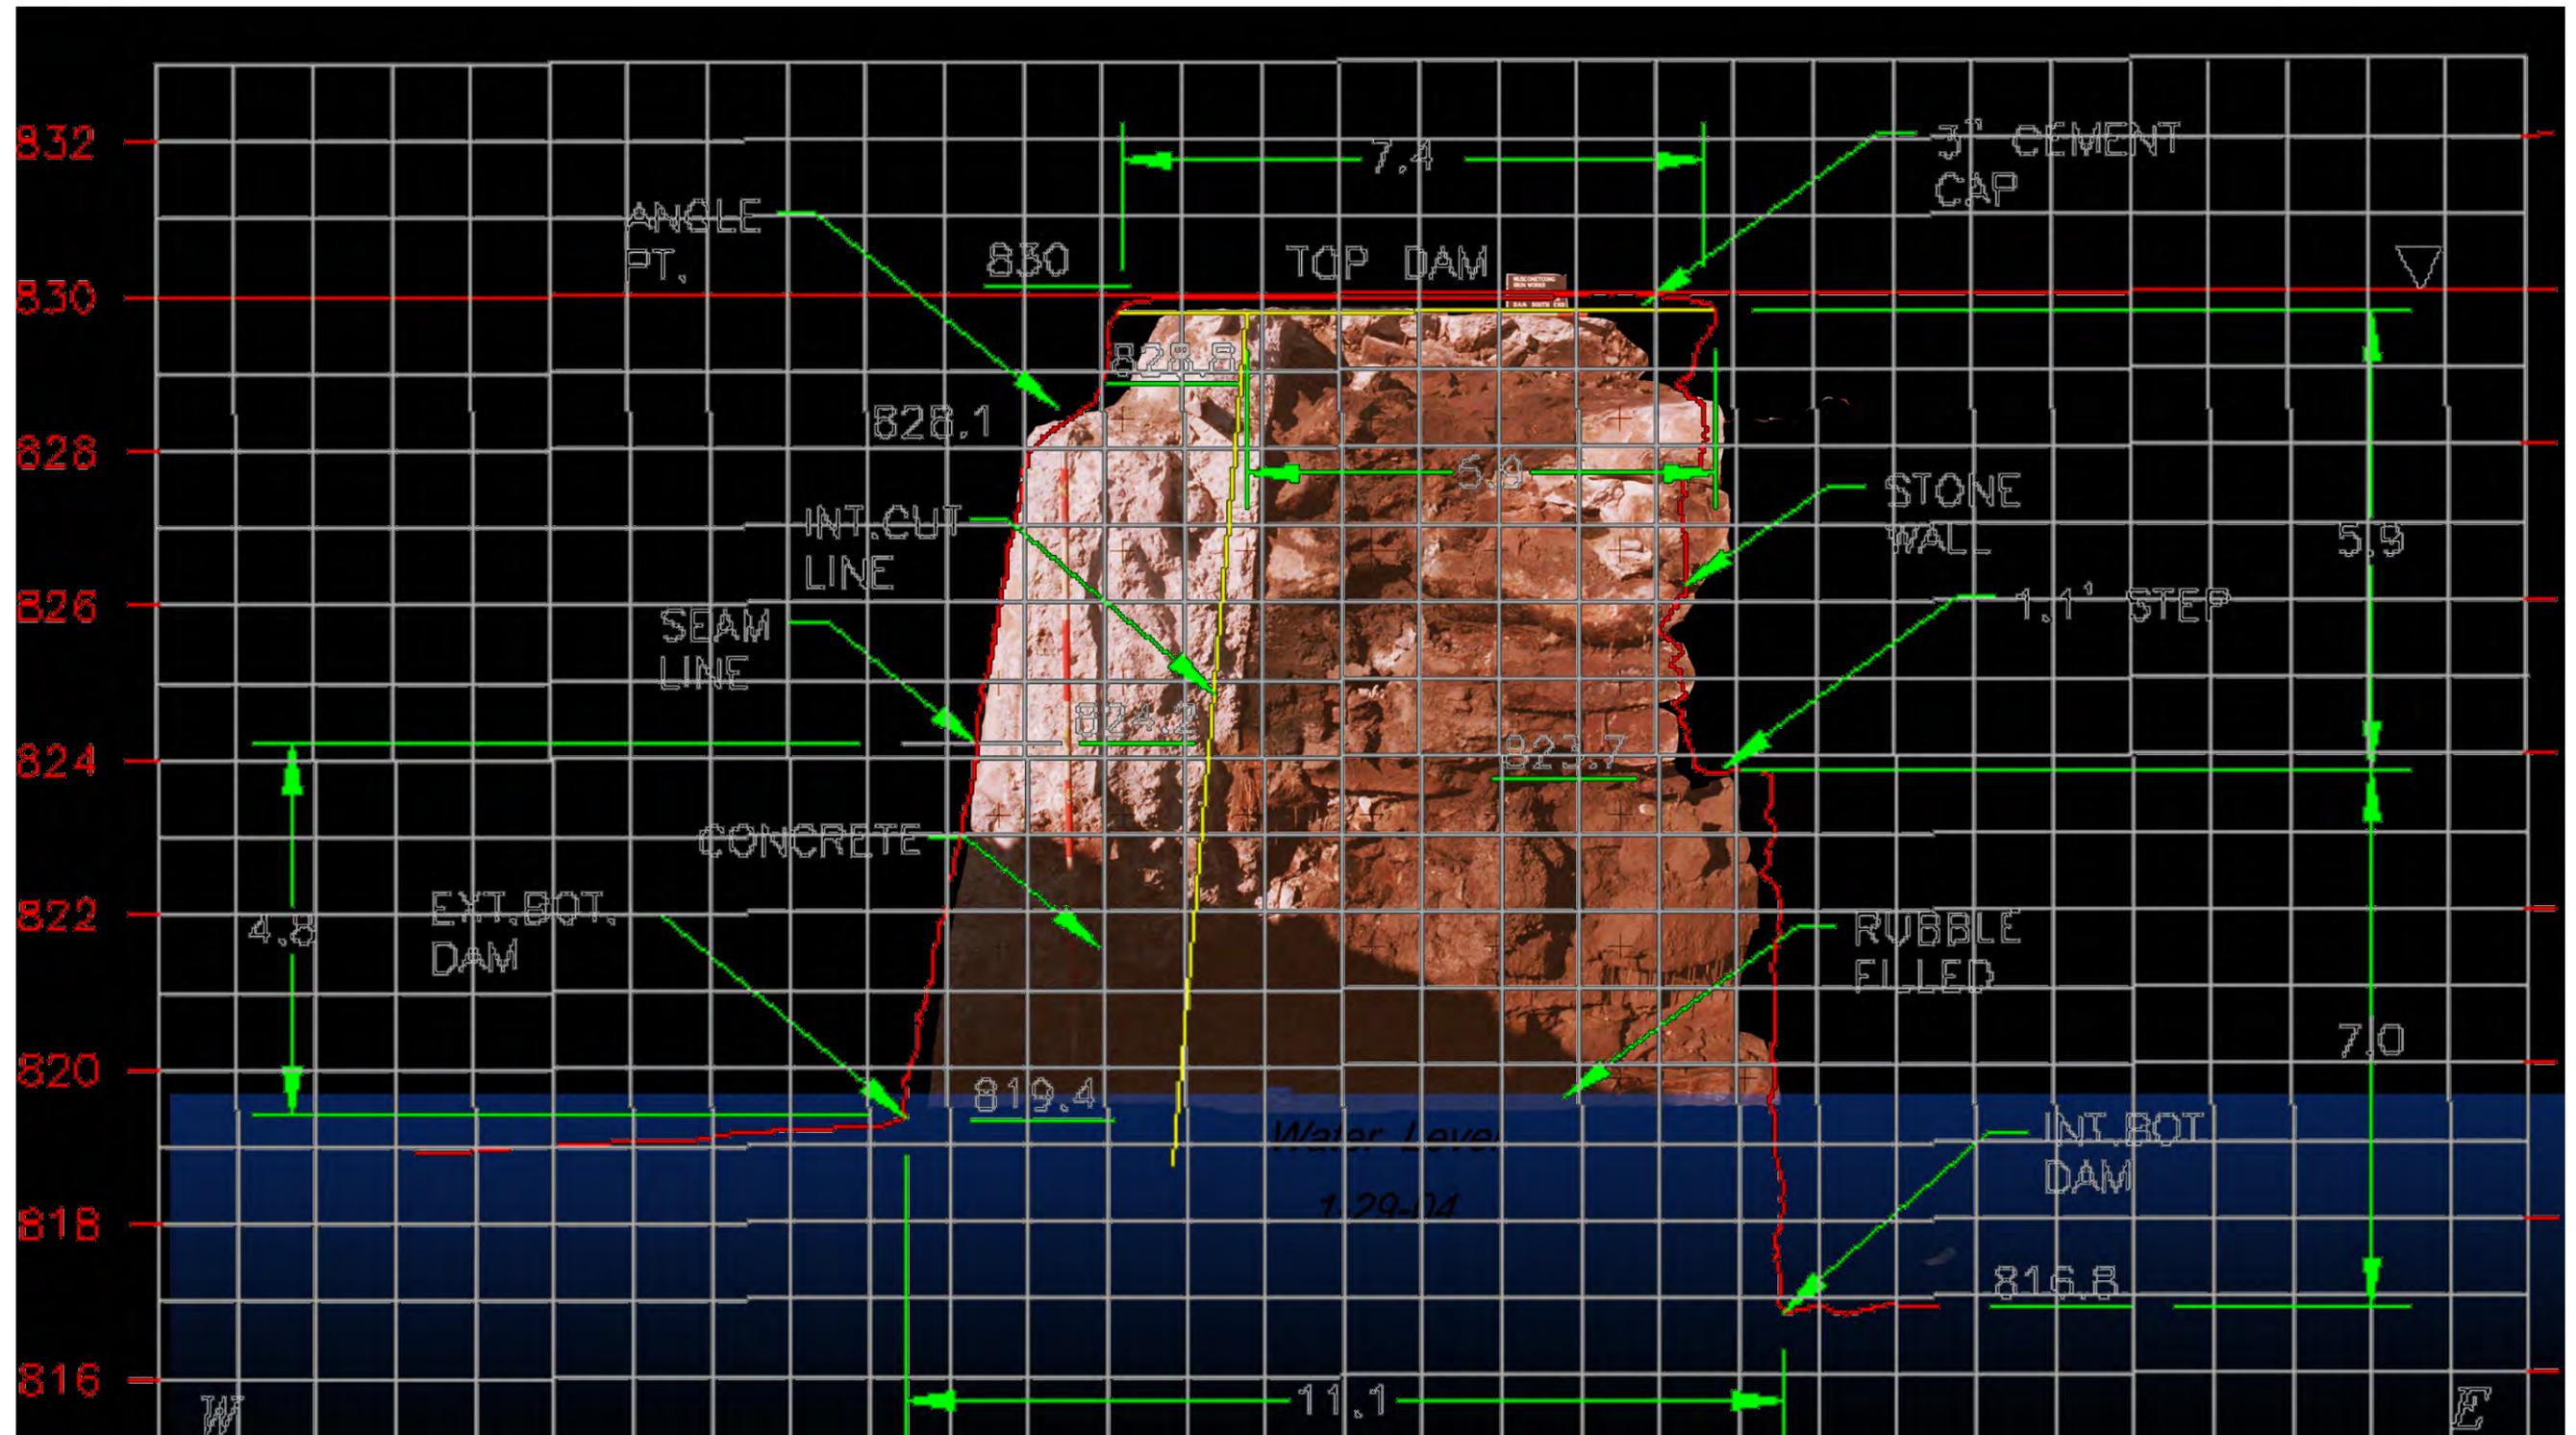
During the LIDAR survey, the top of the stone dam was capped by a 3–5 inch thick layer of cement, which in turn was covered by eight 8 inches of snow and ice. This cover of cement, snow and ice added about a foot to the height of the original dam. It also added an artificial extension, or eve, to the top eastern corner. This frozen overhang gave a false profile signature to the LIDAR scanner at the top eastern edge. As recorded in NPI profile Section “F”, and as captured in the Rolleimetric flat-field macro image, the original edge formed a clean 90 degree juncture at its vertical eastern edge (Figures 31 & 32).

Aside from an unavoidable dark shadow from the brightness and angle of the sun, the automatic wide angle (90 degree) lens of the Rolleimetric and the low light, high speed (800 ASA), high resolution *Fujicolor* film captured a detailed and vivid as well as accurate color record of the exposed face of the dam. The film-based Rolleimetric provided better color accuracy than the digital photography (Figures 29 & 30), which proved adept at capturing detail but had limitations in the color accuracy of red and earth color materials (Figure 31).

Figure 31: Rolleimetric film-based macro flat field photograph of southern profile of Furnace Falls Dam exposed to 11 feet (el: 819 ft.) below lip of spillway(@ 830 ft.). Note imbedded calibration marks for photogrammetric image rectification. Photo by Joel W. Grossman, Ph.D.
